HABILITATION THESIS

Bearing structures in architecture.

Assoc. Prof. Marius MOȘOARCĂ, PhD

*Faculty of Architecture and Urbanism
The "Politehnica" University of Timișoara*

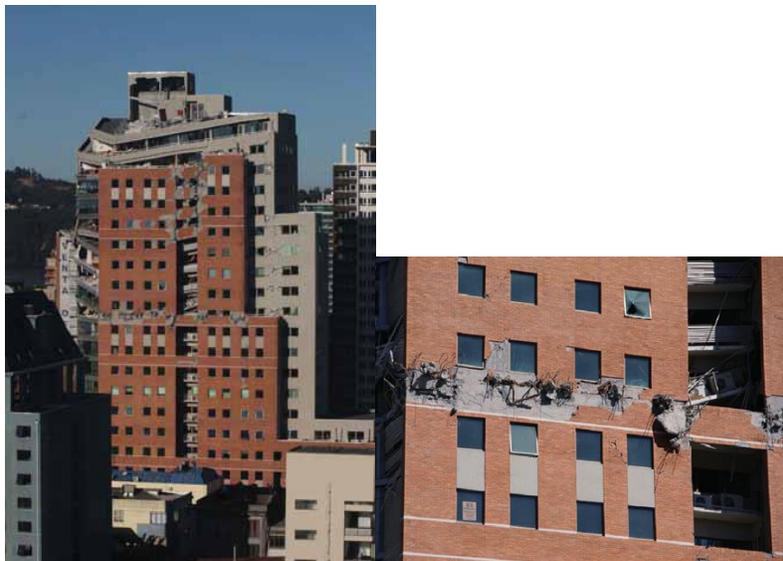
Fig. 2.1 Failures suffered by upper storeys of buildings: Concepcion, Chile [2.16]

Regarding this effect Kam and Pampanin [2.15] state: “the effects of the high vertical acceleration of the 22 February 2011 earthquake could have also amplified the compression force demand on RC walls with already non-negligible axial load”. These large values of the vertical components of the acceleration, together with other specific factors can even explain the particular failure, i.e.: the buckling of the structural walls. After the earthquake from Chile, Wallace and Moehle [2.6]: describe the phenomenon “a second global buckling mode begins with the spalling of cover concrete, leaving a relatively thin core with longitudinal reinforcement that tends to buckle laterally, displacing the remainder of the wall. As noted in the section on recent earthquake reconnaissance, the latter mode was widely observed in the 2010 Chile earthquake. This latter buckling mode has not been studied previously.” Another possible effect of these vertical components is the different zones in which plastic hinges occur. Generally, the plastic hinges and the failures occur at the base of the reinforced concrete shear walls, but, in figure 2.1 [2.2] it can be seen that, in Concepcion, the failures occurred at the upper storeys of the buildings.

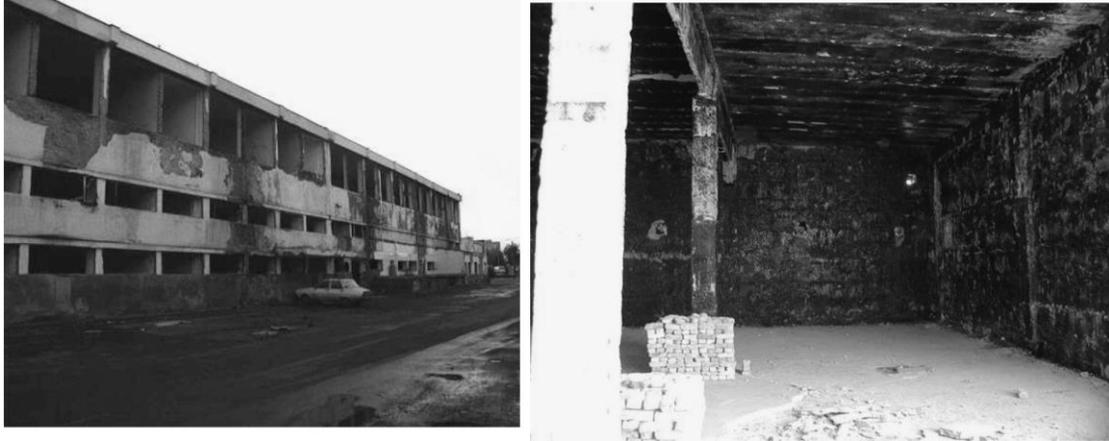
Fig. 2.40 Damage of the existing building

It was used as a meat smoking at the ground level and as meat refrigeration and depositing at the first storey. After 1990 the building was bought by a company which changed its destination, selling the existing equipments. Therefore, many years the building has remained out of the use, years contributing to the structure strong damage (Fig. 2.40).

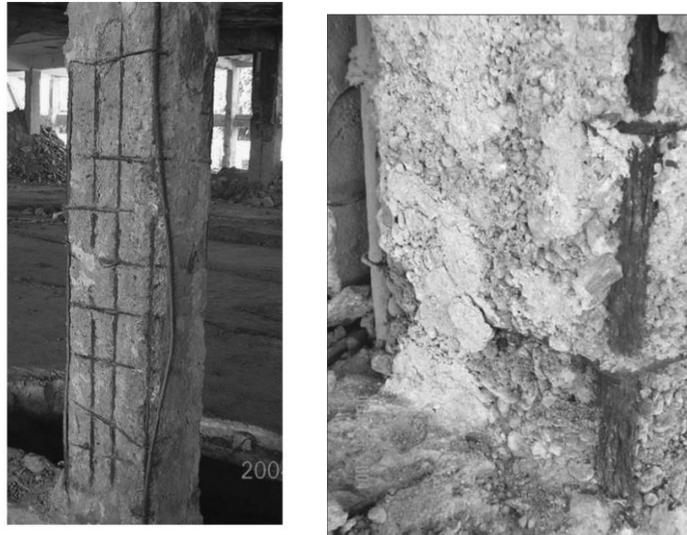
Fig. 2.41 Damage of columns

At the ground level, due to smoke and high temperature, the protection layers of RC columns were destroyed, increasing the corrosion of the steel corner bars (Fig. 2.41).

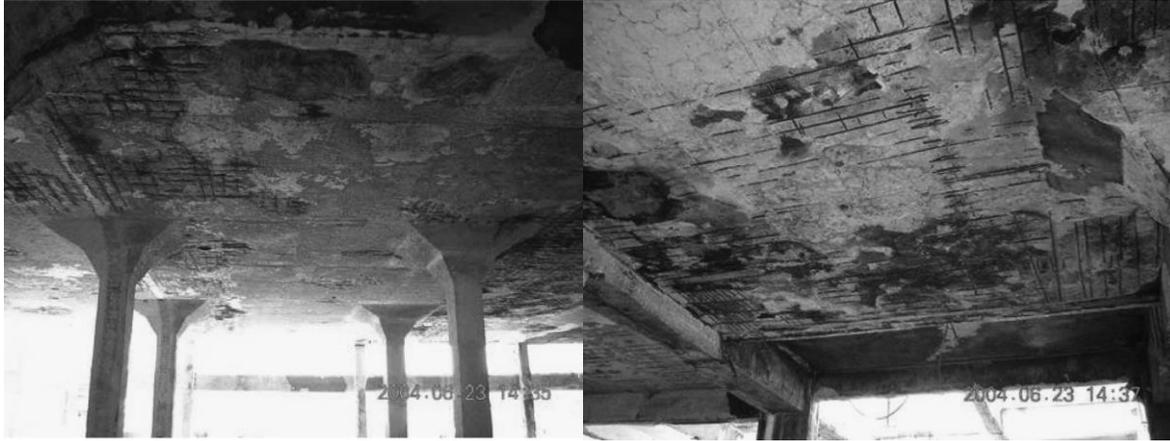
Fig. 2.42 Damage at the first floor

Due to an incorrect operation, required by the technological process, the water vapours from the ground level were condensed in the layer of thermal insulation between the two levels. Therefore, the permanent high humidity and the destroyed protection layer of floor reinforcement due to the smoke, the reinforcement area was reduced by approximately 50% (Fig. 2.42).

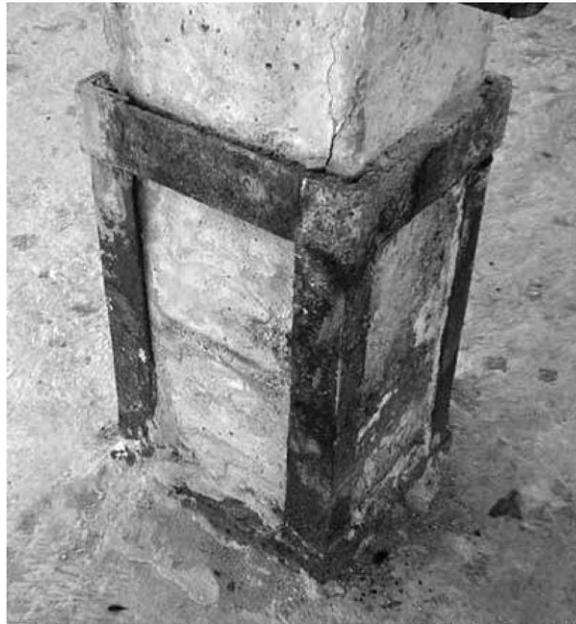
Fig. 2.43 Inadequate connections

At the first level, the main problems are related to the inadequate connections between precast elements (Fig. 2.43).

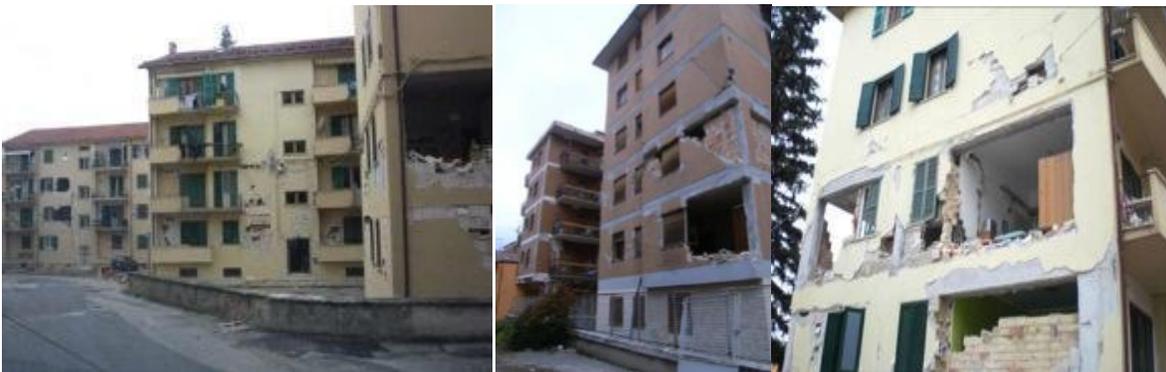
Fig. 2.48 Examples of in-plane and out-of-plane seismic damage to clay unit masonry infill walls

With reference to structural problems, it has to be underlined that they have only recently started calling additional attention, and still no suitable solutions, acceptable under all possible points of view (compliance with code required performance, safety, economy, aesthetics, durability, adequacy of design procedures, etc.), have been investigated and proposed [2.33]. This fact is particularly pronounced when the so-called non-structural elements are subjected to actions that forces them to behave structurally, as in the case of earthquakes, strong winds, etc (Fig. 2.48, 2.49).

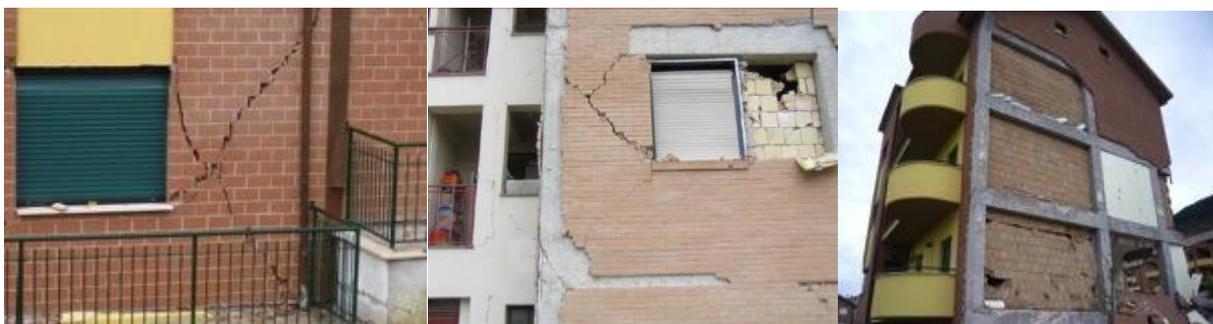
Fig. 2.49 Examples of in-plane and out-of-plane seismic damage to clay brick masonry veneers

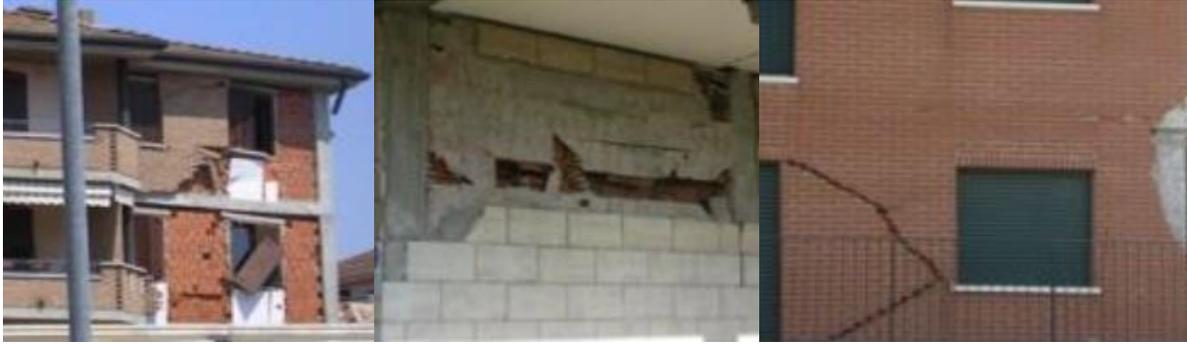
Fig. 2.52 Masonry infill and veneer damage: Emilia, Italy, 2012

The 2011 earthquake in Van (Turkey, Mw=7.1) once again demonstrated the highly variable nature of the seismic damage to infill walls in RC frame buildings. In some cases (Fig. 2.51a, b, c), the infill walls contributed significantly to strength and hence helped in the survival of the building. In some other situations (Fig. 2.51d), masonry infills detached from the structure and/or collapsed due to a combination of in and out-of-plane demand. This type of non-structural damage can be extremely dangerous for occupants [2.38], emphasising the importance of masonry infills in RC buildings and calling for the development of new systems for their improved performance (Fig.2.52).

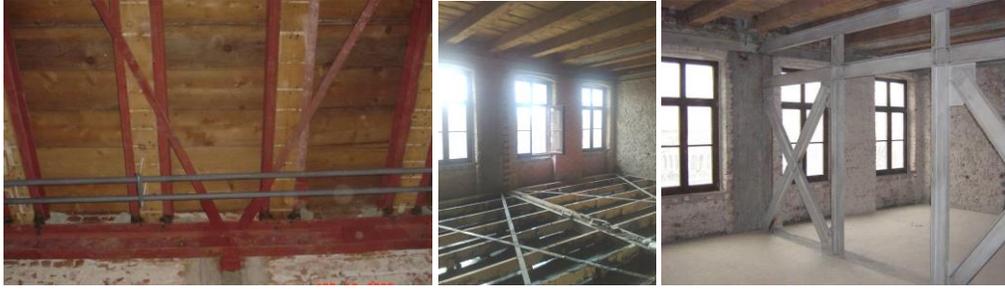
Fig. 5.24 Steel bracings a) for floors; b) vertical steel walls

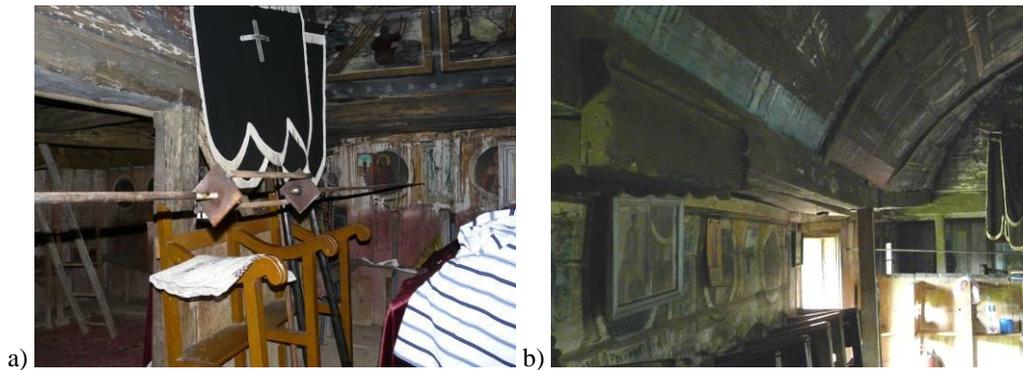
Fig. 6.4 Unauthorized strengthening interventions

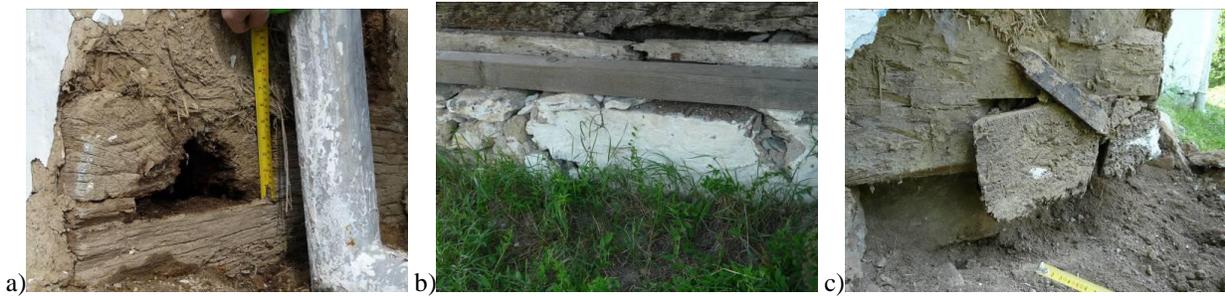
Fig. 6.7 a), b), c) Degradations and breaks of the horizontal wooden beams over the stone foundation
