JRC SCIENCE AND POLICY REPORTS

SEISMIC ENGINEERING RESEARCH INFRASTRUCTURES FOR EUROPEAN SYNERGIES

*Full-scale experimental
validation of dual
eccentrically braced frame
with removable links*

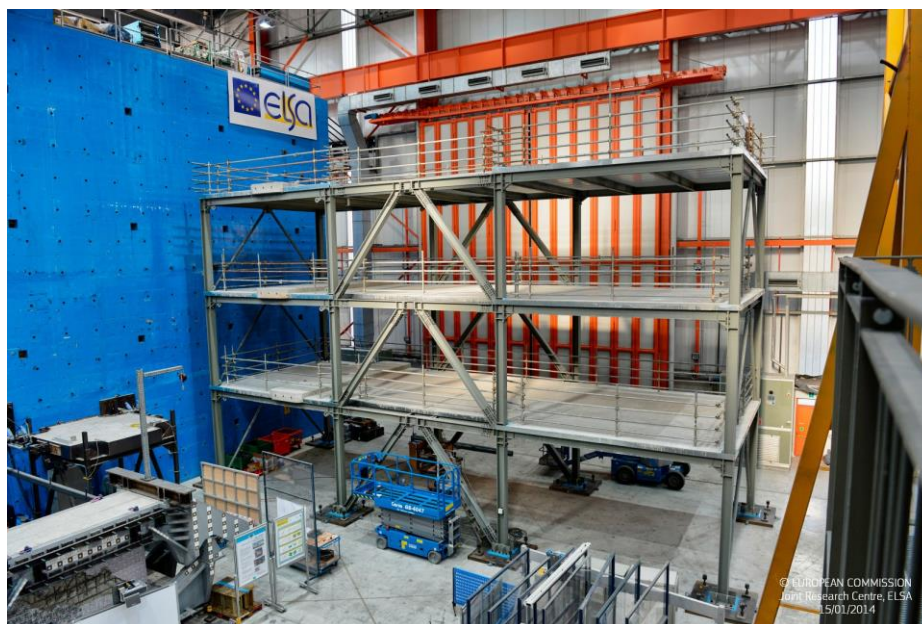
Figure 6. Experimental mock-up in front of the reaction wall.

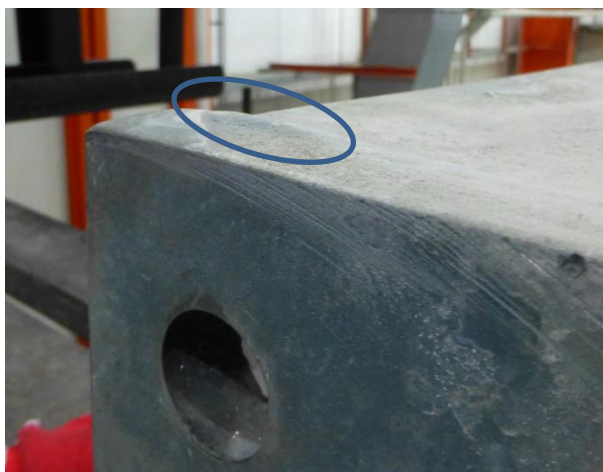
Figure 20. Welding irregularities

The installation of the seismic links after the snap-back test generated a series of difficulties due to some irregularities in the concrete slab and at the level of welding in the links (Figure 20). Another problem was the lack of space under the slab where the seismic links were fitted (Figure 21).

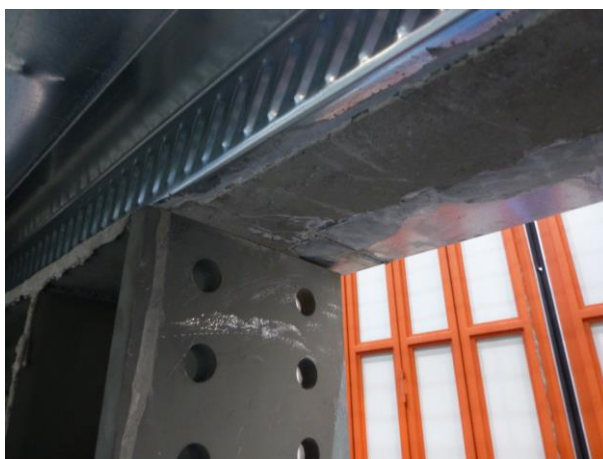
Figure 21. Slab irregularities

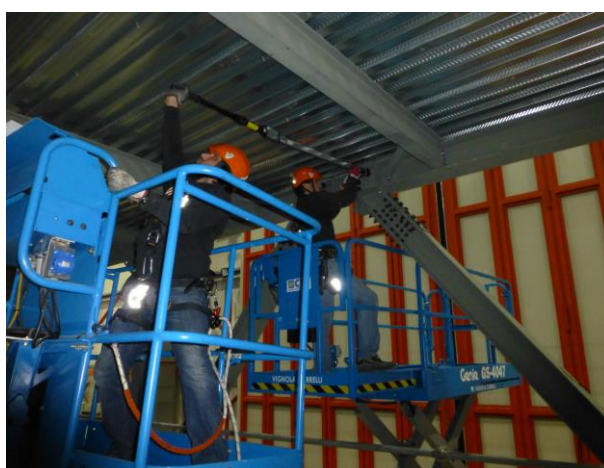
Figure 26. Mounting of the second floor link (northern side)

- Good support had to be provided to ensure that the torque was fully applied (approx. 50 kg at the end of the dynamometric key), therefore two support platforms were used (Figure 26).

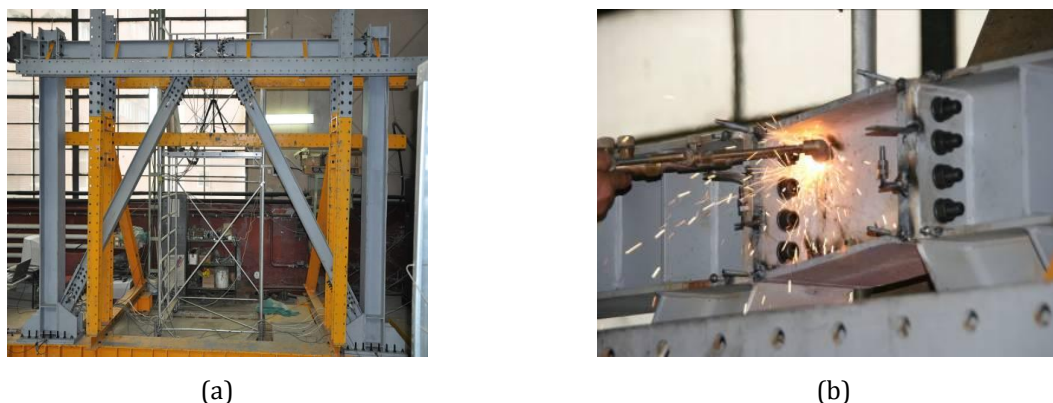
Figure 27. One story frame: (a) experimental setup and (b) flame cutting of the link.

Tests were performed at the Politehnica University of Timisoara on a one storey – one span eccentrically braced frame with a removable link (Figure 27) in order to check the feasibility of link removal through flame cutting (Stratan et al. [7]). It was found that by cutting out the web of the link by oxy-fuel cutting is not enough for eliminating the residual forces in the link, as flanges, in the absence of the web, also contribute to the shear stiffness of the link. Therefore, both the web and the flanges have to be flame cut in order to allow easy replacement of the links.

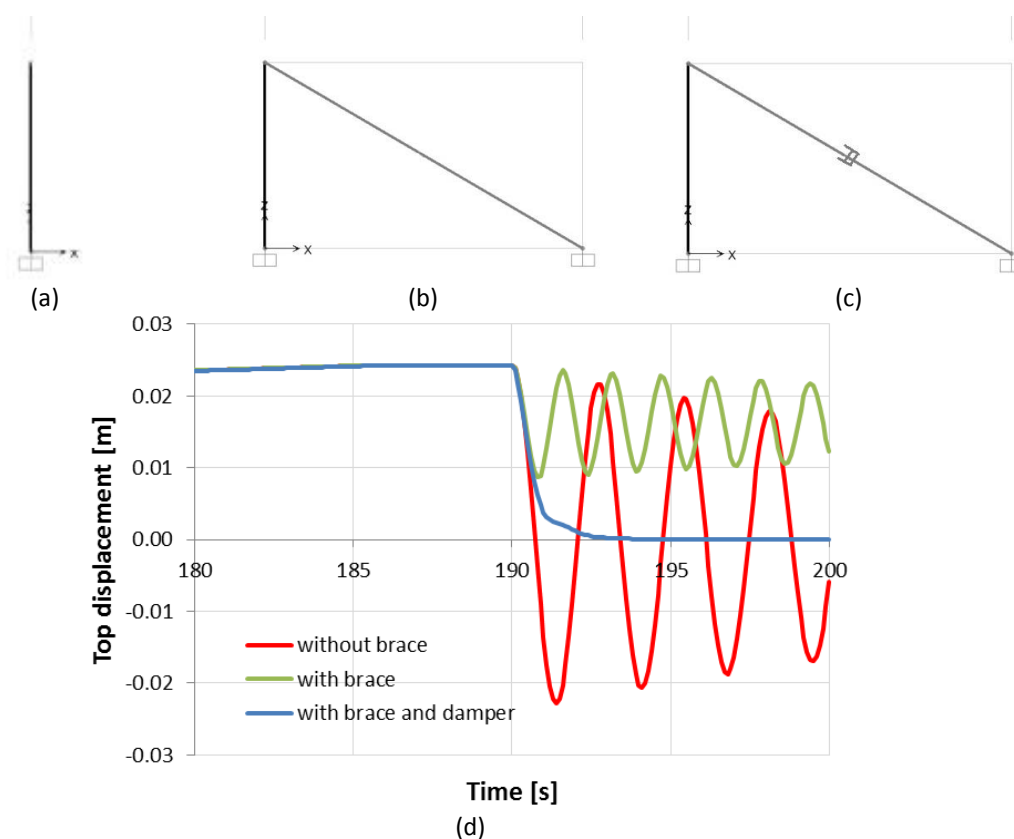
Figure 29. (a) Vertical cantilever; (b) Vertical cantilever with brace; (c) Vertical cantilever with brace and damper; (d) Time-history of displacements for the different configurations

Two solutions that would alleviate these vibrations were investigated. In the first case, a tension brace that releases force through manual or hydraulic de-tensioning (Figure 29b), while in the second one a bracing system composed of a brace with a damper (Figure 29). Damper properties were selected to provide a damping coefficient c close the critical one. Damper response was modelled using the law: $F_D=c \cdot v^\alpha$, with $\alpha=1$. It can be observed (Figure 29a) that the top displacement amplitude decreases by adding the tension brace but the structure still vibrates. Moreover, there is an important amplification (about 2) of the force in the brace with respect to the static force. However, when using the brace with damper, it can be observed that the structure doesn't vibrate, meaning that this is the safest solution. The brace force is very close to the force obtained from static linear analysis.

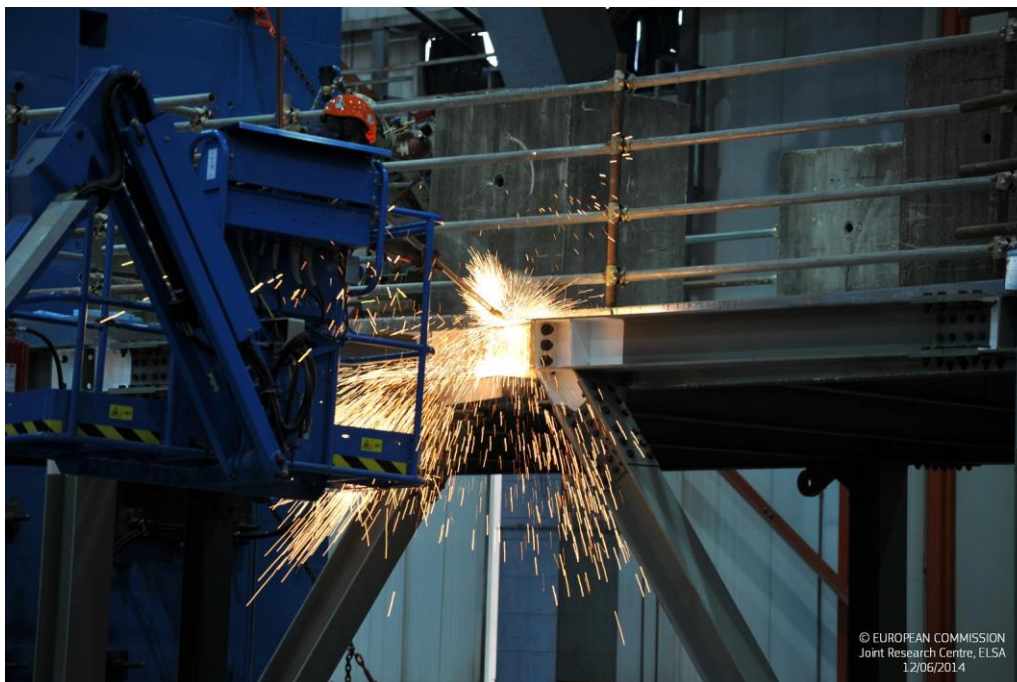
Figure 70. Cutting process of the links

web and flanges in vertical direction. The order of removal was from the third to the first floor on each side (Figure 70, Figure 71).

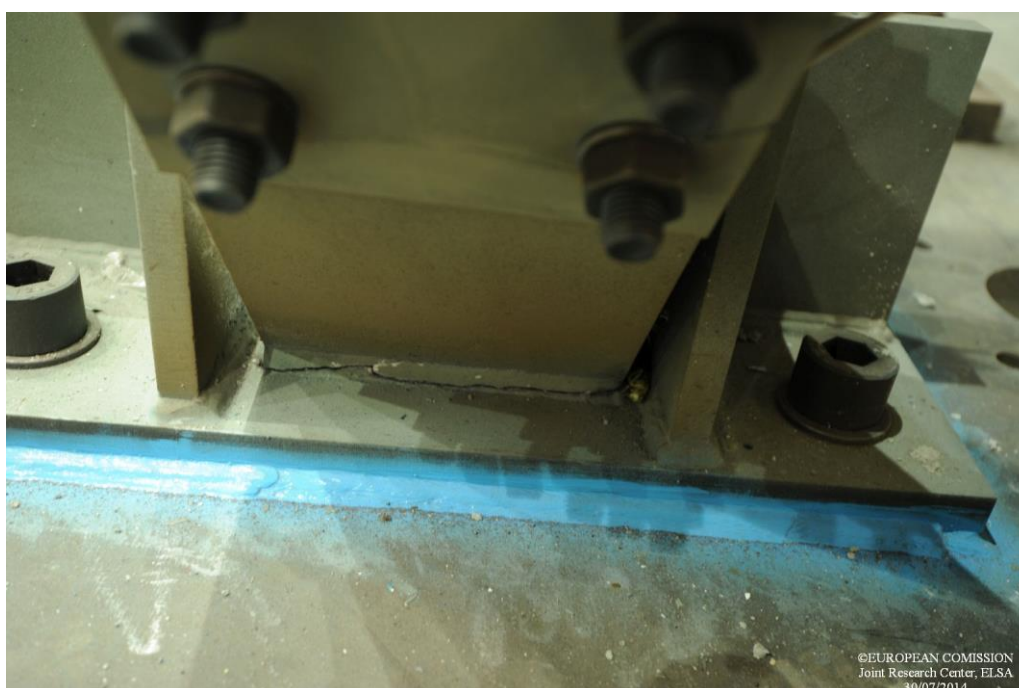
Figure 83. Brace's welding to the footing plate

The welding between the footing plate and the braces on SW side and NE had cracked during the experiment, major damage can be seen in Figure 83.

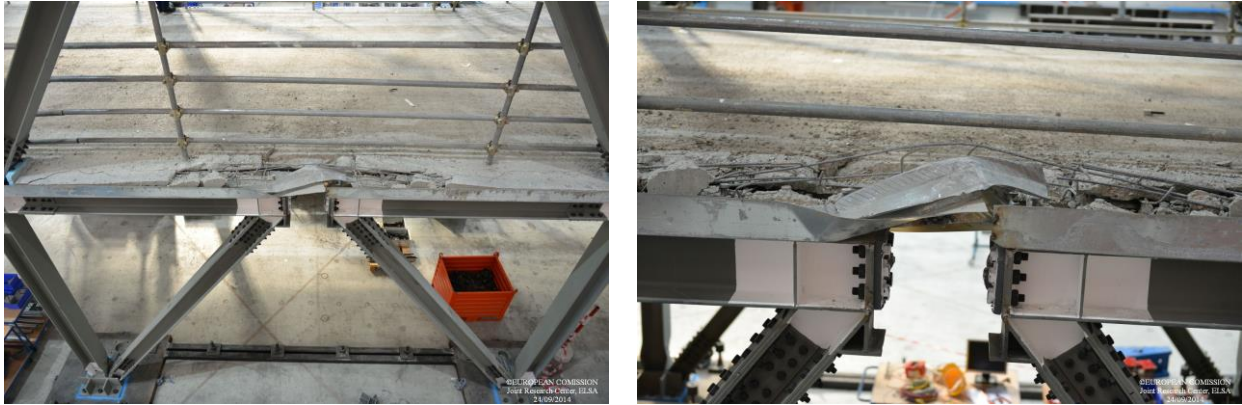
Figure 84. Damaged slab, 1st floor

The slab on the northern side suffered severe damage at the 1st and 2nd storey, leaving the area above the link completely uncovered as seen in Figure 84 and Figure 86, unlike for the 3rd storey where only a few cracks could be noticed. The southern side was left undamaged even at high deformations, since the steel elements did not pierce through the concrete.

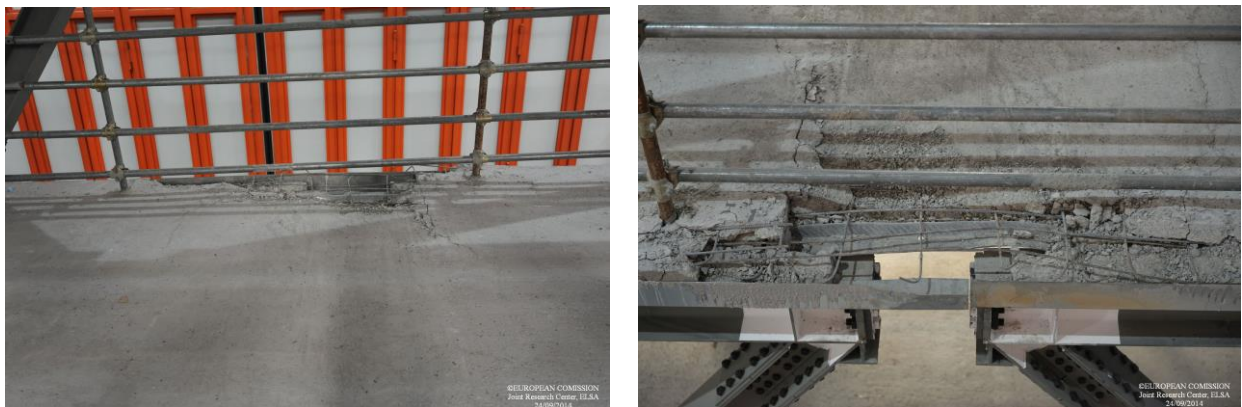
Figure 85. Damaged slab, 2nd floor

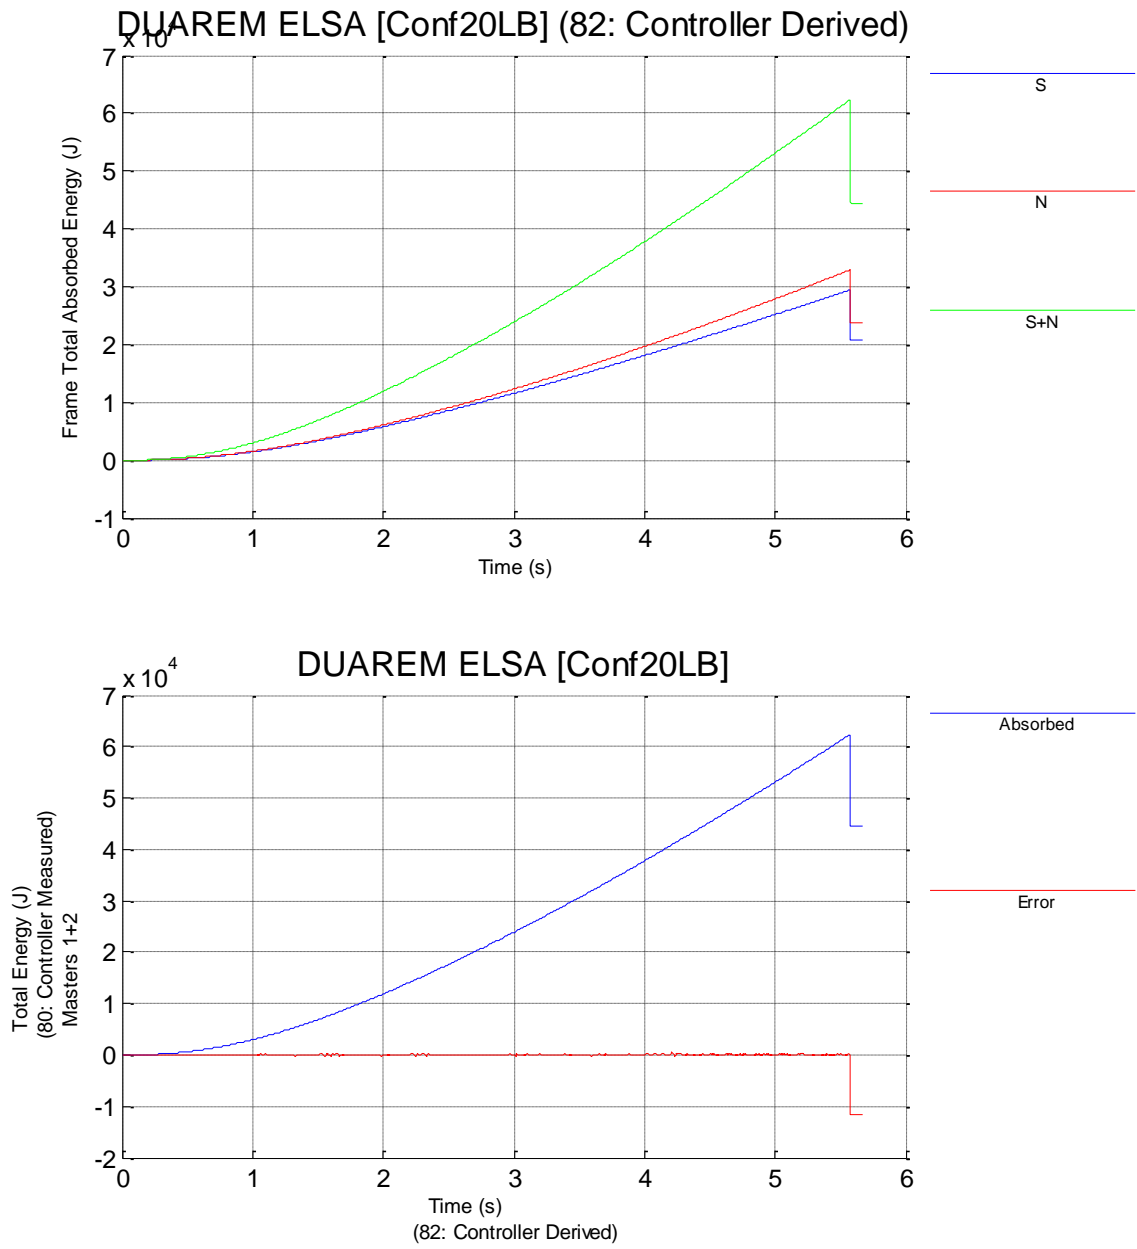
Figure 116 Push over test, Frame absorbed energy
