THE ROLE OF DUPLEX TREATMENT TO INCREASING THE CAVITATION EROSION RESISTANCE FOR STEELS USED IN MANUFACTURING HYDRAULIC EQUIPMENT

Doctoral thesis – Summary

author ing. Cristian GHERA

Timișoara 2017

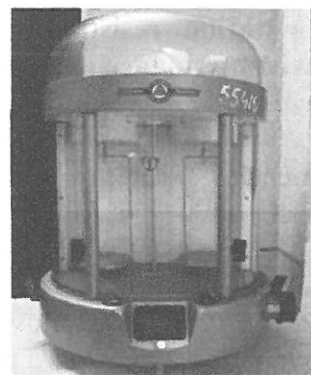
Fig.2.2. Analytical balance type Zatkłady Mechaniki Precyzyjnej WP1

The mass losses were determined by weighing on the analytical balance with an accuracy of 10^{-5} g, Fig. 2.2, and the roughness measurements were made using the Mitutoyo digital rugosimeter.

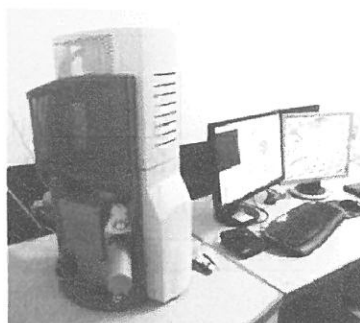
Fig.2.3. Scanning electron microscope TESCAN VEGA 3 LMU Bruker EDX Quantax

The microstructural investigations were done in the Materials Engineering Laboratory, using the provided equipment, such as the optical microscope, Fig. 2.4, the scanning electron microscope, Fig. 2.3, for capturing enlarged images at different scales and the determination of the chemical elements by dispersion analysis in energy and X-rays; Vickers microhardness, Fig. 2.6, for hardness measurements; respectively the X-ray diffractometer, brand X'Pert from the Phillips firm, Fig. 2.5 for the determination of the existent phases by X-ray diffraction analysis.

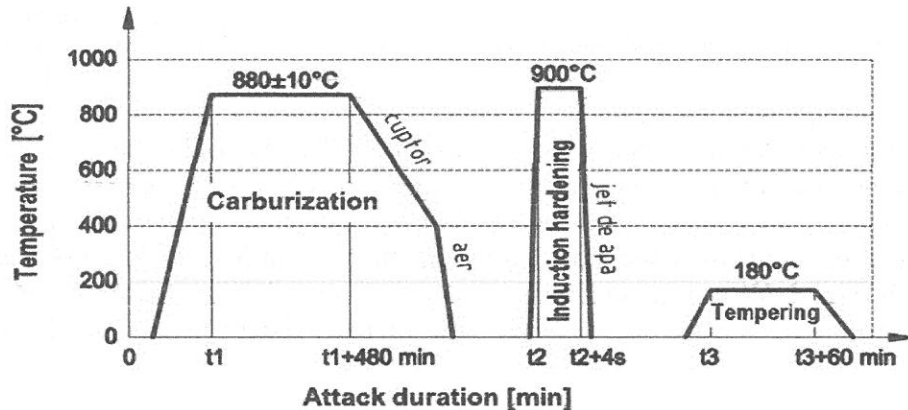
Fig.3.1. Duplex treatment cyclogram

Subsequently to the mechanical processing, a Duplex treatment was applied, according to the cyclogram of Fig. 3.1 [4, 11, 15], which consists of a thermochemical treatment by carburization in gas, followed by a heat treatment of surface by surface induction hardening, and tempering, having as a result the decrease of internal tensions.

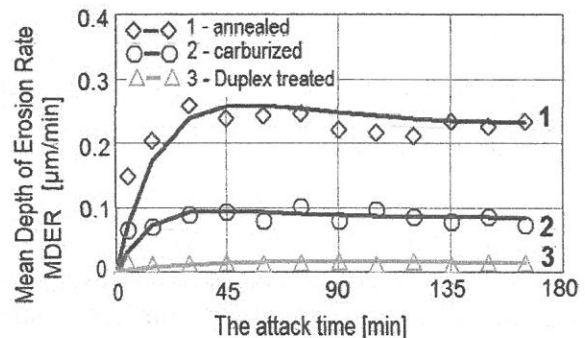
Fig.3.3. Comparisons between the variations of Mean Depth of Erosion Rate with the attack duration, specific to the three treatment regimes

The cavitation tests, performed according to the ASTM G32-2010 normative requirements, following which specific characteristic curves were raised: Mean Depth of Erosion MDE (t), Fig. 3.2, respectively Mean Depth of Erosion Rate MDER(t), Fig. 3.3.

From their evolutions, it can be noticed that the application of the Duplex treatment of carburization, followed by surface quenching by high frequency currents and tempering at low temperature, favors a speed reduction of the cavitation erosion of approx. 17 times compared to the annealed state and approx. 6 times compared to the carburized state.

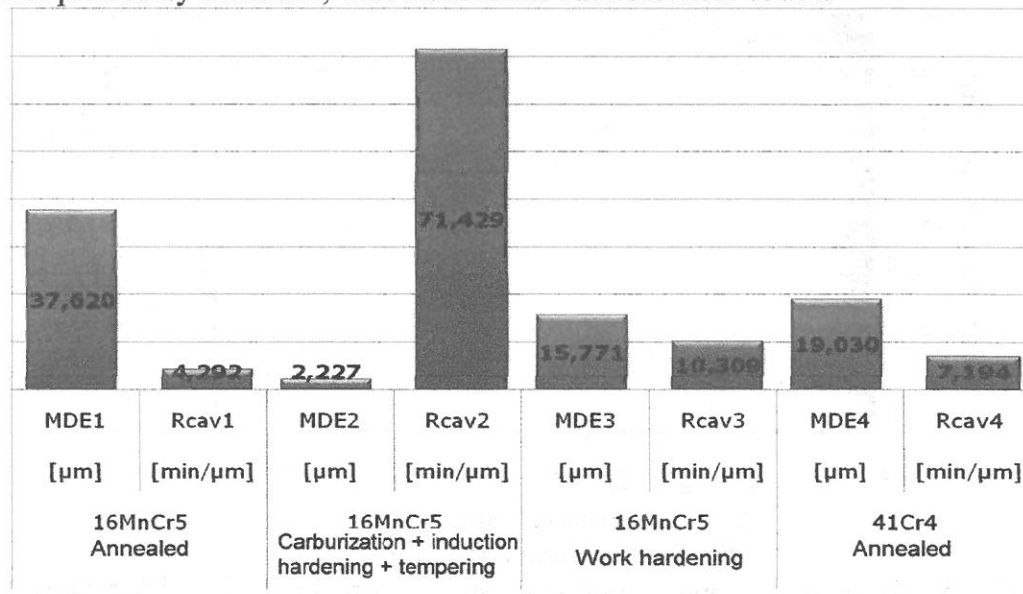
Fig.4.6. Variation of the cavitation destruction parameters depending on the applied treatment

These benefits can also be seen from the histogram shown in Fig. 4.5, in which the main characteristic parameters of cavitation resistance MDE and R_{cav} are compared, for the treatments previously described, with those of the standard steel 41Cr4.

From the analysis of the histogram shown in Fig.4.6, it is shown that by mechanical ecrusion with laser beam, the steel 16MnCr5 benefits of an increase of cavitation resistance of approx. 2,4 times compared to the annealed state, respectively with approx. 43% compared to the standard steel 41Cr4. We appreciate that this gain is caused by the increase in the hardness of the ecrused layer.

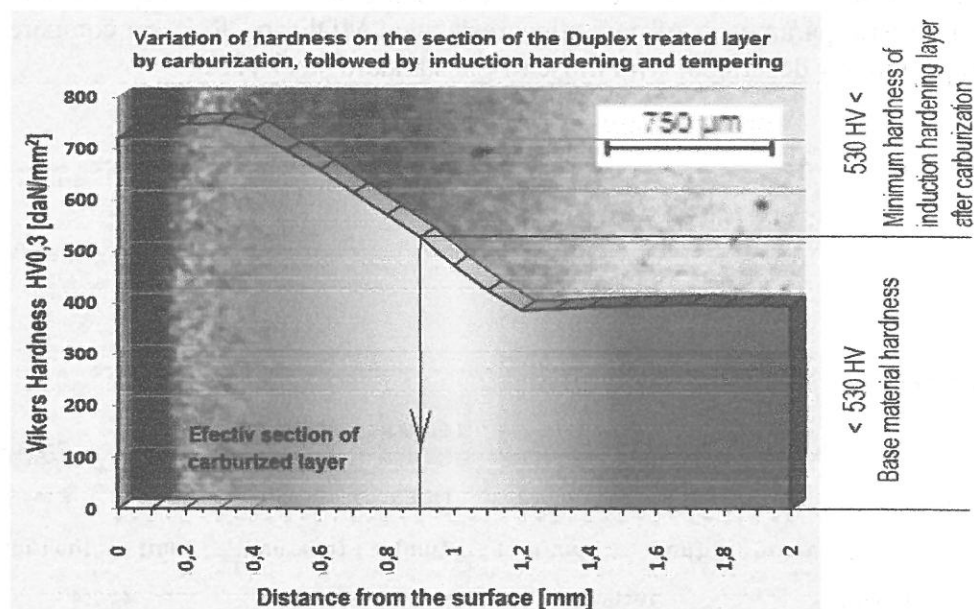
Fig.4.9. Gradient curve of hardness

decrease to the value of the core hardness, at a depth of approx. 0,2 mm.

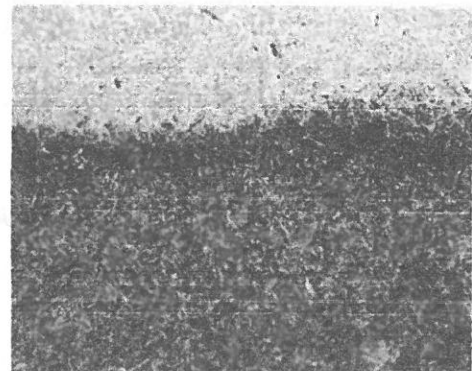
Fig.5.8. Microstructure of the gaseous nitrided layer – x500

annealed material is made of proeutectoid ferrite and bainite [14, 15], after the improvement a sorbitical tempering structure results, made of acicular ferrite and globular carbides [14, 15], which provides the best ratio between resistance, ductility and tenacity.

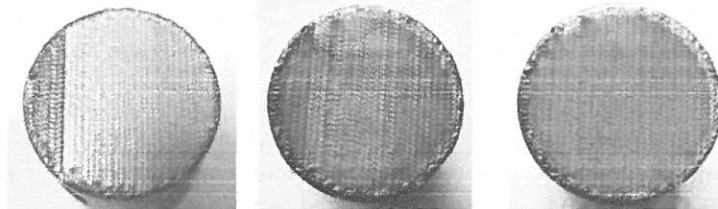
Nitrided sample with laser beam at $P = 120 \text{ W}$

Nitrided sample with laser beam at $P = 180 \text{ W}$

Nitrided
sample with
laser beam at
P = 240 W

Time 0 min 90 min 165 min
