**TECHNIQUES FOR THE OPTIMIZATION OF THE RESISTANCE TO CAVITATION
EROSION OF CERTAIN Cu-Zn AND Cu-Sn ALLOYS**

PhD Thesis - Summary
for the award of the PhD degree
Polytechnic University of Timisoara
in the field of Mechanical Engineering

Author Eng. Iosif LAZĂR

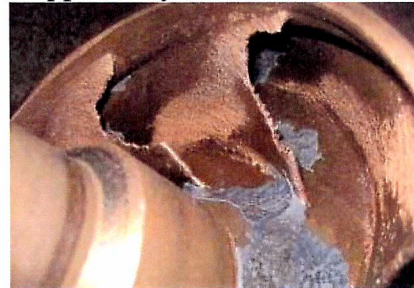
Fig.1.13 Cavitation eroded centrifugal pump components

a) Bronze centrifugal pump rotor [71]

Destroyed by cavitation

b) Centrifugal pump rotor with a common bronze stem, [72], [94]

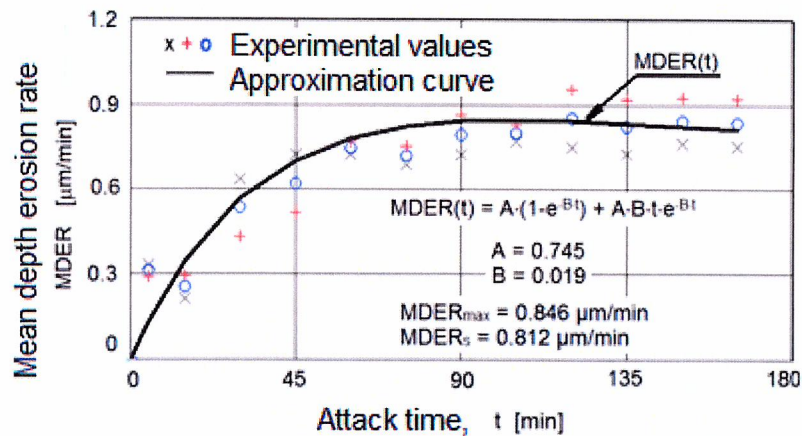
Fig.3.3 Evolution of mean depth erosion rate against cavitation exposure time

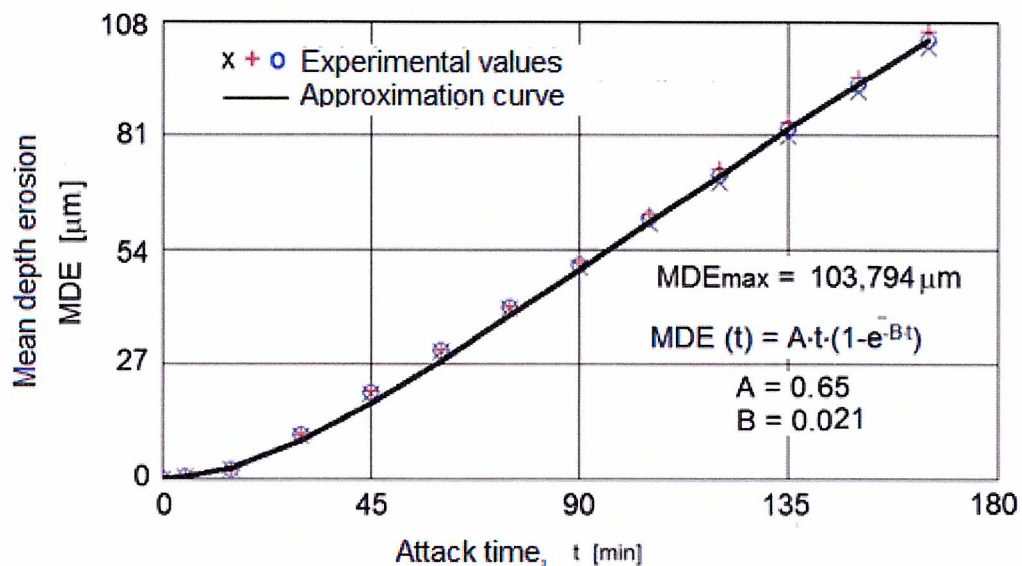
Fig.3.14 Evolution of mean depth erosion against cavitation exposure time

Fig. 3.14 and Fig. 3.15 present the specific diagrams using the experimental values, recorded on the three tested samples, for the cumulated average erosion depth (MDE), the average erosion penetration speed (MDER), and the approximation and mediation curves for these values, MDE(t) and MDER(t).

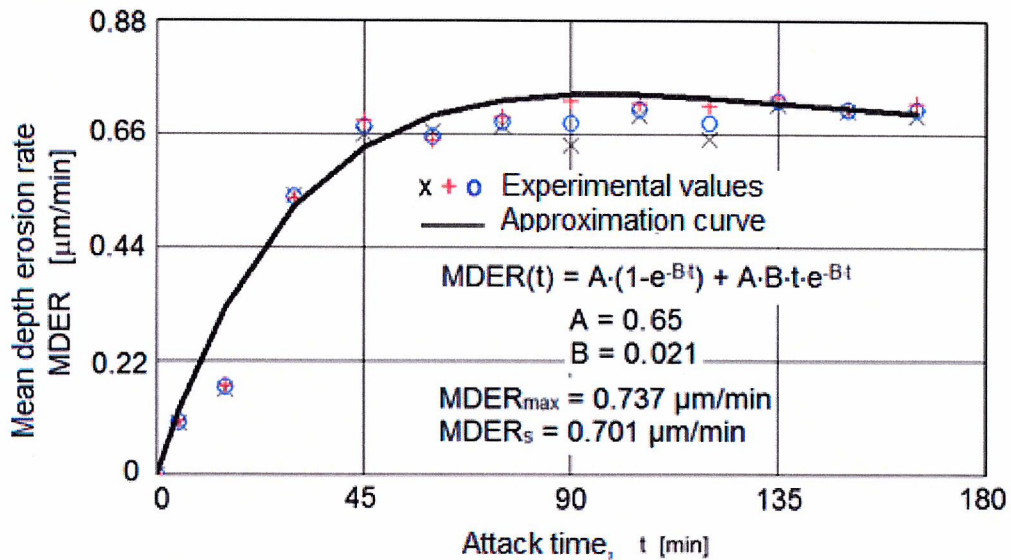
Fig.3.15 Evolution of mean depth erosion rate against cavitation exposure time

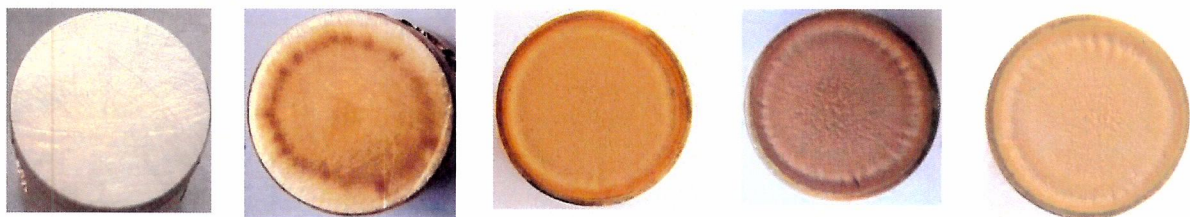
Min 0 Min 15 Min 90 Min 135 Min 165
 Fig.3. Images of specimen surface at different cavitation exposure time (Sample 2)

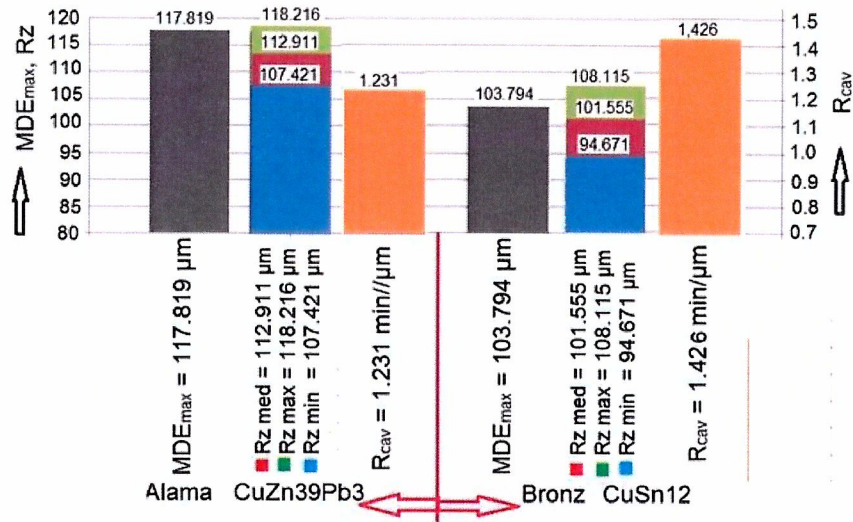
Fig.3.27 Bar chart estimating the resistance to cavitation erosion-corrosion, by comparing the values of the specific parameters

The differences result from a better behavior of bronze (CuSn12), as shown in the bar chart from fig. 3.27, which compares the erosion parameters (cumulated average erosion depth, after 165 minutes of cavitation erosion-corrosion attack, MDE_{max} and the cavitation resistance, $R_{cav} = 1/MDER_s$) and also by comparing the values of the roughness parameter R_z

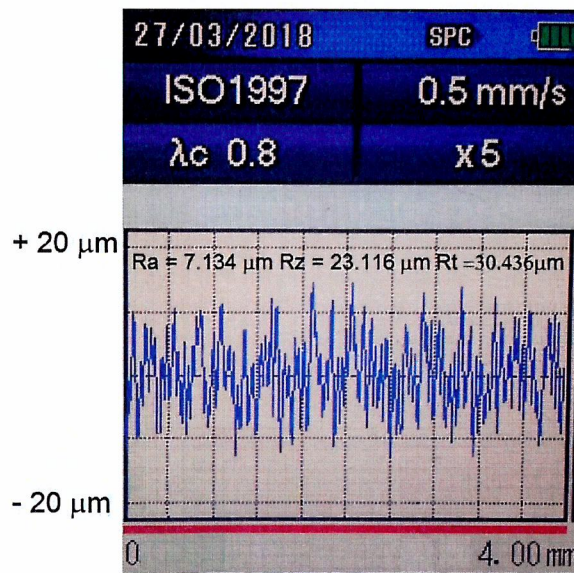
Fig.4.8 Roughness parameters and profile registered with the Mitutoyo SJ 201 P device (**Sample 1**)

Fig. 4.8 shows the profile diagram with the values of the three reference parameters (R_a , R_z si R_t), as recorded with the Mitutoyo SJ 201 analyzer.

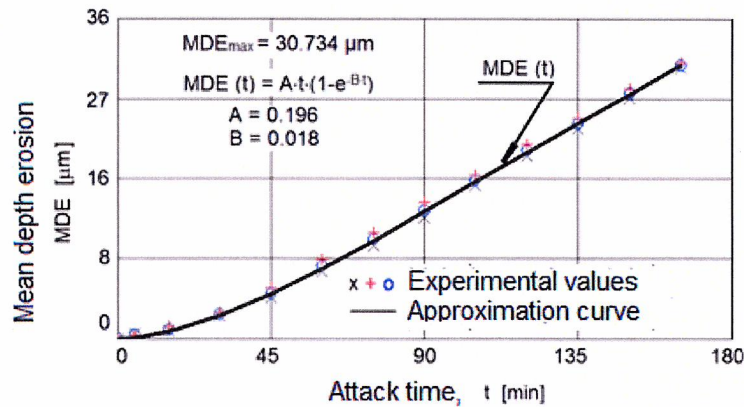
Fig. 4.11 Evolution of mean depth erosion against cavitation exposure time

The statistical processing of the experimental data obtained for the three samples, with a 0.253 standard deviation and a frequency band within a 99% tolerance, shows that the entire research process, carried out on the three samples, has been performed in identical and accurate conditions.

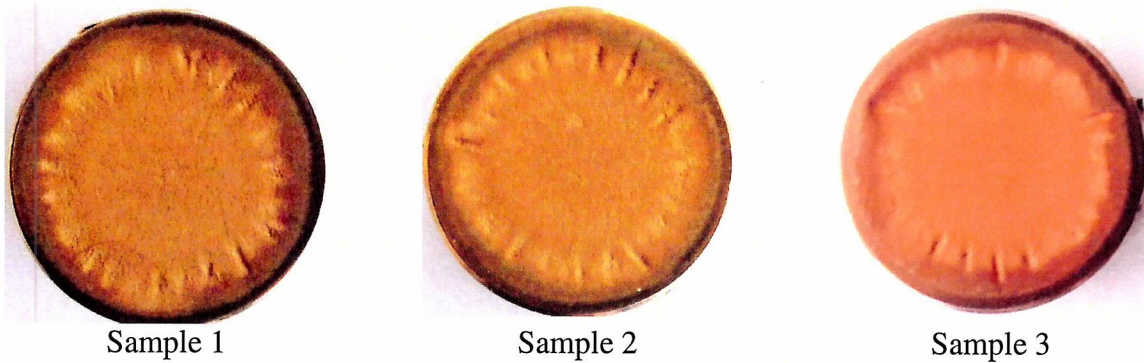
Fig.4.15 Macroscopic images (taken with a Canon A480 camera) of the surfaces eroded by vibratory cavitation, after 165 minutes of cavitation exposure

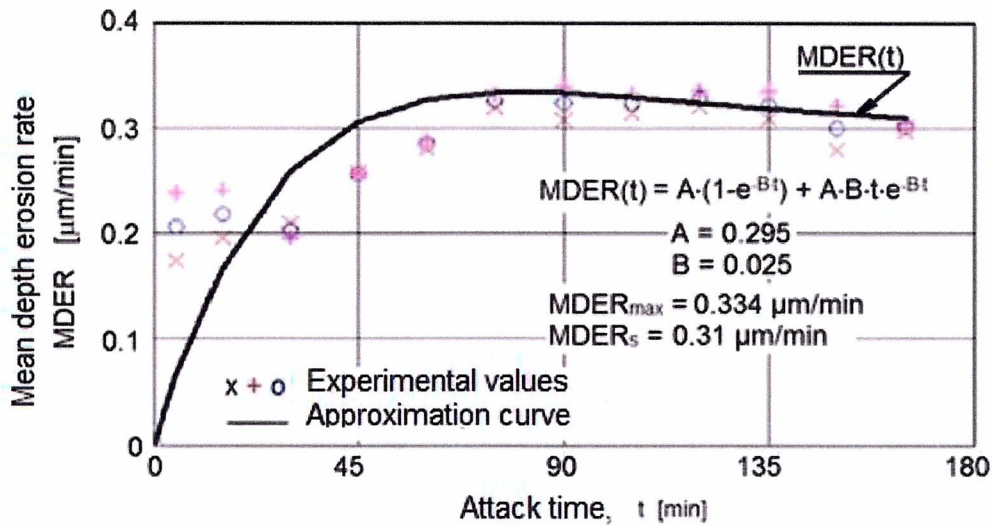
Fig.4.21 Evolution of mean depth erosion rate against cavitation exposure time

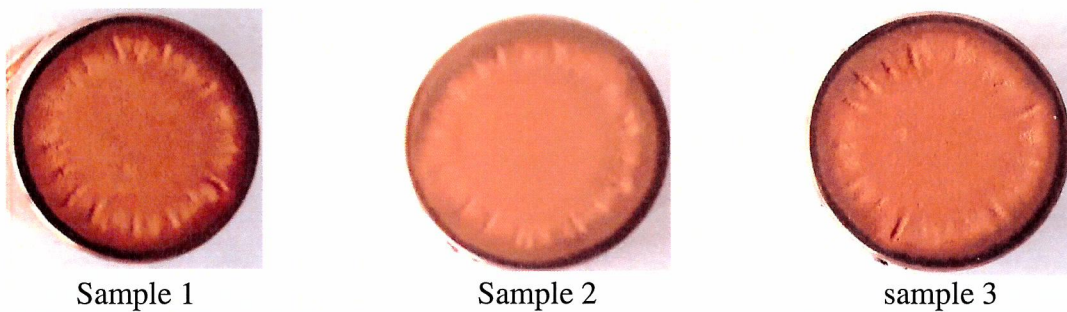
Fig.4.33 Macroscopic images (taken with a Canon A480 camera) of the surfaces eroded by vibratory cavitation, after 165 minutes of cavitation exposure

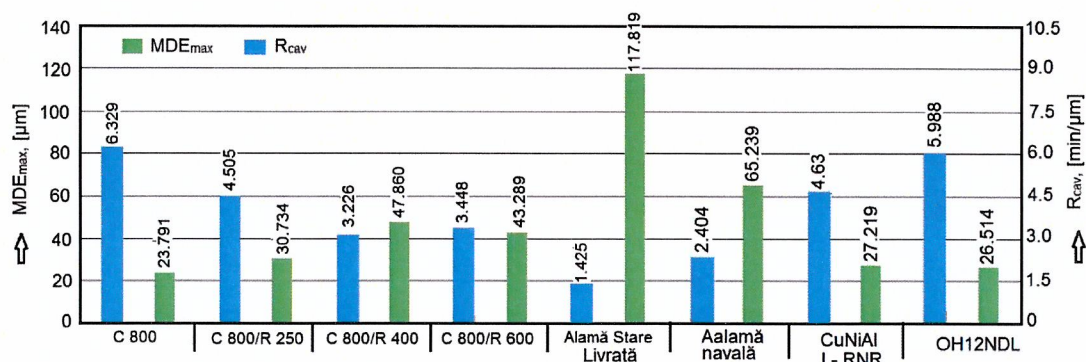
Fig.4.42 Histogram of estimation of resistance to erosion of cavitation (comparison of the heat treatment regimes and the standard materials)

The bar chart data show that, after hardening, the resistance of brass (CuZn39Pb3) exceeds the resistance of the control materials. According to the data from table 4.3, the maximum erosion depth decreases by 11.45% when compared with steel (OH12NDL), by 14.41% when compared with bronze (CuNiAl I-RNR), and by 174.22 % when compared with the brass used in the naval industry. Based on the values acquired by the R_{cav} parameter, we have noticed that the resistance to cavitation erosion increases by 5.7% when compared with stainless steel (OH12NDL), by 36.71% when compared with bronze (CuNiAl I-RNR), and by 163.29% when compared with the resistance of the brass used in the naval industry.

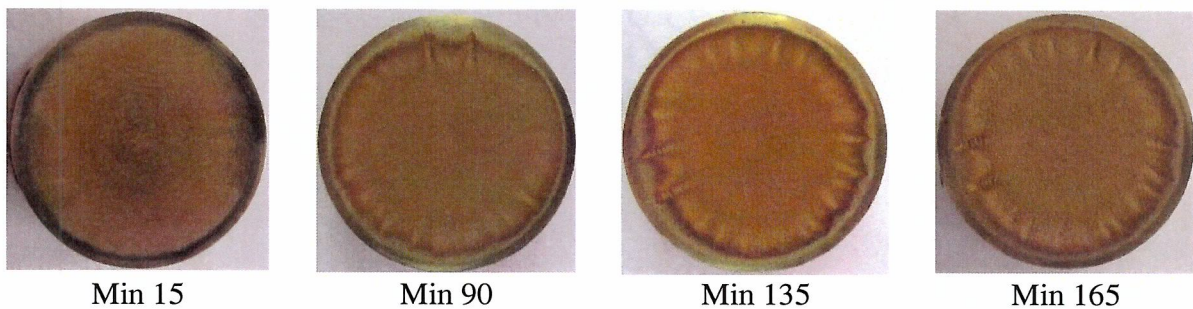
Fig.4.56 Images of specimen surface at different cavitation exposure time (**Sample 2**)

The evolution of the mean depth of penetration rate, in relation to the duration of the cavitation test, in terms of its expansion in the exposed sample area, is visible in the macroscopic images, captured with a camera at significant intervals (fig. 4.57), while the degree of damage and penetration in the structure of the material is shown in the SEM image, accompanied by the macroscopic image (fig. 4.58).

The bar chart from fig. 4.59 and the values for the three characteristic parameters (R_a , R_z and R_t), as recorded with the Mitutoyo analyzer, are in line with the macroscopic aspect of the sample surfaces from fig 4.56 and 4.57, as well as with the SEM image from fig. 4.58, thus showing the erosion propagation into the sample microstructure.

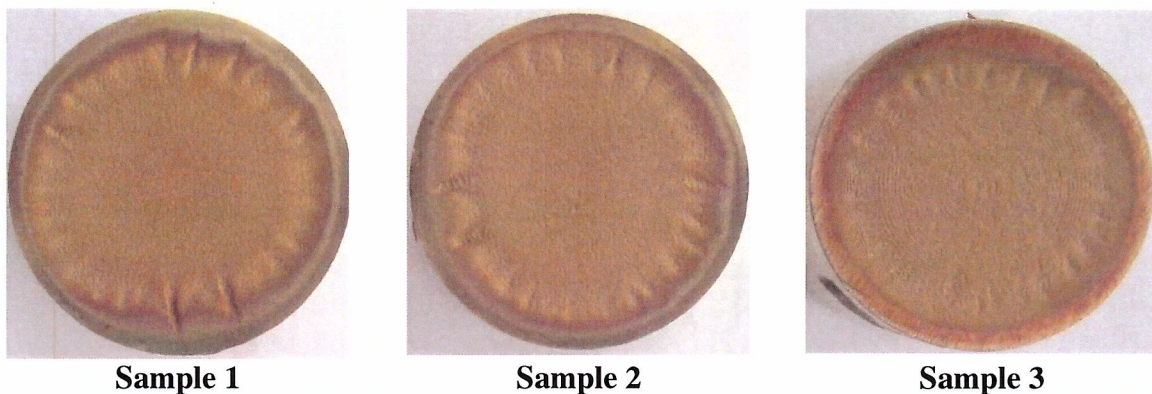
Fig.4.57 Macroscopic images (taken with a Canon A480 camera) of the surfaces eroded by vibratory cavitation, after 165 minutes of cavitation exposure

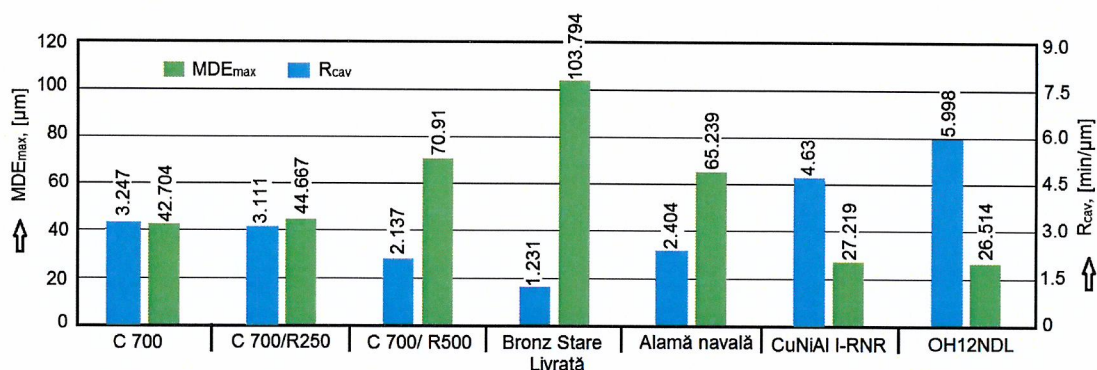
Fig.4.79 Histogram of estimation of resistance to erosion of cavitation (comparison with the standard materials)

The bar chart shows the upper values for the maximum erosion depth MDE_{max} , as well as the lower values of the cavitation resistance R_{cav} , in comparison with the values pertaining to the marine-grade bronze (CuNiAl I-RNR) ($MDE_{max} = 21.219 \mu\text{m}$, $R_{cav} = 4.63 \text{ min}/\mu\text{m}$) and with the values pertaining to stainless steel (OH12NDL) ($MDE_{max} = 26.514 \mu\text{m}$, $R_{cav} = 2.404 \text{ min}/\mu\text{m}$).

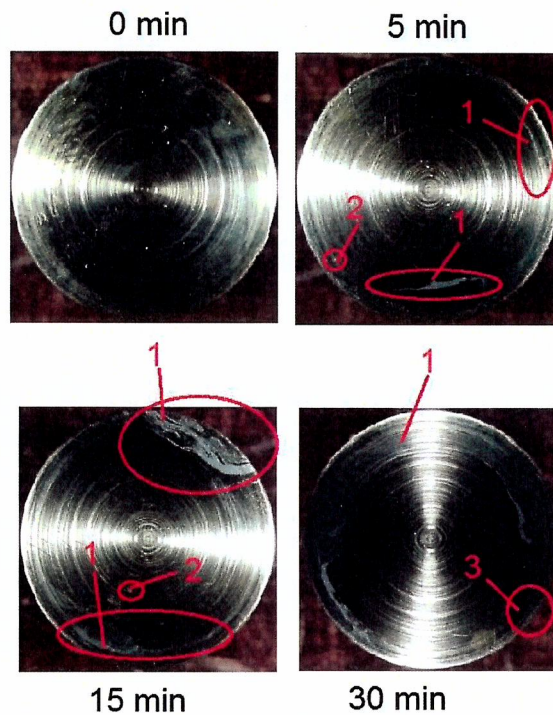
Fig.5.21 Behavior evolution to vibratory cavitation of the mixture layers typ 3 deposited on the flat surface of the sample
 1. water and bubbles between the polymer film and the metal surface of the sample; 2. perforations in the polymer film; 3. erosion in the metallic surface (cracks/pittings).

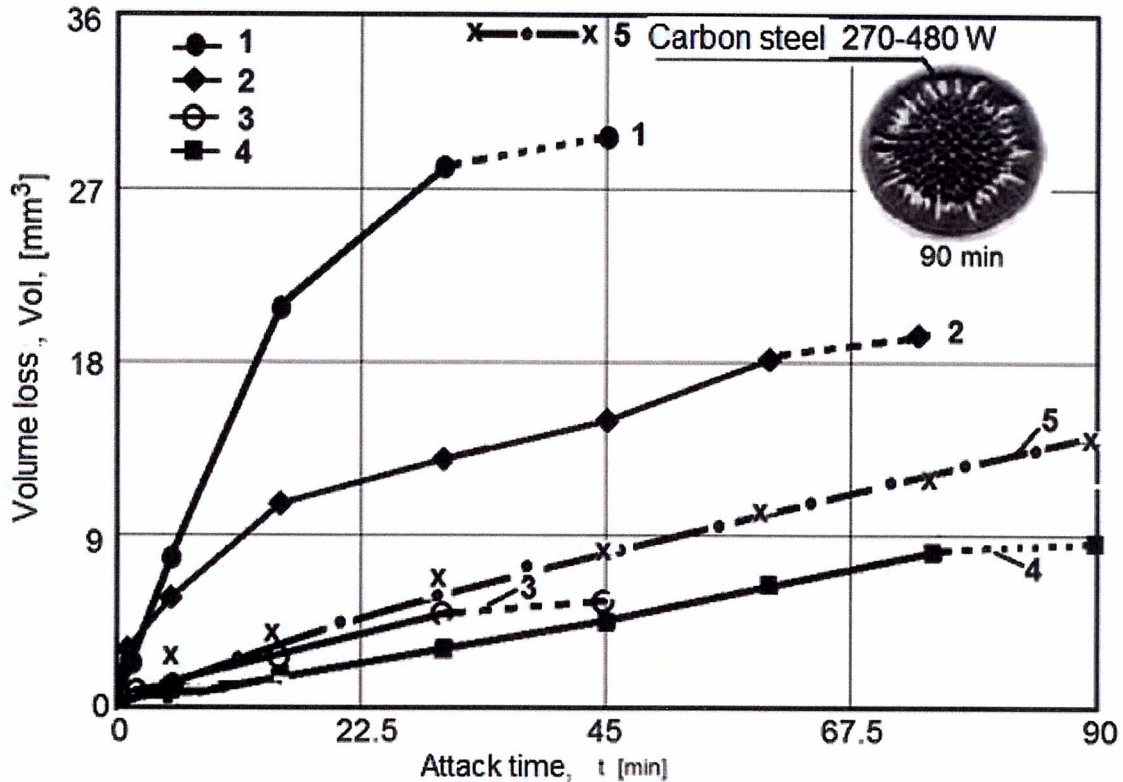
Fig.5.34 Evolution of the volume losses of the layers deposited by thermal spray

Fig. 5.34 shows the evolution in volume loss which, due to the approximately identical thicknesses ($\cong 0.8$ mm), represents a percentage indication of the coating expulsion from the surface subject to cavitation, with a 15.8 mm in diameter. In order to better show the resistance achieved by using these coatings, the diagram also shows the volume loss in the base 270-480 W steel.
