Polytechnic University of Timisoara

FACULTY OF MECHANICS

**Microstructure and cavitation erosion resistance of
weld-deposited layers on Duplex stainless steels**

- ABSTRACT -

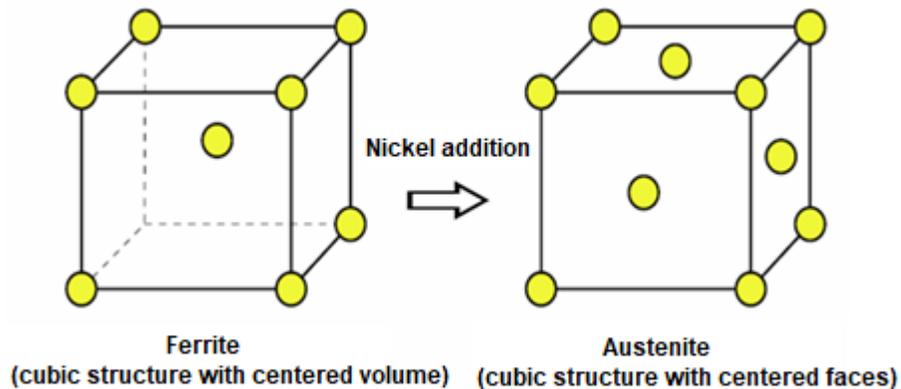
Figure 1.1 Crystal lattice type modification by nickel alloying

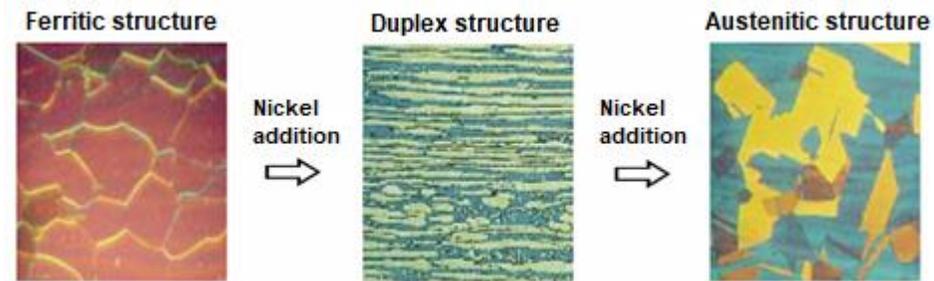
Figure 1.2 Microscopic structure modification by nickel alloying

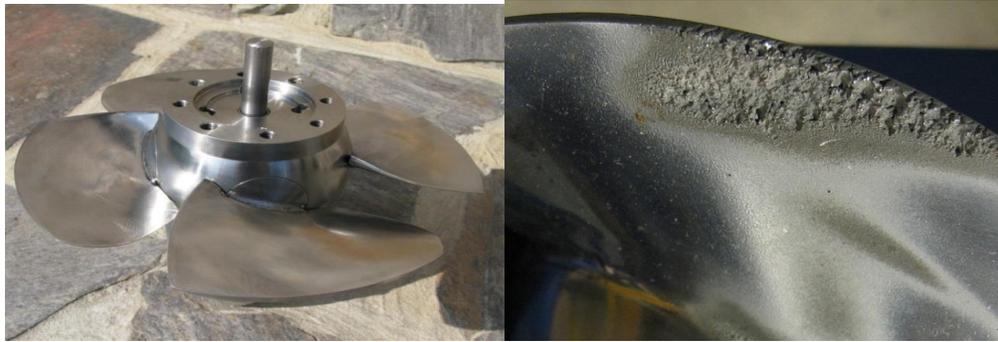
Figure 1.3 Kaplan stainless steel turbine rotor [14]:

a - turbine rotor before degradation by cavitation erosion;

b - rotor blade after cavitation erosion degradation.

Figure 1.3 a,b and Figure 1.4 a,b show a Kaplan turbine rotor and a Francis turbine rotor, respectively, both before and after degradation by cavitation erosion [14]. The different and much more pronounced mode of destruction is observed for the Francis turbine rotor.

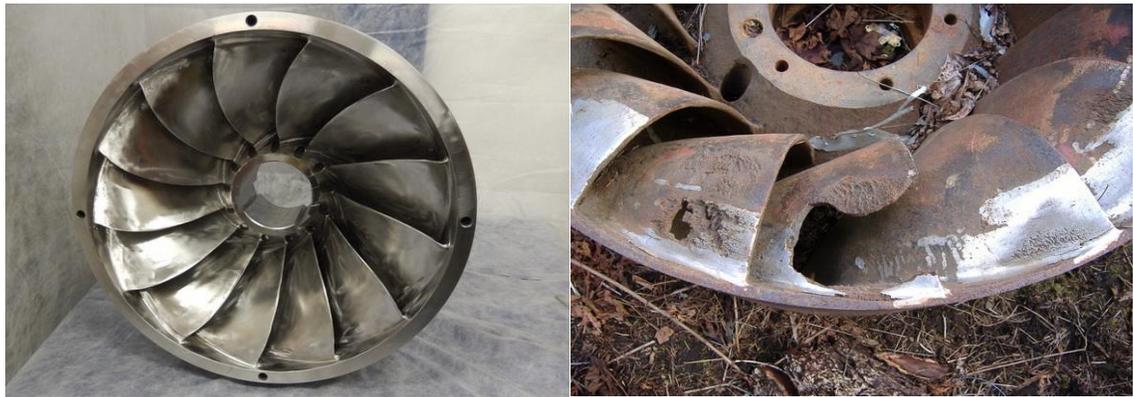
Figure 1.4 Francis turbine rotor made of stainless steel [4]:

a – turbine rotor before degradation by cavitation erosion;

b – rotor blade after cavitation erosion degradation.

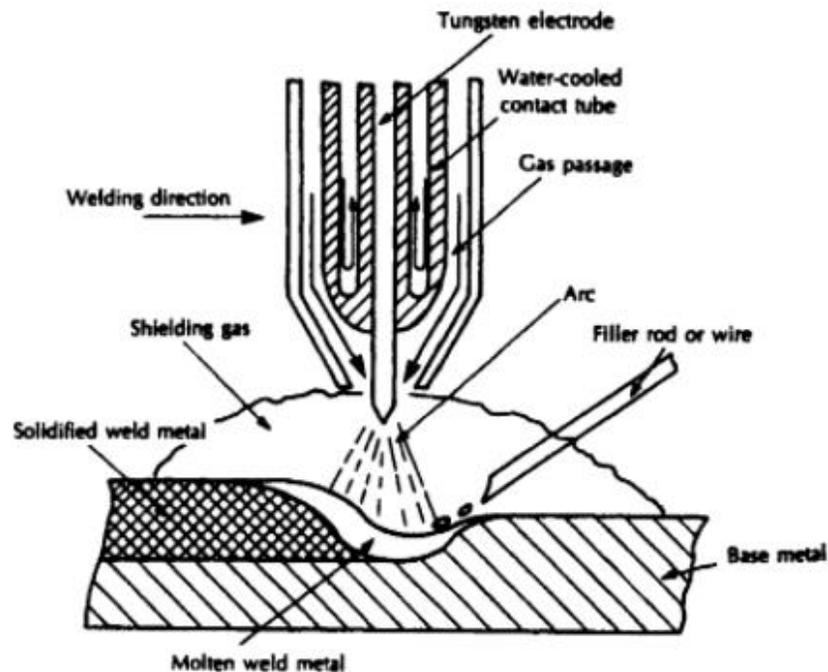
Figure 2.1 TIG welding charging process

In manual operation, the alloys selected for hardening are delivered in the form of metal rods and are melted and flowed onto the substrate to form the deposited layer. In automated operation, this process usually requires an alloy feeder and part handling devices.

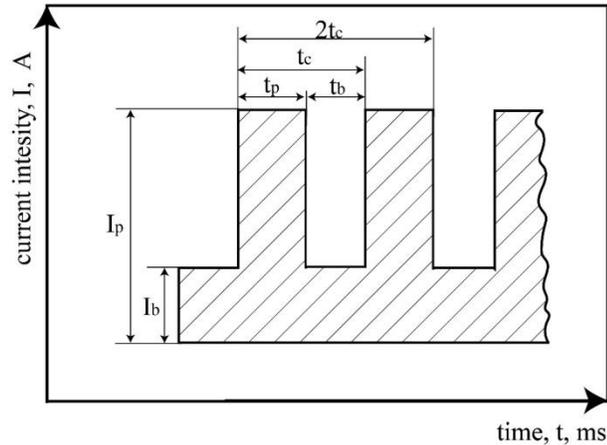
- I – current** **t – time**
- I_p – pulse current** **I_b – basic current**
- t_p – pulse time** **t_b – basic time**
- t_c – cycle time** **f – pulse frequency ($f = \frac{1}{t_c}$)**
- $t_a = \frac{t_p}{t_p + t_b} \cdot 100$ [%] (active pulse time)**

Figure 2.2 Pulsed current TIG welding process parameters

The dosing of the linear energy introduced into the workpiece is achieved by adjusting the technological parameters I_p , I_b , t_p , t_b and the frequency f . At the same value of the average welding current, the seam penetration is higher than in classical TIG welding and the linear energy is lower, which leads to a reduction of the welding stresses and strains. As general recommendations, the pulse current has values 1.5 - 2 times higher than the classical constant current

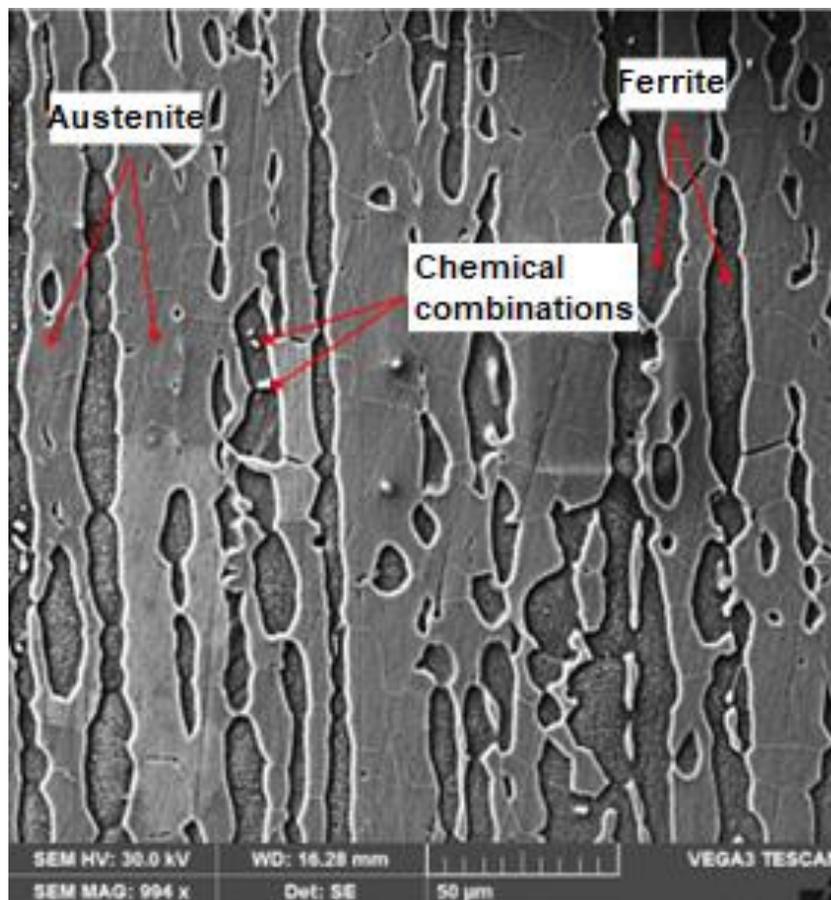
Figure 2.3 Duplex stainless steel substrate microstructure - SEM x 994

The material subject of the experimental research carried out is the Duplex 2205 stainless steel brand, symbolized X2CrNiMoN22-5-3 according to the European standard EN 10088 and UNS S31803 according to ASTM A276. It was subjected to solution heat treatment at 1060 °C with quenching in water. The typical microstructure of this heat-treated steel, as assessed by quantitative metallographic determinations using a Fischer feritscope, is composed of ca. 48 % ferrite and 52 % austenite.

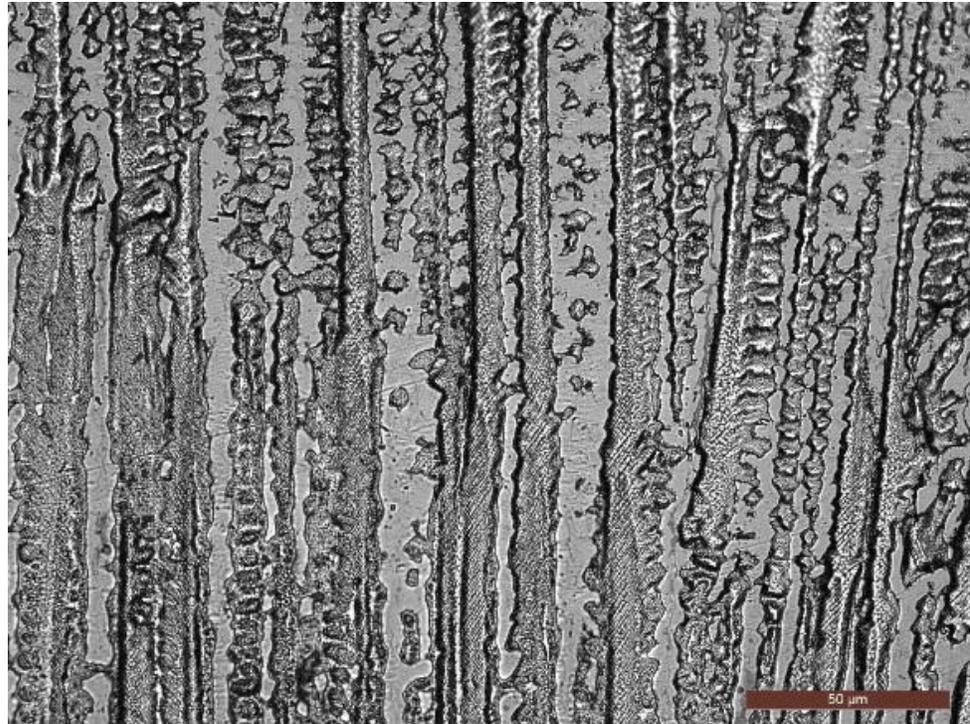
The microstructure of the deposited layer of Stellite 21 alloy is shown in figure 2.4. As demonstrated in other research works [32], [59], it consists of a Co-rich matrix with a dendritic appearance in which particles of carbide-like chemical combinations are distributed. Both Cr as the main alloying element and Mo, are elements that react with C to form carbides distributed in the interdendritic zones and on the boundaries of crystalline grains. They have size and distribution dependent on processing conditions.

Figure 2.4 Microstructure of the outer zone of the deposited layer - x 300

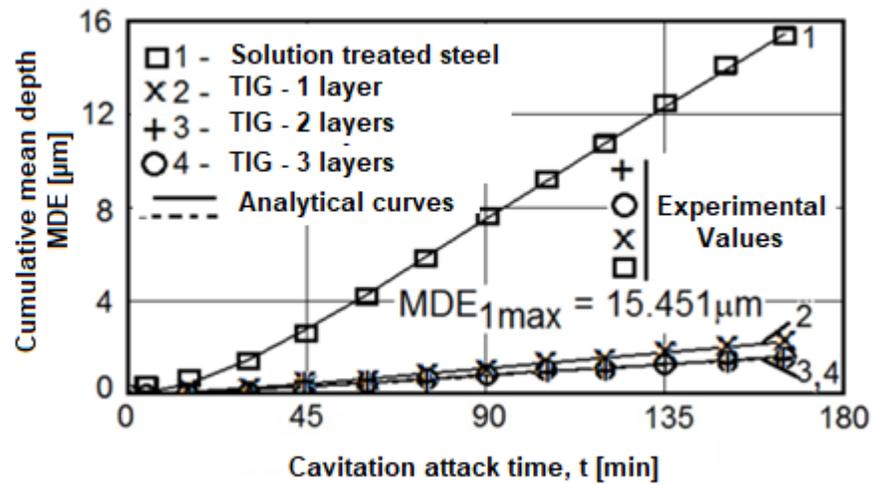
Figure 2.5 Evolution of erosion penetration depth with duration of cavitation attack

The analysis of the data in Figures 2.5 and 2.6 reveals the following observations:

- after 165 min. of cavitation attack, the mass loss of Duplex stainless steel is approx. 24 mg and the cavitation erosion rate is ca. 0.16 mg/min.;
- compared to the base material, TIG welded layers show a decrease in mass loss by (7÷10) times and in erosion rate by (7÷11) times;
- independent of the number of deposited TIG layers, the resistance to cavitation erosion of "Stelite 21" alloy is excellent.

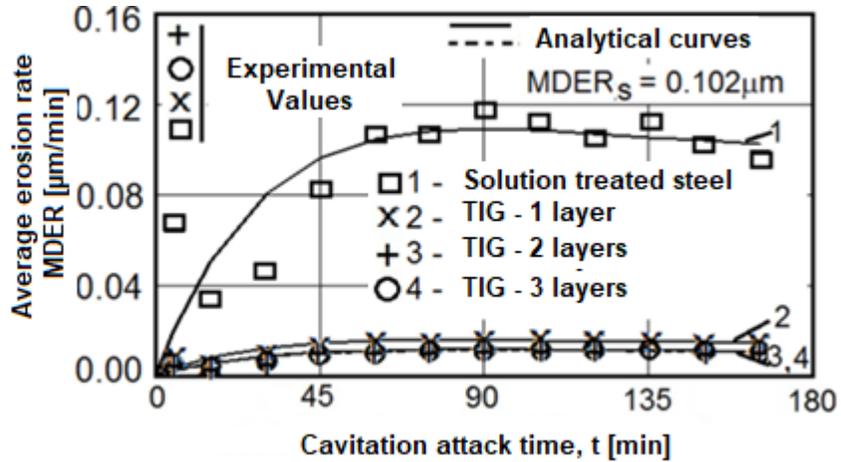
Figure 2.6 Variation of erosion rate with duration of cavitation attack

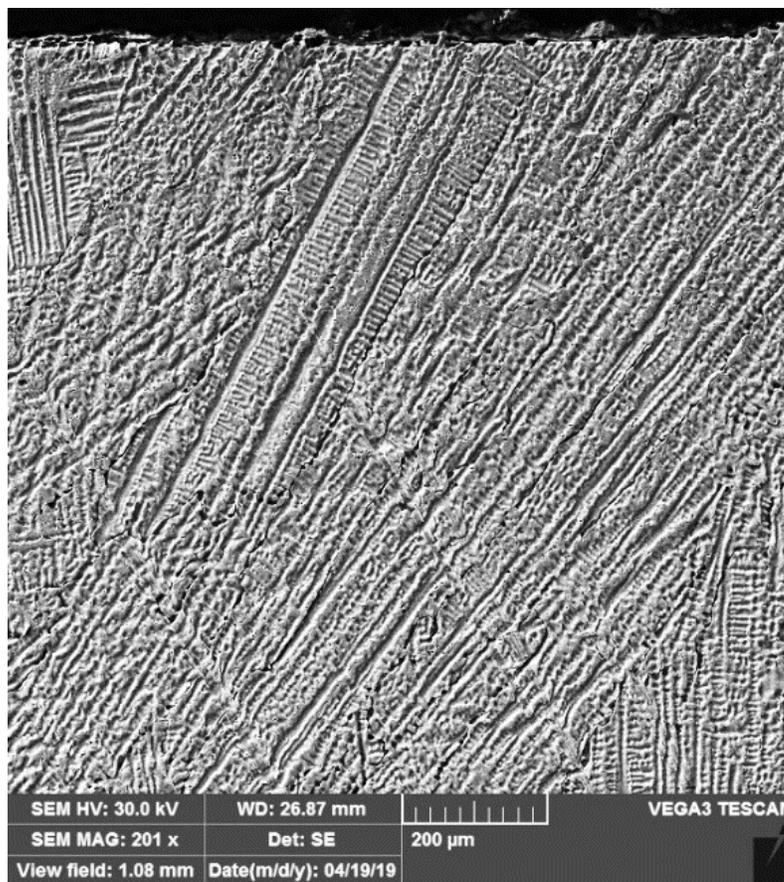
Scanning electron microscope examination of cross-sections through cavity surfaces for 165 min (figure 2.7) allows the following observations:

- the onset of cavitation attack is initiated at the phase boundaries, followed by the removal of carbide particles, and then attack of the cobalt-based solid solution matrix;
- the low values of linear energy characteristic of the pulsed TIG process lead to microstructure finishing. The smaller the size of the grains, the larger the areas of the grain boundaries between them and the more pronounced will be the effect of blocking cavitation degradation;
- a mechanical and phasic hardening of the surface layer, with a thickness of 280...410 μm, caused by the mechanical action of the imploding of cavitation bubbles, respectively by the induction of a martensitic transformation.

Figure 2.7 SEM image of a cross-section through the cavitation test samples

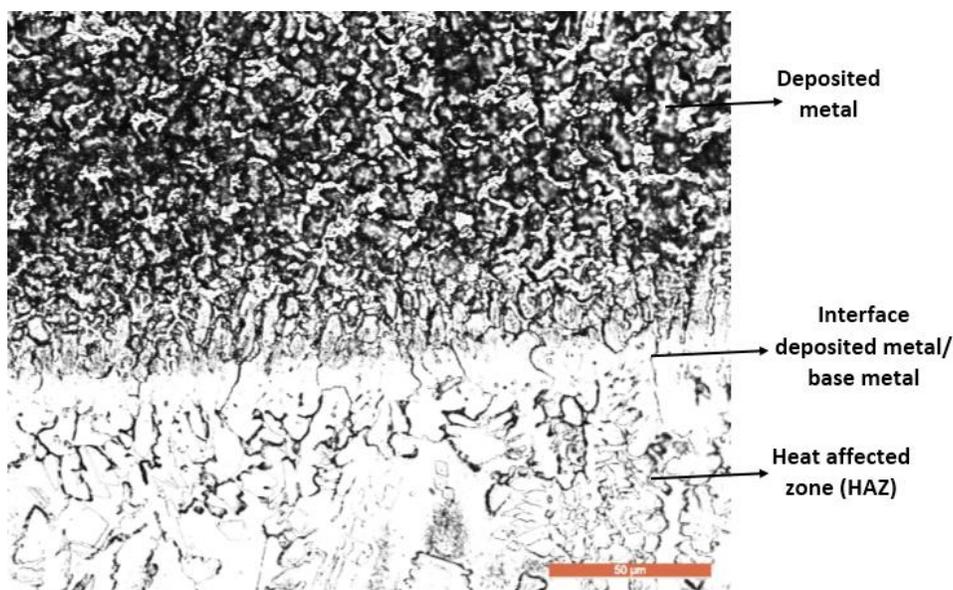
Figure. 3.1 Optical microscopy, x 500 - microstructure of the interface between the deposited metal and the base metal

Scanning electron microscope investigations reveal that secondary phases are precipitated in both intercellular and interdendritic regions. The cellular and cell-dendritic structures are located at the bottom of the fusion zone, just behind the line of its interface with the base metal.

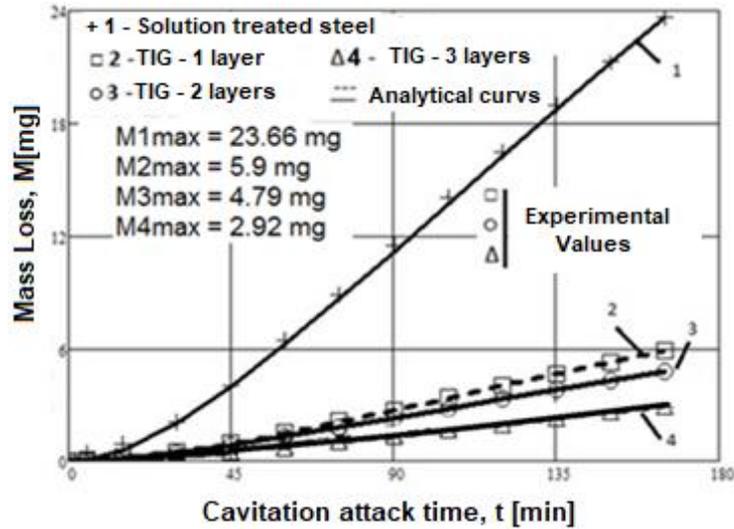
Figure 3.2 Evolution of mass loss with duration of cavitation attack

The findings from the diagrams in figures 3.2 and 3.3 are:

- 1- the evolution of the mass loss curves (figure 3.2), with linear variation starting from minute 75, and of the erosion rates, with a tendency to stabilize at the maximum value after the same exposure time, suggest, as specified in [13], [19], [26] that the layers resistance is high, specific for surfaces with high hardness, relatively fine structure and homogeneous dispersion of the mechanical properties in the volume of the deposited layer;
- 2- the dispersion of the experimental values of the erosion velocities with respect to the averaging curve (figure 3.3) is the expression of a fine-grained structure [15], which leads to an increased resistance to cavitation erosion;
- 3- comparison with the substrate material, the curves marked with 1, show that:

- a. the increase in strength expressed by the total mass value (M_{\max} , after 165 minutes) varies from 4.01 to 8.1 times, depending on the number of layers;

- b. the increase in strength, as a function of the number of layers deposited by TIG welding, expressed by the value towards which the erosion rate tends to stabilize (v_s) after 165 minutes of cavitation attack, varies from 3.9 to 7.7 times;

- 4- Increasing the number of layers deposited by TIG welding leads to increased cavitation resistance. Surfaces with 3 and 4 layers have approximately identical behavior and strengths, higher by (80...100)%, compared to the surface with one layer deposited and higher by (39...50)% compared to the surface with two layers.

- 5- The fact that between 3- and 4-layer surfaces the differences in behavior and resistance to cavitation erosion is insignificant shows that any increase in the number of layers above 3 is uneconomical.

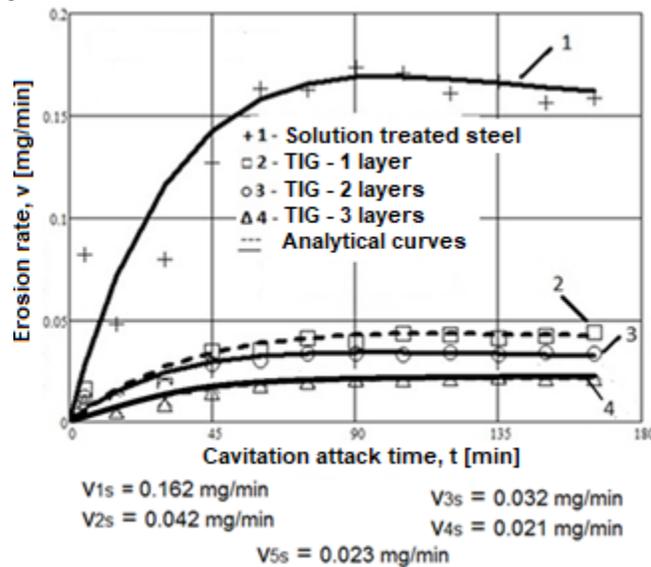
Figure 3.3 Variation of erosion rate with duration of cavitation attack

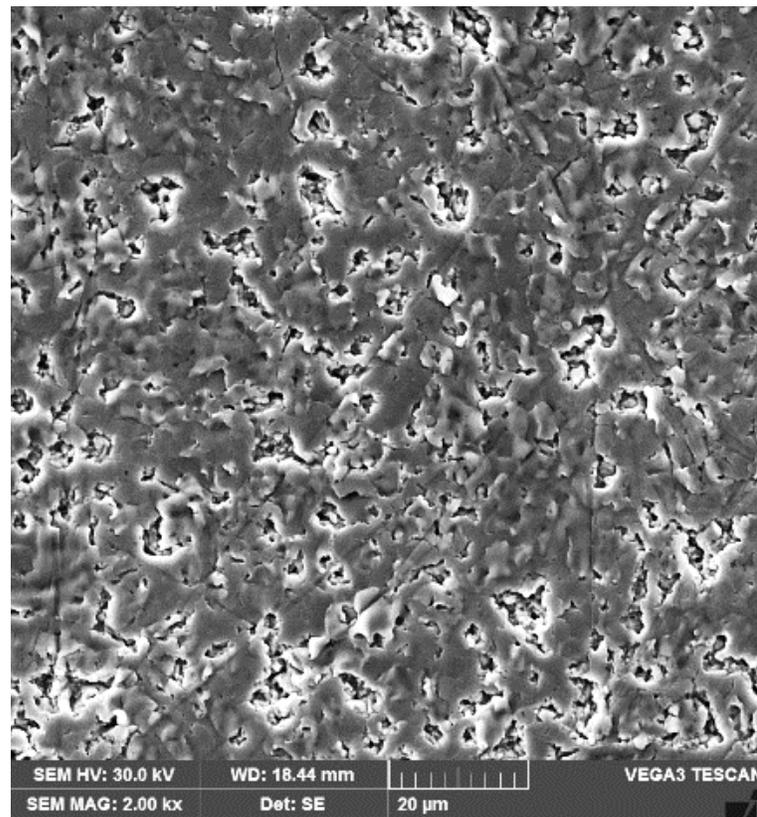
In figure 3.4 show the SEM image of the surface of the 3-layers deposited sample, which was tested by cavitation erosion for 165 min. In this situation, carbide particles were preferentially removed as a result of initial deformation and crack generation at the particle - austenitic matrix interface. As a consequence, this plastic deformation causes the initiation and propagation of fatigue micro-cracks, which ultimately lead to fatigue failure and material erosion.

Figure 3.4 SEM images of cavitation degraded surfaces - 3 deposited layers

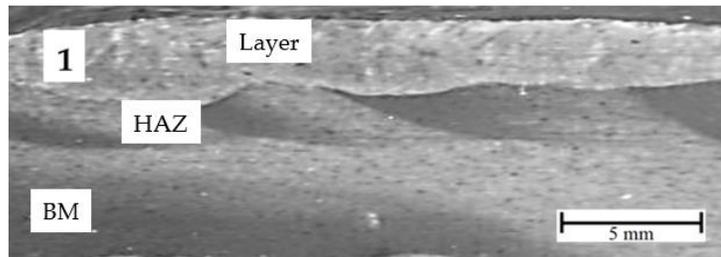
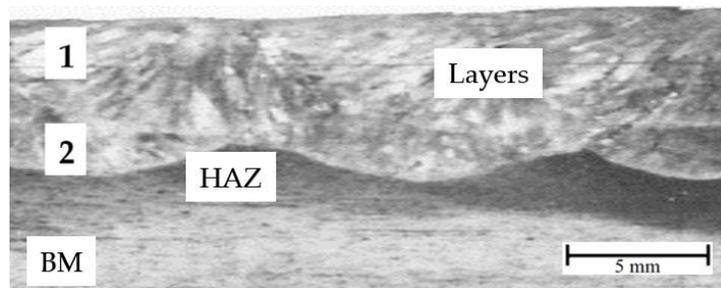
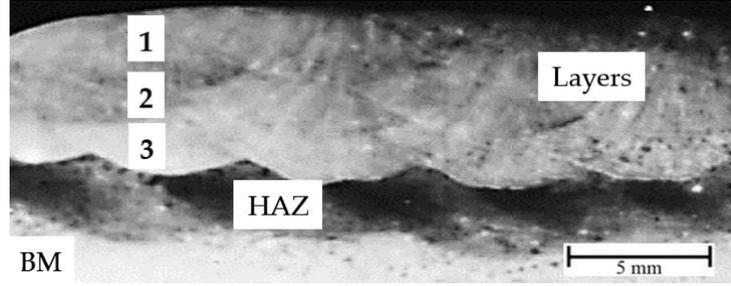
Figure 4.1 shows examples of macrographic images of samples loaded with one, two and three layers. These images highlight a proper geometry of the deposited metal zone, and the absence of material continuity defects. Since austenitic steel does not exhibit polymorphic transformation, no grain refinement is possible in the thermally influenced zone (HAZ), and the large grains resulting from each pass appear to impede each other in growth.

Figure 4.1 Macro images of the layer-substrate system: a) - 1 layer deposited; b) - 2 layers deposited; c) - 3 layers deposited

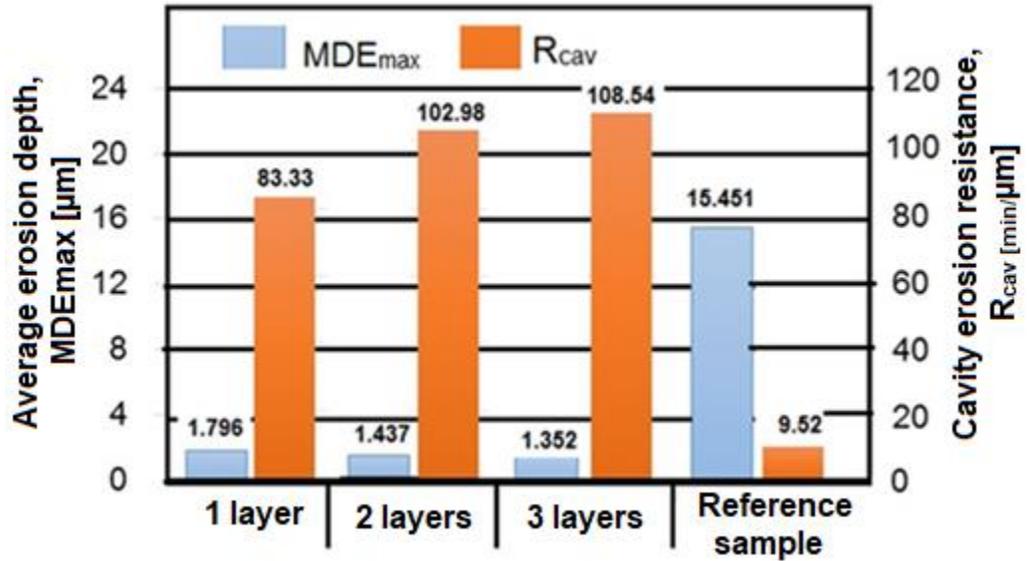
Figure 4.2 Histogram comparing cavitation erosion resistance

The histogram presented in figure 4.2 shows:

- by the deposition of 2-3 layers of austenitic manganese austenitic alloy, the resistance to cavitation erosion is clearly superior to the structure of Duplex stainless steel, resulting from the solution hardening heat treatment (control, reference sample).

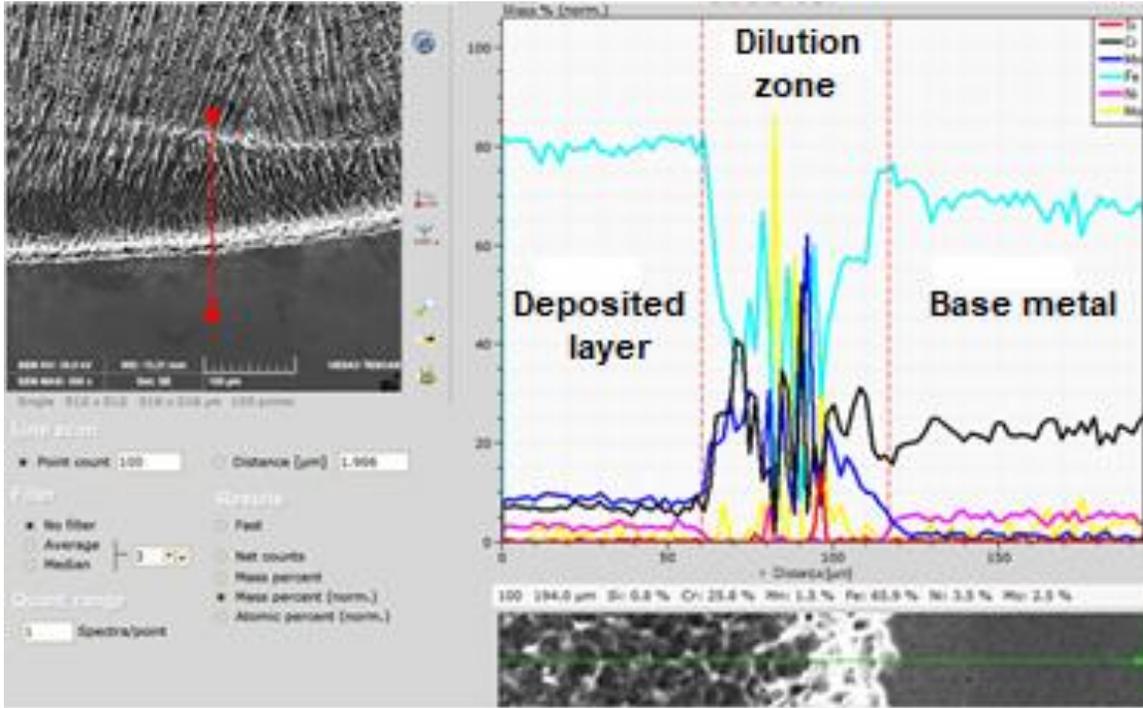
Figure 4.3 SEM image and alloying element concentration profiles on either side of the interface between the deposited metal and the base metal
