DAN Sorin – LISTA PUBLICAȚII RELEVANTE
(lucrările in-extenso sunt cuprinse pe CD-ul atașat dosarului)

Classic and Modern Rehabilitation Techniques in Seismic Zones

Strengthening of Reinforced Concrete Framed Structures in Seismic Zones by Using CFRP

Modern Solutions for Strengthening of Masonry Structures

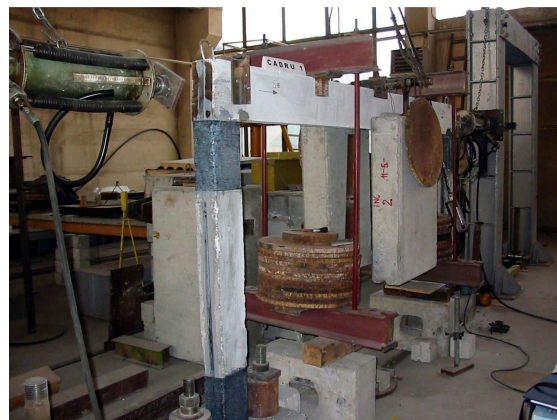
Fig. 1 RC frame + CFRP strengthening

The strengthening was performed on both columns by using CFRP materials (*Fig. 1*): longitudinal strips, SIKA Carbodur, anchored in foundations and at the top joints; transversal confinement with SIKA wrap at both ends of the columns.

The experimental programme focussed on RC frames (*Fig. 1*) assumed, designed and erected as existing structures.

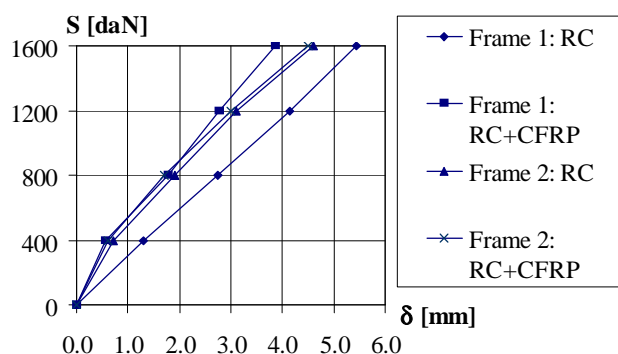
Fig. 2 Top-displacement values

- the stiffness increase of strengthened structure implies the smaller value of the top displacement at the yielding stage of loading (*Fig. 2*).

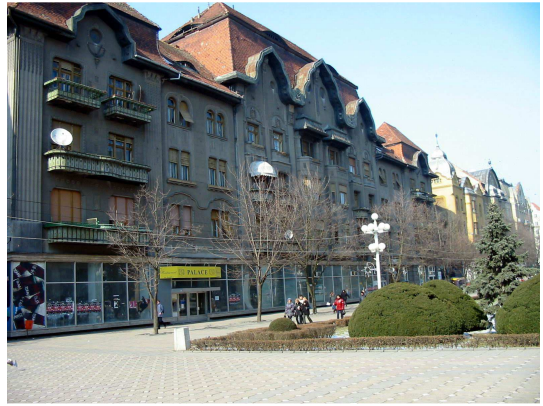
The "Palace" structure (Fig. 3) is a huge building built before 1900's with a composite structure: masonry and reinforced concrete framed structure. Initially it was an entire masonry structure, but later the ground floor was changed: some resistance brick walls were cut and two longitudinal RC frames were erected to sustain all the vertical loads. Due to this architectural operation the structure became more vulnerable at seismic actions: by the transversal direction main part of the ground floor became unstable at horizontal actions because of some erected columns with hinge connection at both ends (masonry wall supports from the underground floor and first storey). The results of the static and dynamic analysis presented below:

Fig. 3 The "Palace" building

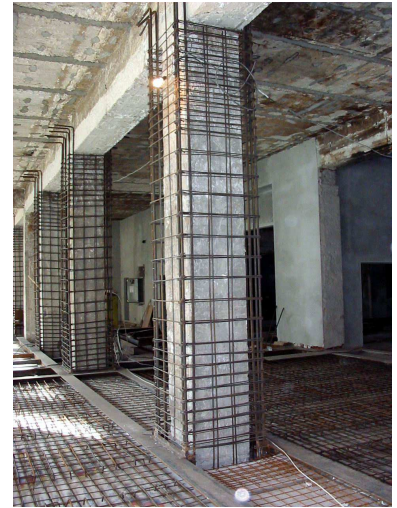
Fig. 4 Strengthening solution

- new reinforced concrete floor with embedded steel profiles (HEB 220) in two directions as beams for the new structure;
 - strengthening of columns (by RC coating) and erecting of new transversal RC beams in order to create new transversal frames.
- The efficiency of strengthening solutions is shown by the increased **R** values presented above.

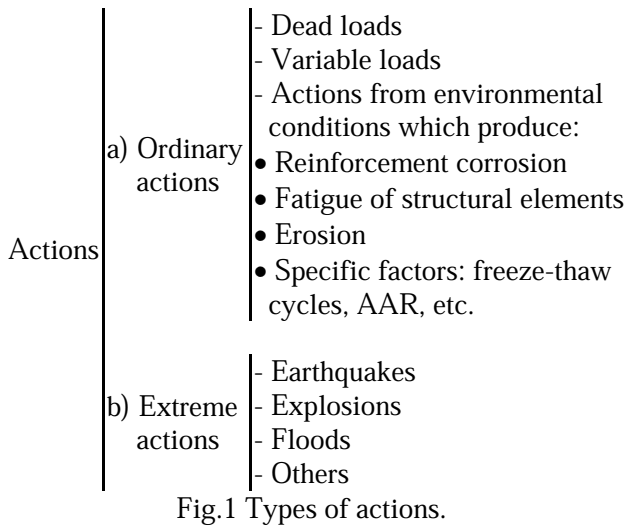
Fig.1 Types of actions.

The effect of different actions, ordinary and special (Fig.1), on the structural safety and S_{cap} is presented in Fig.2 for the service live of a structure.

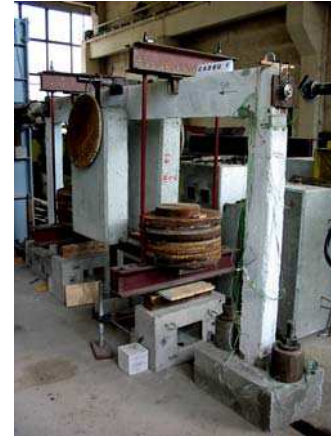
Figure 1. RC frame model.

The experimental programme focussed on RC frames (Figure 1) assumed as existing structures. Single span and single story frame (scale 1:2) was designed and detailed according to the design codes from 1970 under which seismic design was inadequate. These frames were loaded vertically

with constant forces V and horizontally with variable alternant forces S^+ or S^- (seismic action). During the test were measured: load forces S ; strain in reinforcement bars of columns and beams; horizontal top-displacement.

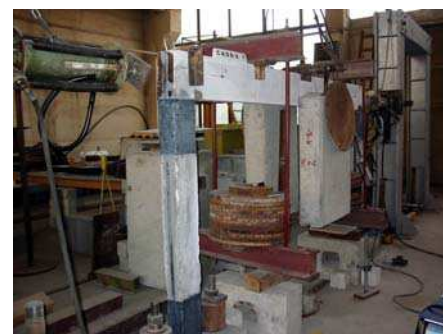
Figure 2. RC frame + CFRP strengthening.

Than the RC frame was strengthened (Figure 2) on both columns by using CFRP materials:

- longitudinal strips, SIKA Carbodur, anchored in foundations and at the top joints in different manners:
 - glued anchorage (Figure 3);
 - wrap anchorage (Figure 4);
 - mechanical anchorage (Figure 5);
- transversal confinement with SIKA wrap at both ends of the columns.

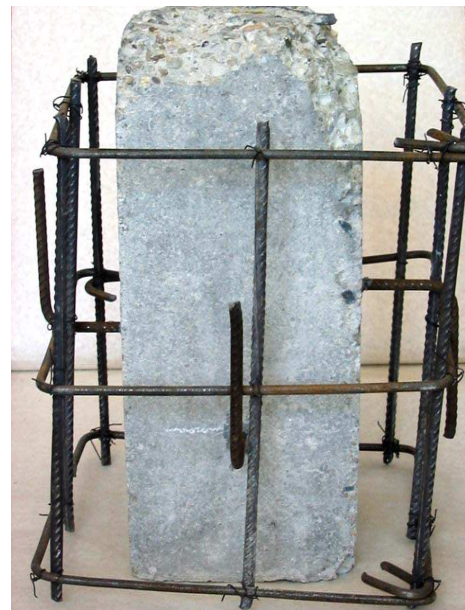
Fig. 3. Using of chemical anchored connectors.

- three specimens without special technique for connection (concrete-to-concrete bond);
- one specimen with a bonding agent – a two-component epoxy resin;
- three specimens with steel connectors Φ 10 mm PC52, anchored in the prism with a two-component epoxy resin (Fig. 3);
- one specimen with special mechanical connectors M10/40/100 mm, anchored in the substrate into holes drilled in the prism (Φ 12 mm), Fig. 4.

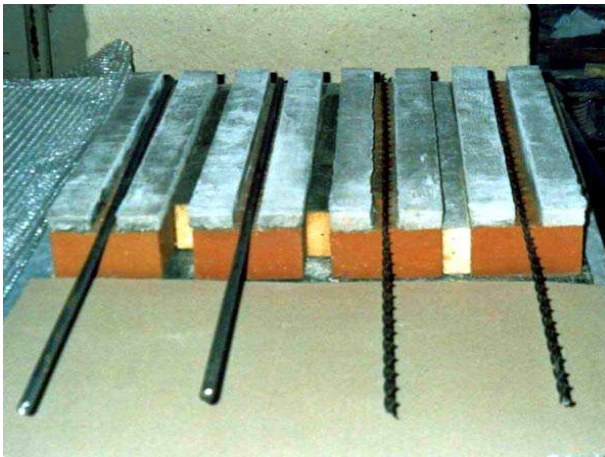
Fig. 1. The samples before embedment.

The effect of the near-surface technology can be explained by results of the experimental tests of adherence between brick masonry and steel bars. The test samples before the two bricks specimen are glued together are presented in Fig.1.

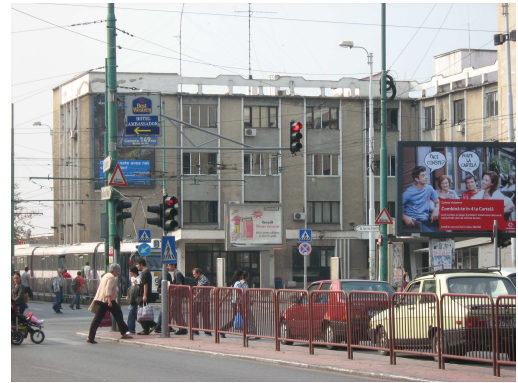
The office building (Fig. 1) from Timisoara Nord Railway Station, a reinforced concrete framed structure with five storeys (one underground storey; ground storey and three upper storeys) was assessed and strengthened. The building was erected in 1971 in a seismic zone – Timisoara. The monolithic RC structure consists of: spatial frame; horizontal slabs supported by frame beams; isolated foundations under columns.

The assessment of in-situ conditions showed up the main problems of the RC structure which consisted of inadequate concrete strength at some columns; $f_{co} = 6,5 \text{ N/mm}^2$ at underground storey; $f_{co} = 9,5 \text{ N/mm}^2$ at the ground storey.

Fig. 1: Office building from Timisoara Nord Railway Station

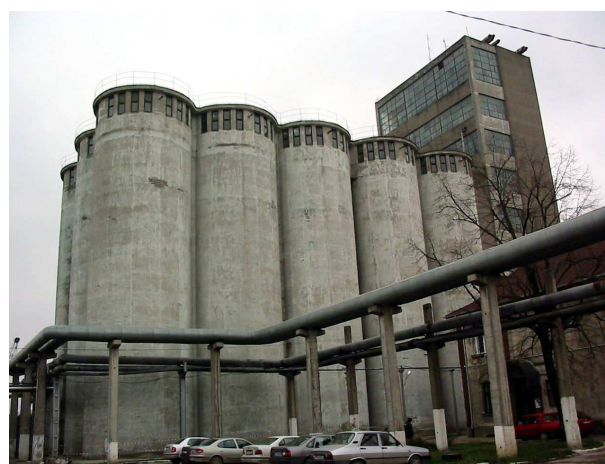
The assessment and rehabilitation solutions for a group of silos owned by the SAB Miller Brewery Company "Timisoreana" are presented. The silos (Fig.1) were built 40 years ago and stand 28 m high and 7.30 m in diameter.

Fig.1. RC silos.

Initial silos inspection (1999) revealed large zones of circular cells with concrete cover dislocated and corrosion of circumferential steel reinforcement. Recent silos inspection and assessment (2004) emphasized other vulnerable parts: infrastructure and charging platform (gallery).

The silos were built 40 years ago and stand 28 m high and 7.30 m in diameter. Silos inspection and assessment (1999 and 2004) revealed: cover concrete dislocated and corrosion of steel reinforcement (circular cells; supporting columns and beams of discharge funnel) due to high humidity; wide open cracks at the windows bottom of RC walls of the charging platform due to temperature action. The strengthening solution consists of: use of CFRP strips as near surface mounted reinforcement for the **silos circular cells** and **charging platform cracked walls**; use of steel profiles for **supporting columns for the discharge funnel**.

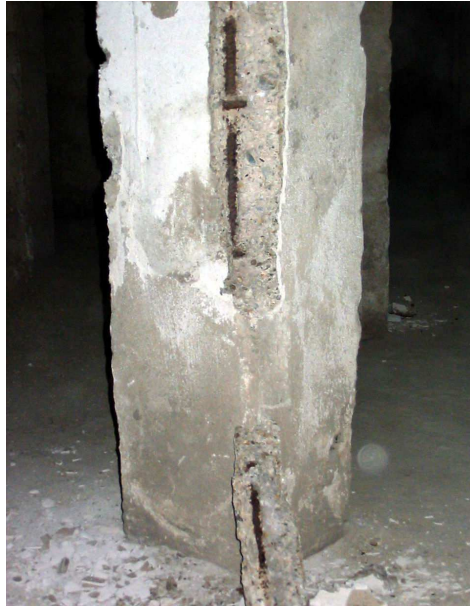
Fig.2. Reinforcement corrosion of discharge funnel supporting columns.

The main damages are due to water infiltration and high humidity inside of each cell bottom part, which caused important dislocated concrete cover and corrosion of the columns steel reinforcement (Fig.2).

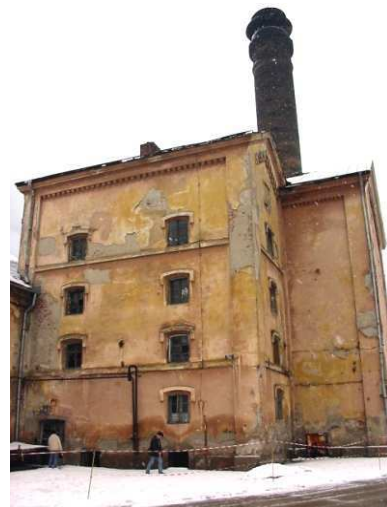
The old malting building, erected between 1857-1876 at the “Timisoreana” Brewery, is a five storeys masonry structure and a tower (Fig. 1) composed of:

Fig. 1. Old malting building.

- walls of 50 – 140 cm thickness;
- inter-storey floors - brick masonry vaults supported by steel profiles;
- a tower, of about 14.00 m height and 2.80 m diameter, supported by an interior dome.

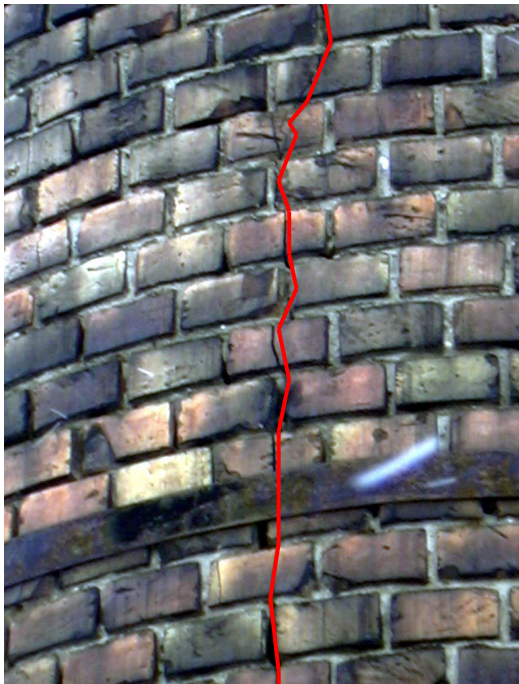
Fig. 2. Vertical cracks of masonry tower.

- vertical cracks in the tower masonry structure – Fig. 2;
- corrosion of steel members: horizontal circular rings for confining the tower; profiles for supporting the floor masonry vaults.

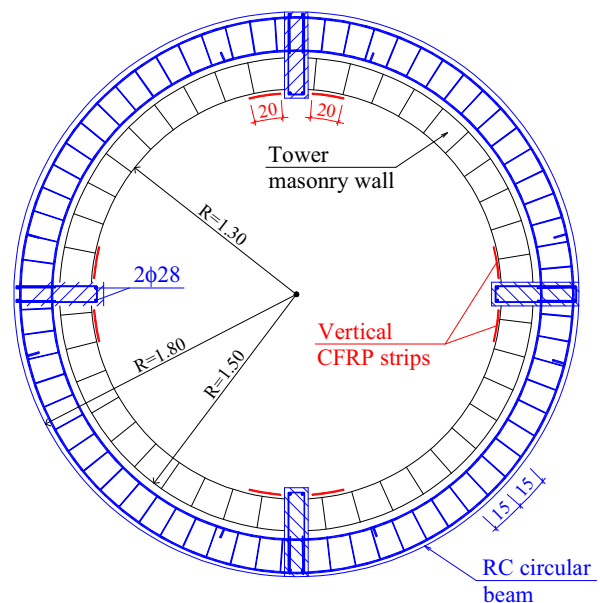
Fig. 3. Tower strengthening at base section.

- for general stability of masonry tower: vertical reinforcement (Fig. 3) bars (4 x 2 ϕ 28) embedded at the upper side of the tower in a RC beam (Fig. 4) and welded on steel profiles (Fig. 6) I 30 placed in the dome, at the tower base (Fig. 5); vertical CFRP wrap (4 x 2 strips of 20 cm width) on the entire tower height (Fig. 3);
