# HABILITATION THESIS

**Rehabilitation of Existing Concrete and/or  
Masonry Structures in Seismic Regions.  
A Permanent Challenge for Civil Engineers**

**Assoc. Prof. DAN Sorin-Ioan, PhD**

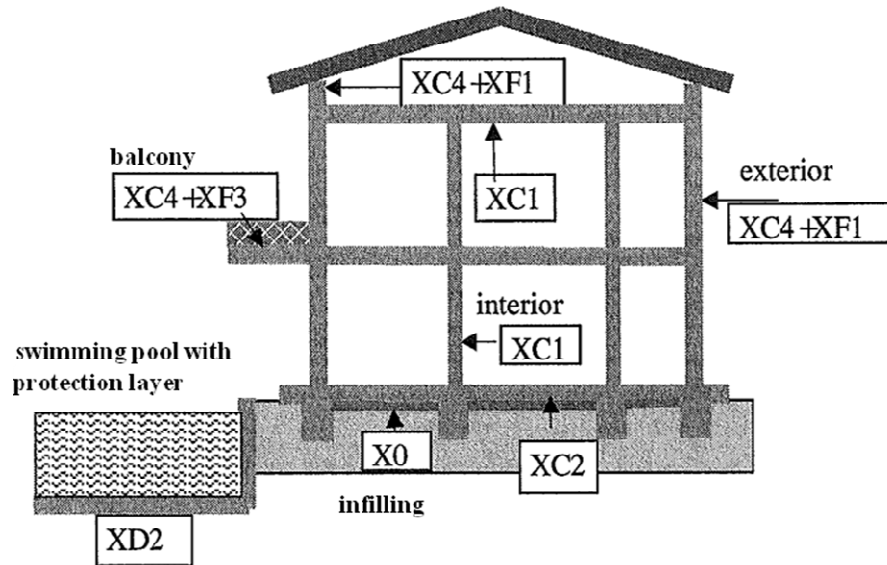
Figure 1.2. Concrete exposure classes [3]

Combinations of exposure classes could be (see Figure 1.2):

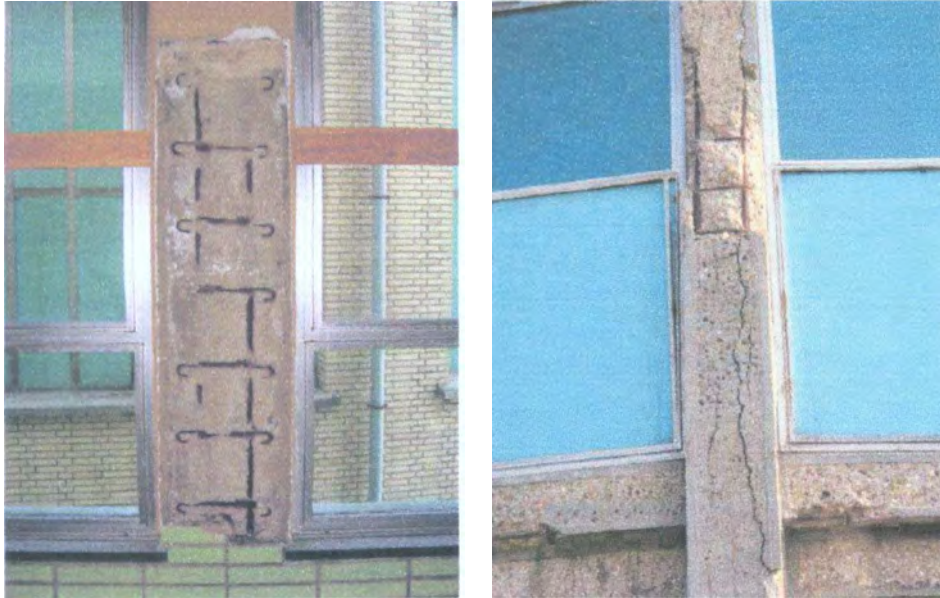
Figure 1.5. Corrosion of columns' reinforcement

- Damage of concrete structures could be due to:
- corrosion of reinforcement steel due to:
    - concrete carbonation
    - chloride ions (salts) penetration

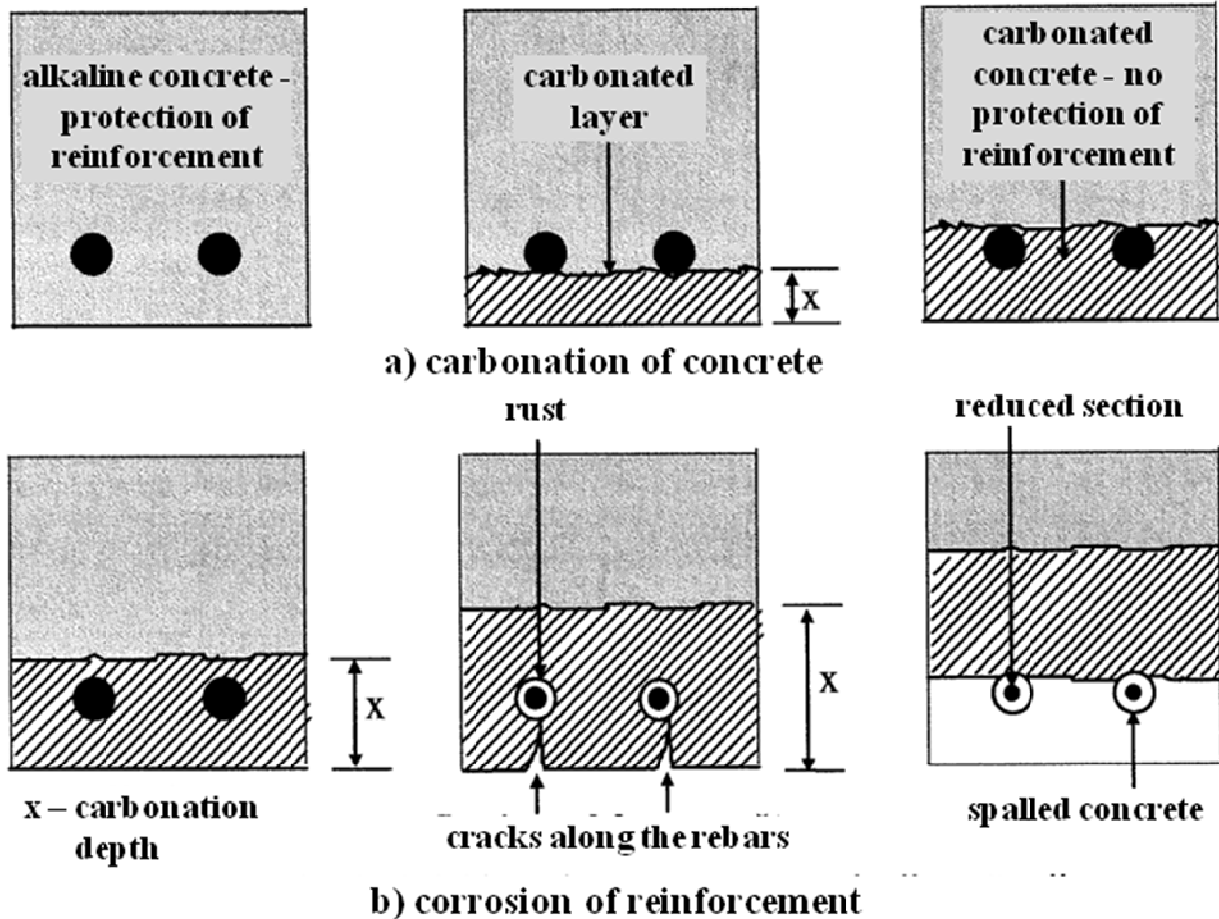
Figure 1.9. Corrosion of reinforcement – mechanism [5-7]

Reinforced concrete structures that are subjected to environmental conditions are likely, after a certain period of exposure, to exhibit signs of distress as a result of initiation of reinforcement corrosion process.

The initial corrosion occurs mainly in two different ways: carbonation of the concrete surrounding the reinforcement and presence of chloride.

The principal correlation, which characterizes the reinforcement corrosion – an important part of concrete durability – is the depth of carbonation or chloride penetration and the time of  $\text{CO}_2$  or/and  $\text{Cl}^-$  action.

Main factors influencing carbonation and chloride ingress are: carbonation dioxide and chloride concentration, environmental conditions, permeability properties and chemical reaction.

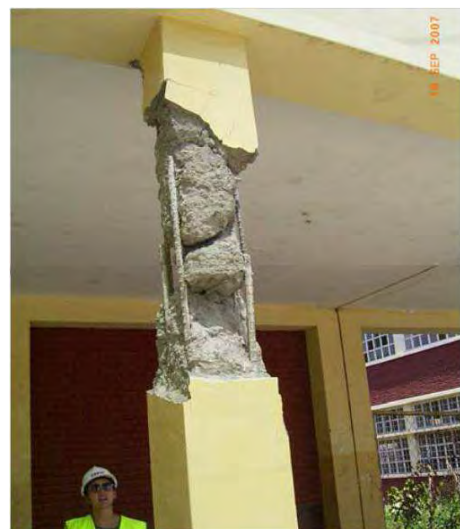
Figure 1.19. Column failure in shear due to insufficient shear reinforcement and low quality of concrete

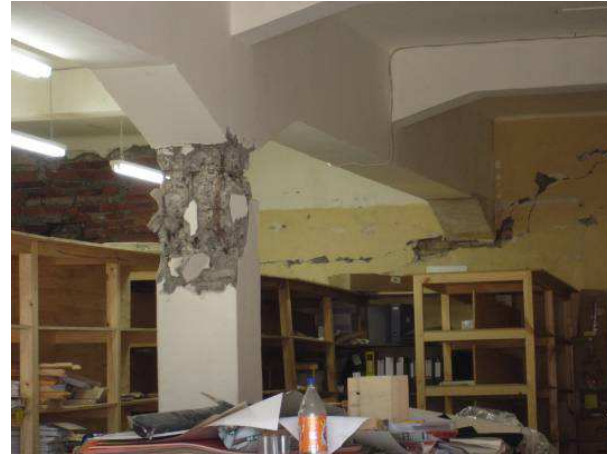
Figure 1.21. Insufficient shear reinforcement and low quality of concrete

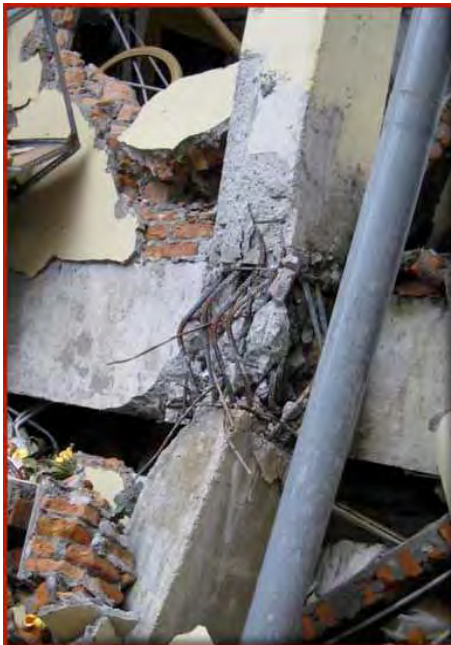
Figure 1.22. Lack of transverse reinforcement in beam-column connection

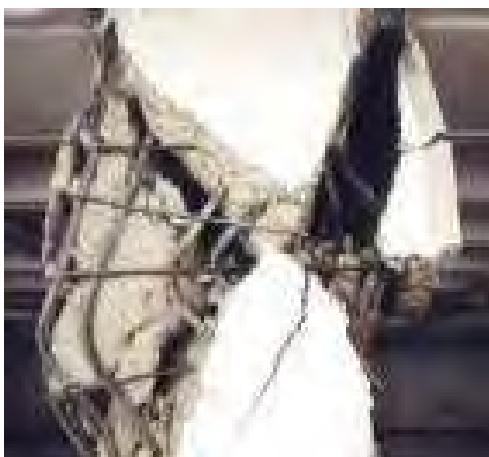
Figure 1.24. Buckling of main reinforcement at compression

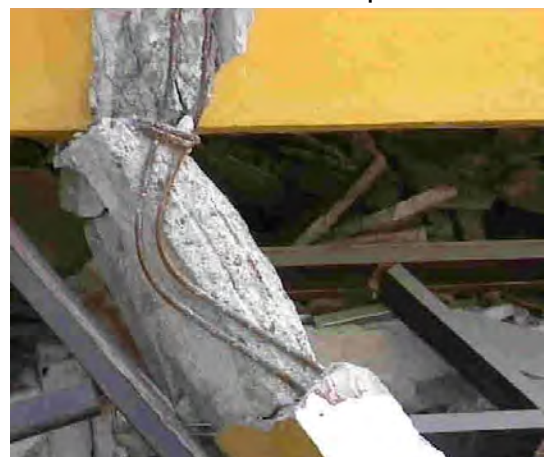
Figure 1.25. Slender columns, lack of bonding and absence of stirrups

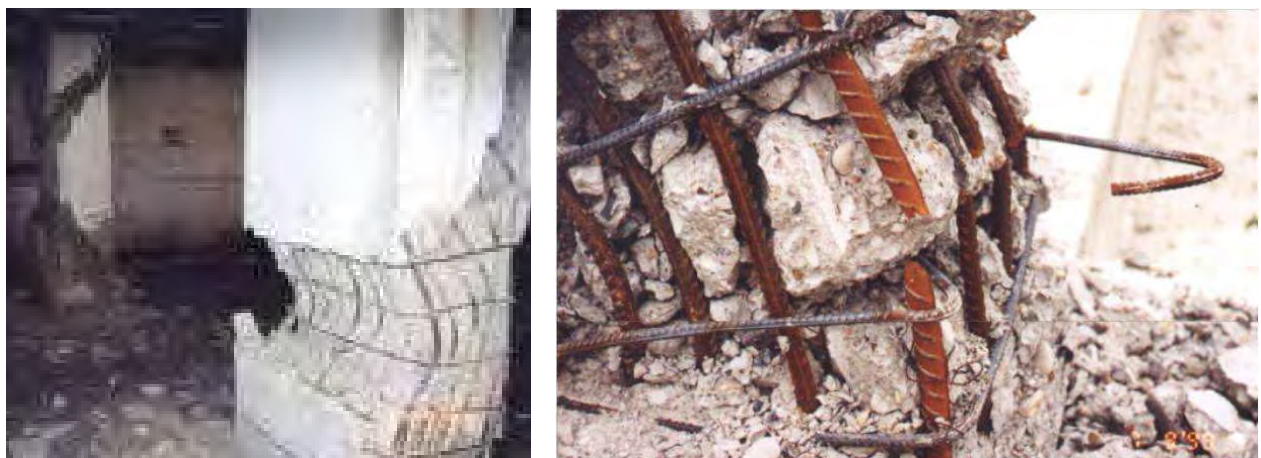
Figure 1.27. Plastic hinges in columns

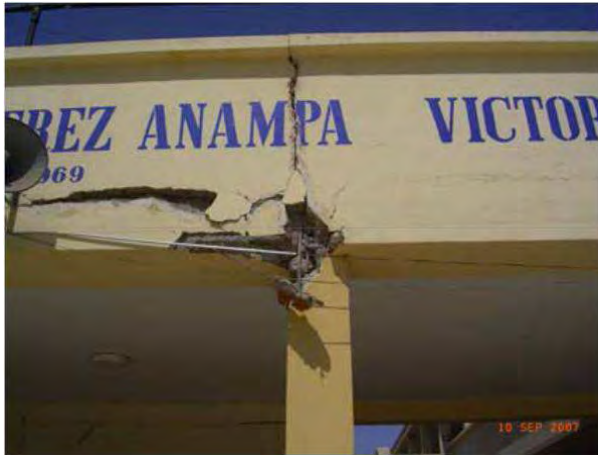
Figure 1.28.  
Column failure at top end: roof parapet activated a strong-beam-weak-column mechanism

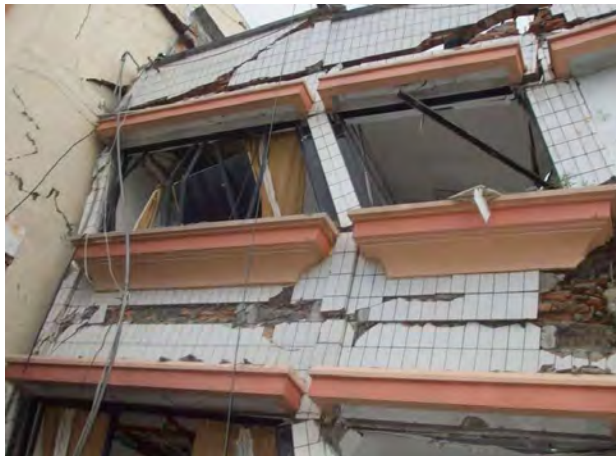
Figure 1.30.  
Plastic hinges at column ends

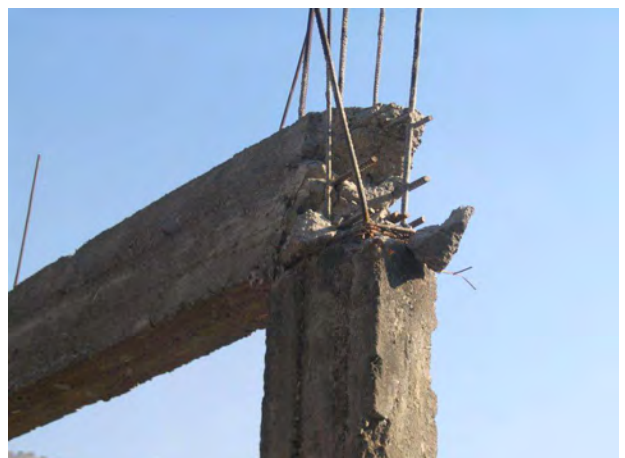
Figure 1.32.  
Roof columns failure

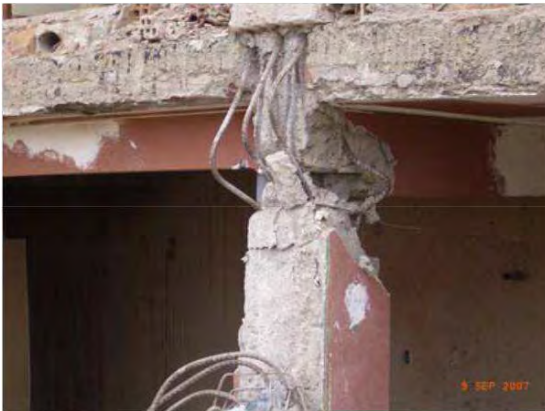
Figure 1.35. Detail of column failure in shear

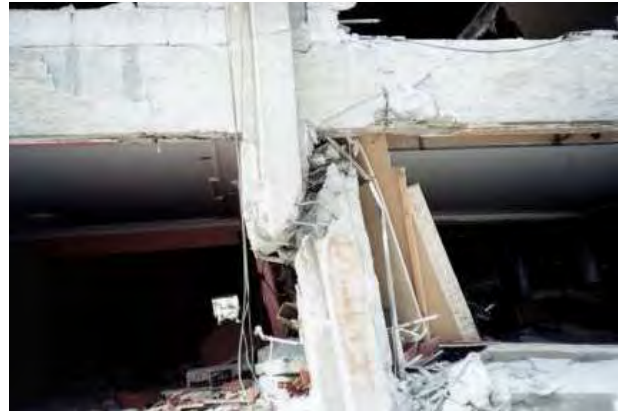
Figure 1.36. Shear failure at ground floor column

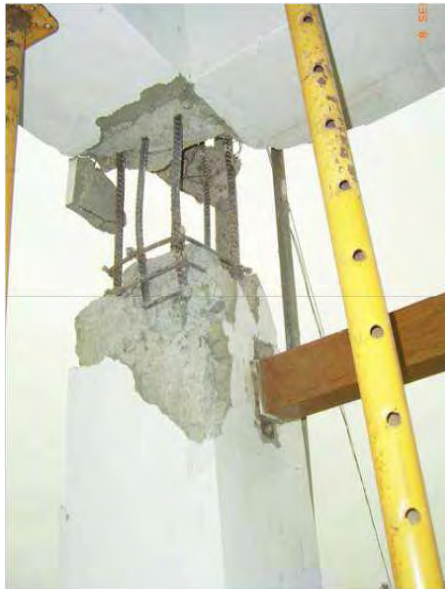
Figure 1.37. Failure of column at top end at the second storey, due to insufficient shear reinforcement and activation of a strong-beam-weak-column mechanism

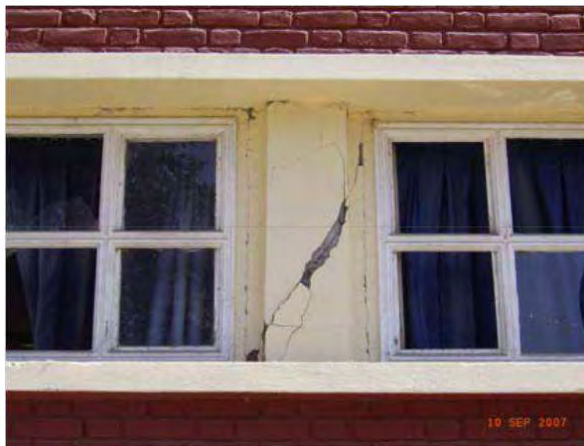
Figure 1.39. Detail of column failure in shear

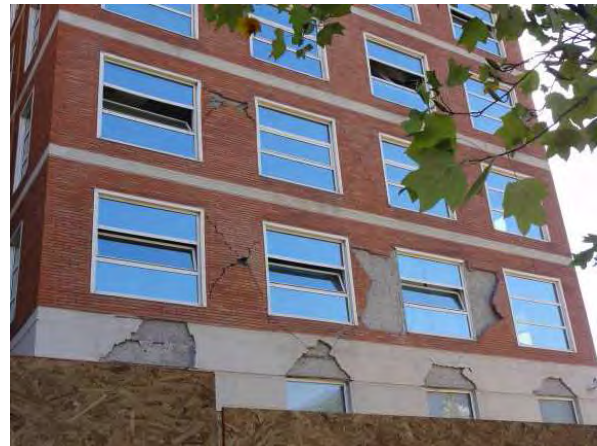
Figure 1.40. Cracking of shear walls

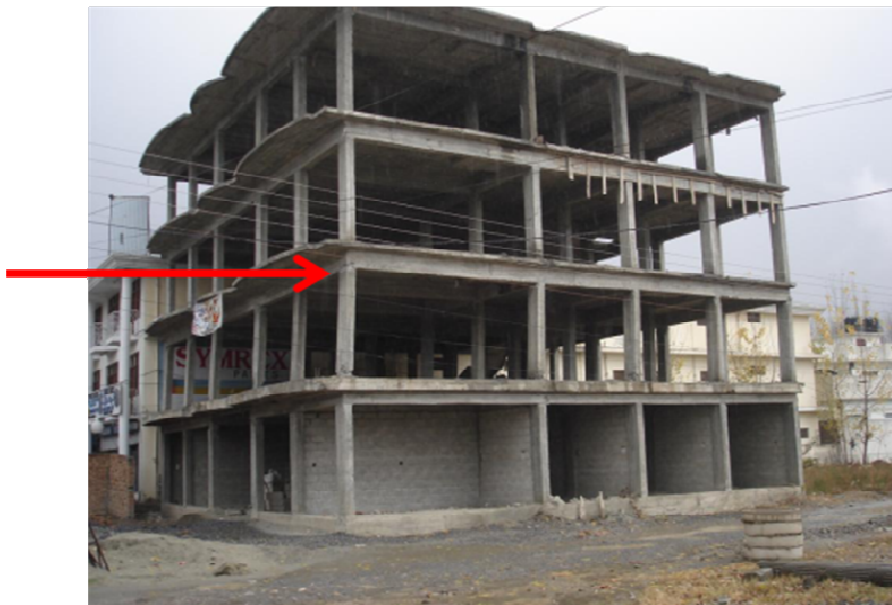
Figure 1.41.  
Permanent drift at the first floor of a reinforced concrete frame 4-storey structure under construction. Ground floor drift may have been prevented by the infill masonry walls

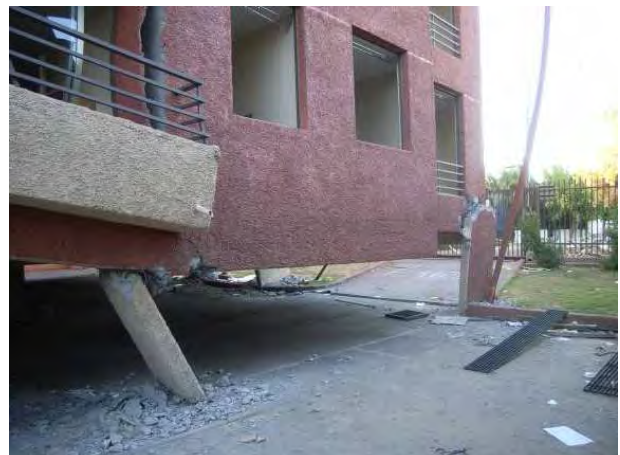
Figure 1.51. Soft ground storey collapse

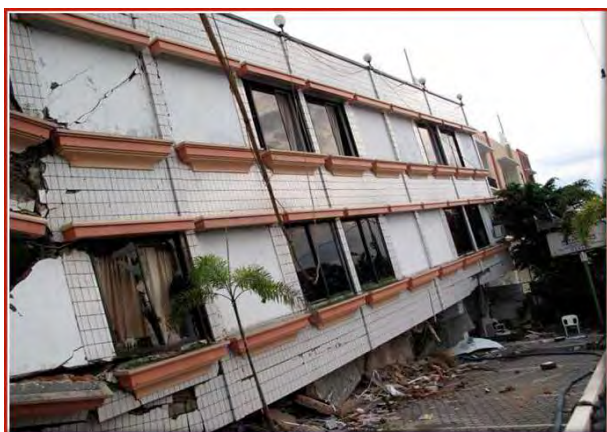
Figure 1.52. Soft ground storey collapse

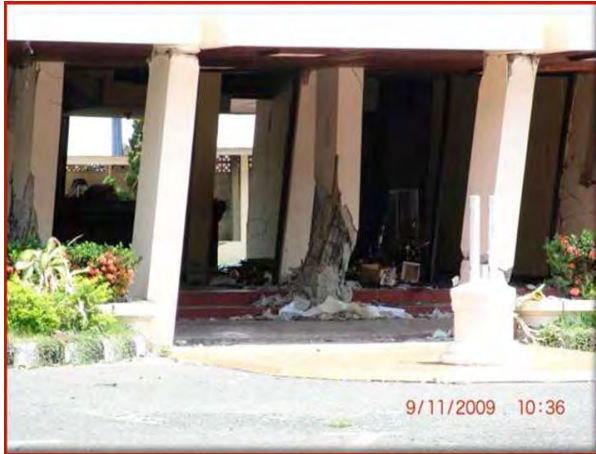
Figure 1.53.  
Soft ground storey collapse

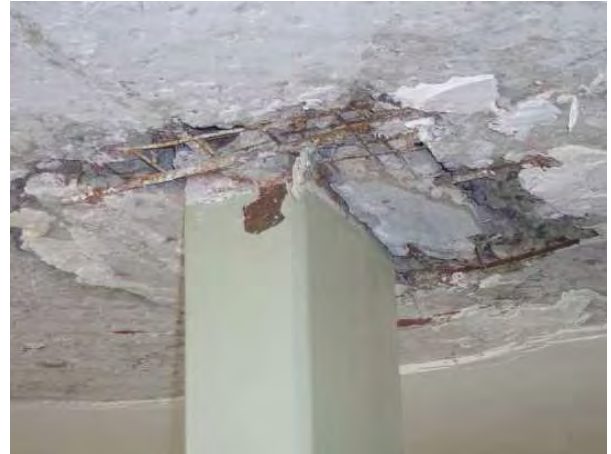
Figure 1.54.  
Punching of flats slab by column due to vertical seismic action

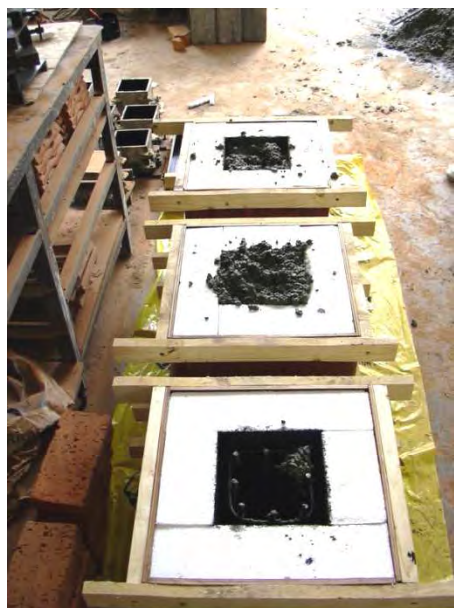
The adopted geometry for the pull-off specimens is presented in the Figure 2.1: a prism of 200x200x500 mm for the concrete substrate, reinforced with 8 $\Phi$ 12 mm PC52 longitudinal bars and stirrups  $\Phi$ 6/150 mm OB37; added concrete as RC jacketing of 100 mm width as illustrated in the other Figure 2.2 and a reinforcement similar to the inner prism.

Figure 2.1. RC columns – initial specimens

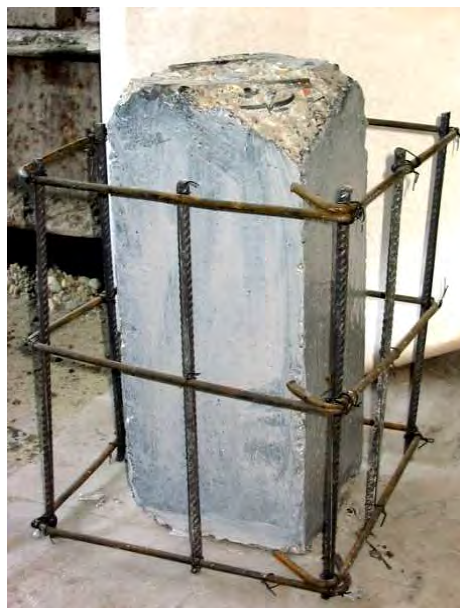
Figure 2.3. Using of bonding epoxy resin agent

- three specimens without special technique for connection (concrete-to-concrete bond), Figure 2.2;
- one specimen with a bonding agent – a two-component epoxy resin, Figure 2.3;
- one specimen with steel connectors  $\Phi 10$  mm PC52, anchored in the prism with a two-component epoxy resin, Figure 2.4;
- one specimen with special mechanical connectors M10/40/100 mm, anchored in the substrate into holes drilled in the prism ( $\Phi 12$  mm), Figure 2.5.

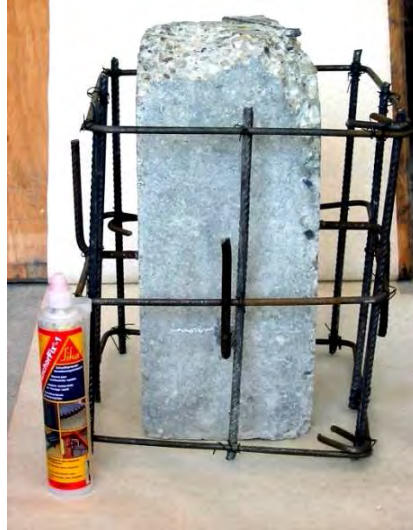
Figure 2.4. Using of chemical anchored connectors

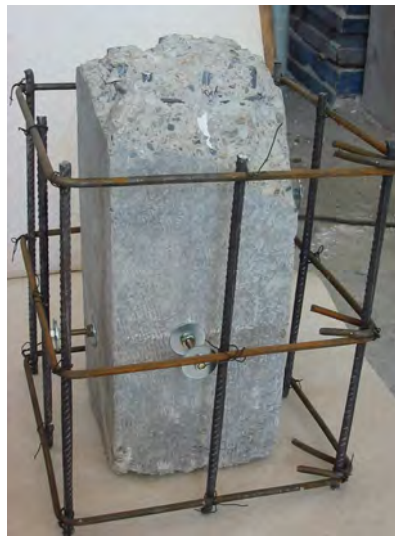
Figure 2.5. Using of mechanical anchored connectors

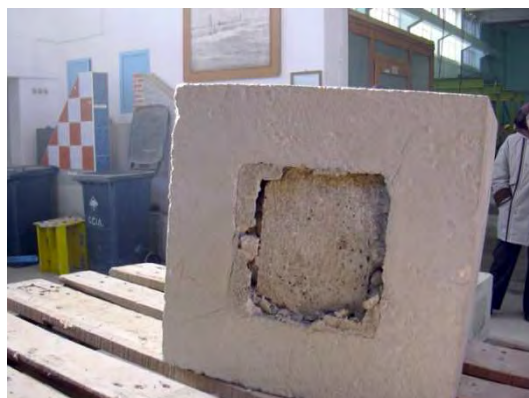
The samples of RC columns strengthened by jacketing after the pull-off tests are presented in Figure 2.6:

Figure 2.6. RC column samples after the pull-off tests

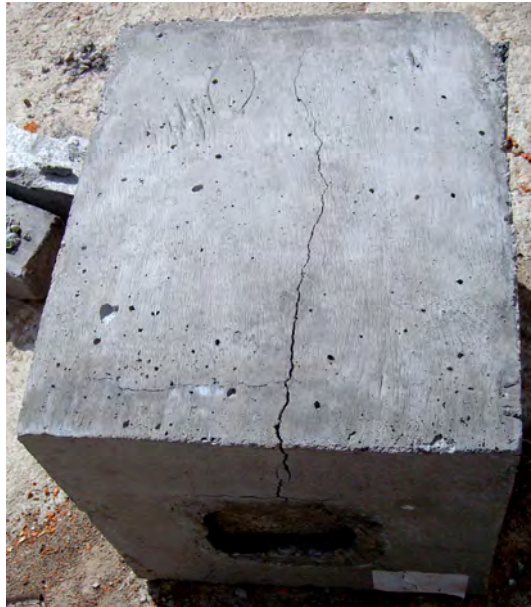
Figure 2.7. Fracture by longitudinal cracking at pull-off test

The cracking and fracture pattern at pull-off tests is similar to compression tests on prism specimen: either by vertical longitudinal cracking, Figure 2.7, or by inclined cracking, Figure 2.8.

Vertical cracking and pull-out of the prism is the normal failure, at which the bond strength was  $1.92 \text{ N/mm}^2$ . This value was used for further comparison of results. Inclined cracking appeared due to imperfections at casting (inclined inner prism). In this case the bond strength was  $1.50 \text{ N/mm}^2$  smaller than at the normal failure. Consequently, this value was neglected.

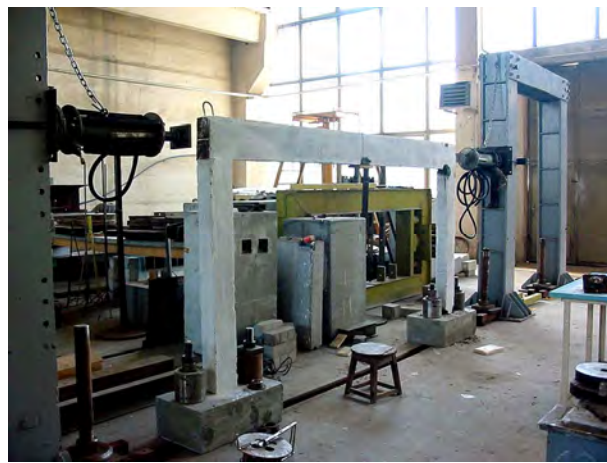
Figure 2.10. Reinforced concrete frame model

The materials used were: concrete C16/20 ( $f_{ck} = 16 \text{ N/mm}^2$ ;  $f_{cd} = 11 \text{ N/mm}^2$ ;  $\epsilon_{cu} = 0,0035$ ;  $E_c = 27 \text{ kN/mm}^2$ ); Romanian plain reinforcement bars OB37 ( $f_{yk} = 245 \text{ N/mm}^2$ ;  $f_{yd} = 210 \text{ N/mm}^2$ ;  $E_s = 210 \text{ kN/mm}^2$ ).

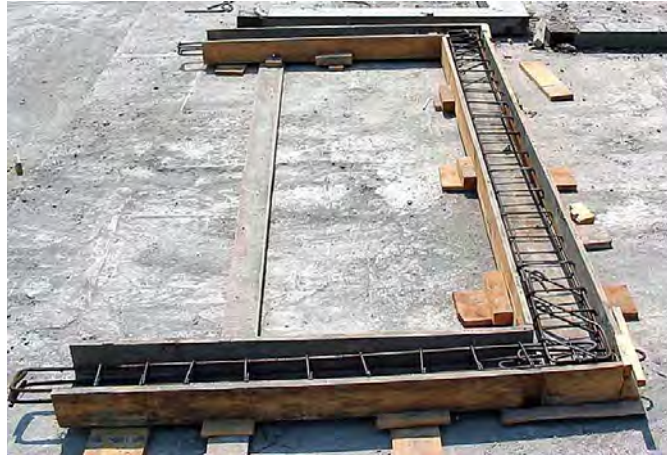
Figure 2.12. Prefabricated frame

Finally, due to practical aspects, the manufacture of the experimental models was done as prefabricated frames, Figure 2.12 which were placed in cast on-site foundations, Figure 2.13.

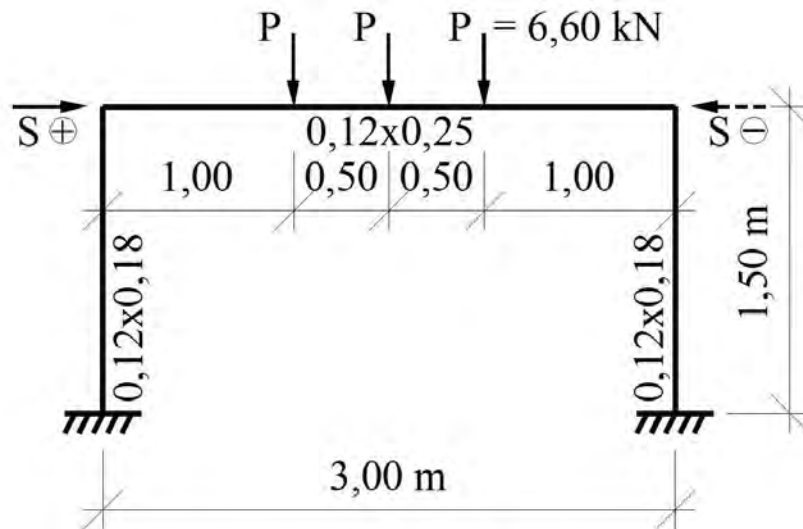
Figure 2.14. RC frame - loading outline

These frames were loaded vertically with constant forces  $P$  and horizontally with variable alternant forces  $S^+$  or  $S^-$  (seismic action), as presented in Figures 2.14 and 2.15. During the test were measured: load forces  $S$ ; strain in reinforcement bars of columns and beams; horizontal and vertical displacements.

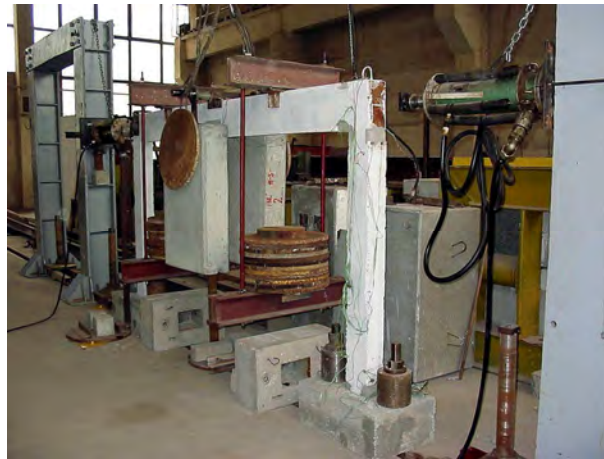
Figure 2.15. RC frame – experimental loading

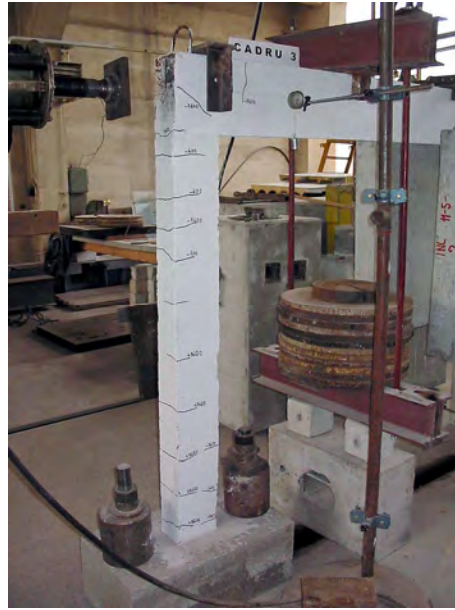
Figure 2.16. Damage of columns

The RC structural design, according to the Romanian design codes from 1970, and the magnitude of applied forces were ensuring the failure mechanism, of non-strengthened RC frames, by plastic hinges at columns ends as in Figure 2.16. It is typical “strong beams-weak columns” failure model.

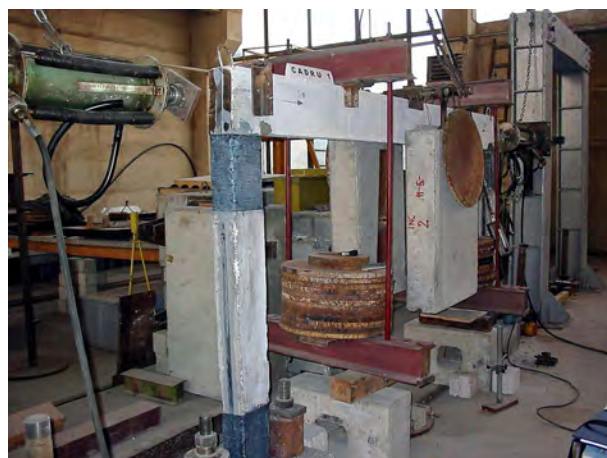
Figure 2.17. RC frame + CFRP strengthening

- longitudinal strips, on two sides, had a width  $b_f = 25$  mm and a thickness  $t_f = 1,2$  mm. The strips were anchored in foundations (on 100 mm depth) and at the top joints in different manners: glued anchorage – Figure 2.18.; wrap anchorage – Figure 2.19; mechanical anchorage – Figure 2.20;
- transversal confinement with a single layer of wrap closed jacket at both ends of the columns. The jackets had a width  $b_f = 300$  mm and a thickness  $t_f = 0,12$  mm.

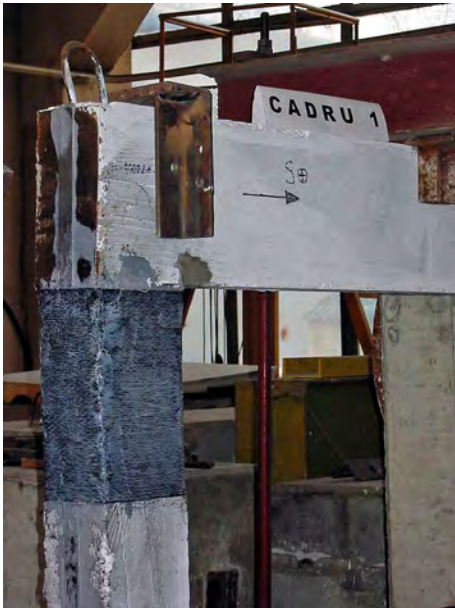
Figure 2.18. Glued anchorage – Frame 1 (CADRU 1)

- debonding of CFRP vertical strips from glued anchorage (Frame 1 – CADRU 1), see Figure 2.22, and wrap anchorage (Frame 2) due to tensile stress at the top joints;
- no debonding of CFRP strips from mechanical anchorage (Frame 3) at the top joints;
- debonding of CFRP vertical strips on inside face of the column (Frame 2 – CADRRU 2) due to compression stress which shows the lack of some necessary transversal stirrups to prevent strip buckling, see Figure 2.23;
- a pull-out tendency of ordinary concrete around the polymer mortar used for CFRP fixing into foundations, see Figure 2.24.

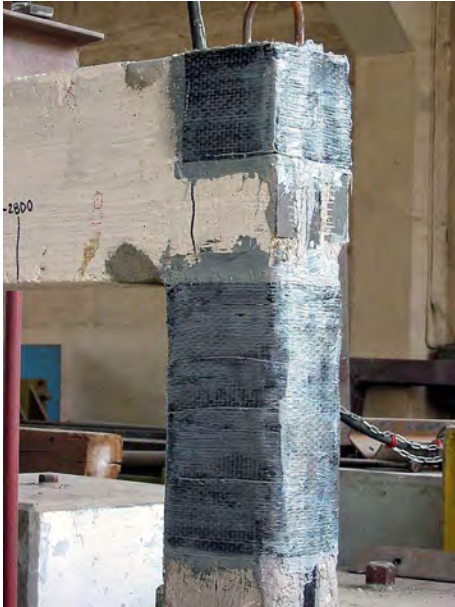
Figure 2.19. Wrap anchorage – Frame 2 (CADRU 2)

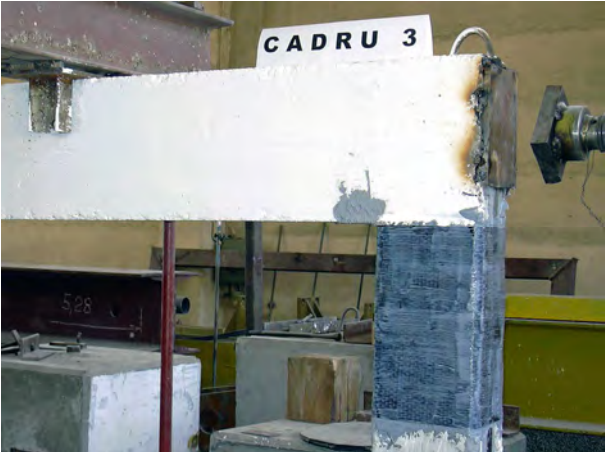
Figure 2.20. Mechanical anchorage – Frame 3 (CADRU 3)

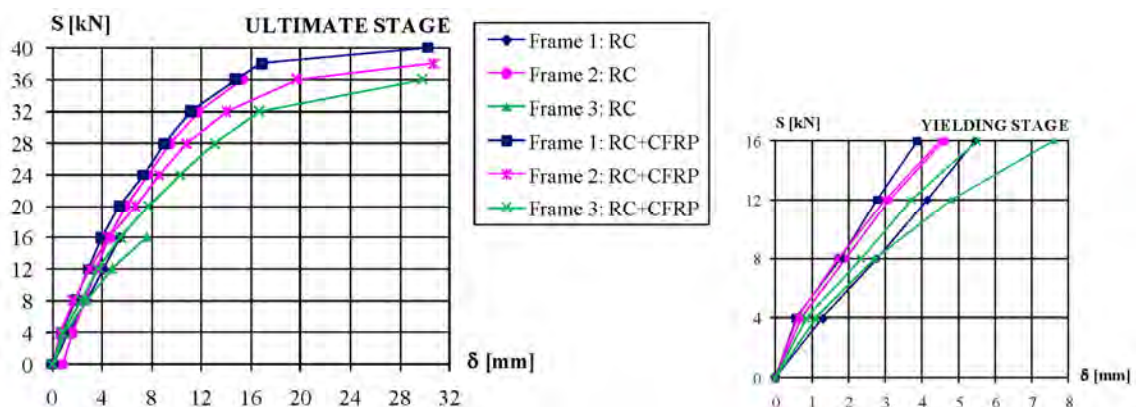
Figure 2.21. Top-displacement values for RC non-strengthened and CFRP strengthened frames.

\* yielding stage of reinforcement; \*\* ultimate stage

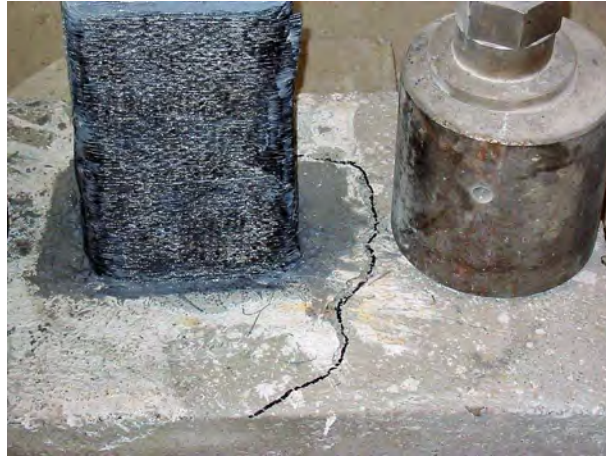
Figure 2.24. Pull-out of concrete and CFRP from foundation

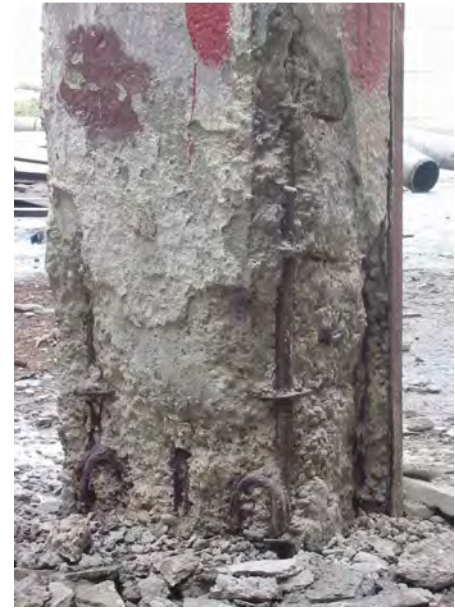
The main damages consisted of: concrete cover dislocated over large surfaces; high corrosion of stirrups and longitudinal reinforcement of columns (Figure 2.29) and beams.

Figure 2.29. Columns damages

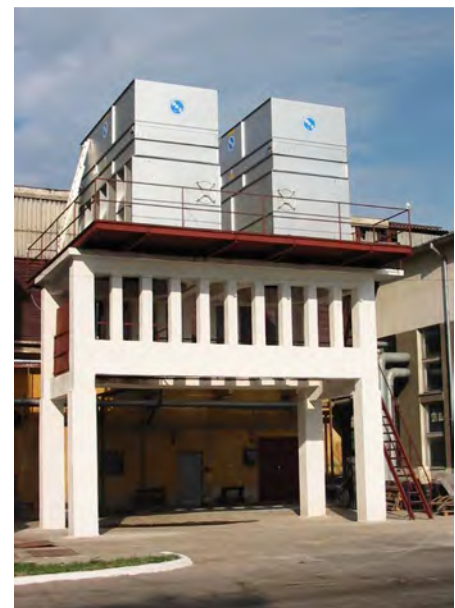
Figure 2.31. Rehabilitated structure

In order to supply the columns corroded reinforcement, structural rehabilitation was performed using steel profiles (Figure 2.30). After rehabilitation the utility of the structure was changed for supporting new cooling equipment (Figure 2.31).

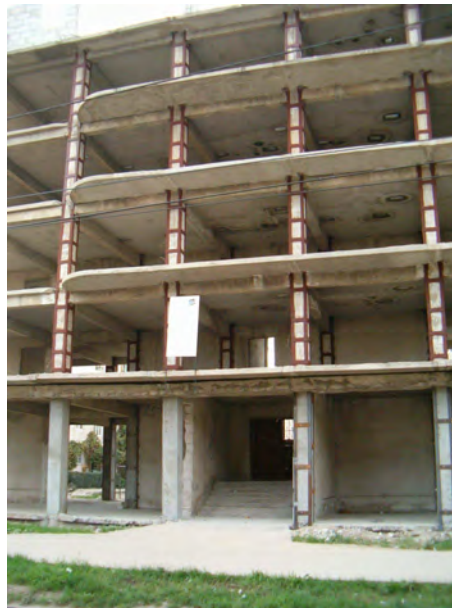
Figure 2.32. Strengthening of columns for an office building

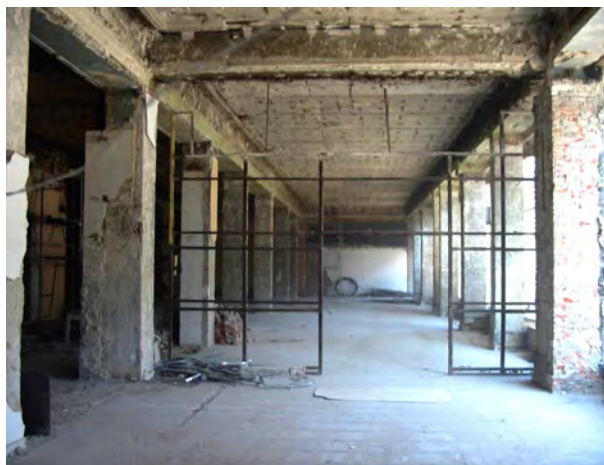
Figure 2.34. Longitudinal reinforced concrete frames

Initially it was an entire masonry structure, but later the ground floor was changed: some resistance brick walls were cut and two longitudinal reinforced concrete frames (Figure 2.34) were erected to sustain all the vertical loads. Due to this architectural operation the structure became more vulnerable at seismic actions: by the transversal direction main part of the ground floor became unstable at horizontal actions because the new reinforced concrete columns present hinge connection at both ends in masonry walls from the underground floor and first storey. Other vulnerabilities of the building consist of: overall lateral stiffness values along the two main axes are different; lack of seismic joints to divide building parts having different dynamic characteristics; lack of straps at each floor.

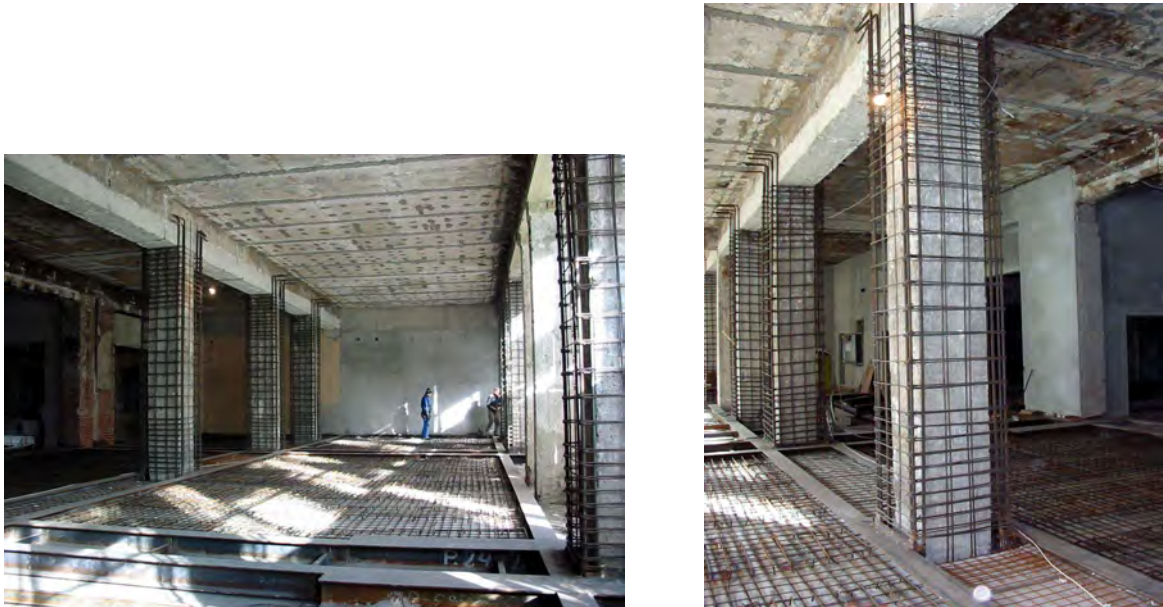
Figure 2.35. Strengthening of slab and columns

- strengthening of half from the existing columns (0,60x0,60 m coated by reinforced concrete to become 0,90x0,90 m) and erecting of new transversal reinforced concrete beams in order to create new transversal frames;
- strengthening by reinforced concrete coating of existing longitudinal beams;
- rehabilitation of some structural elements having corroded reinforcement as well as of some brick walls.

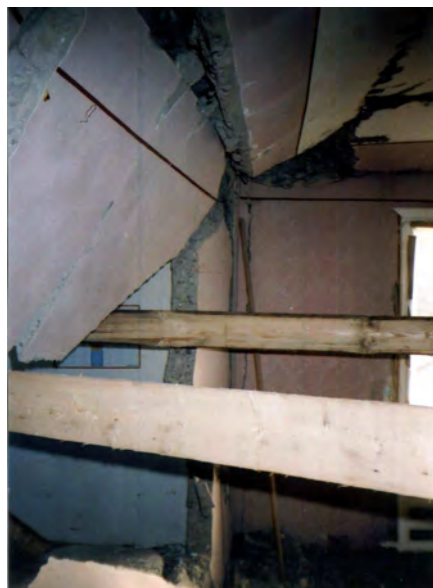
Figure 2.38. Fracture of reinforced concrete walls

This building is 5 stories with 100 bed-sitters and the explosion was located in the second flat at the 4<sup>th</sup> storey. The cause of explosion was the leaking and accumulation of propane gas from a gas recipient into the flat. The initial explosion totally destroyed the concrete walls, reinforced concrete floors, windows and door of the flat and caused serious damage of the others structural members.

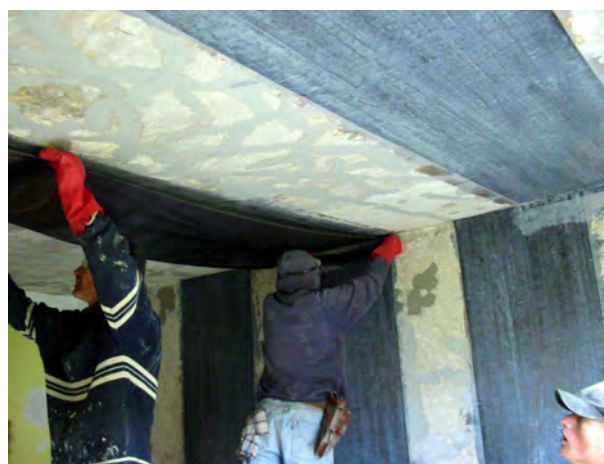
Figure 2.40. CFRP structural rehabilitation of walls and floors

- new reinforced concrete walls at levels 4 and 5 which represent 4 transversal walls (with the same width as of the corresponding walls with new shirts) and 4 longitudinal – lateral walls;
- local strengthening with reinforced concrete shirt (50 mm on each side), columns (0,60x0,20 m in the gangway and 0,30x0,20 m at facade) and longitudinal beams at all levels (0,20x0,30 m), vertical elements from ground floor to the roof, incorporating the new walls, on the one part of the gangway (Figure 2.39);
- rehabilitation of the cracked elements with carbon fibre reinforced polymer (CFRP) wrap for 10 transversal walls and 12 floors (Figure 2.40).

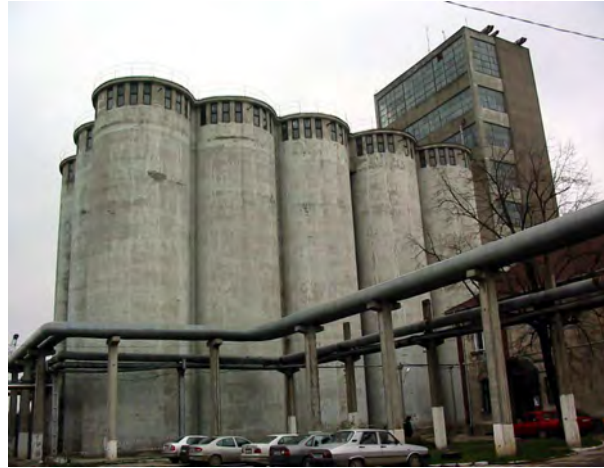
Figure 2.41. Reinforced concrete silos

The assessment and rehabilitation solutions for a group of silos owned by the SAB Miller Brewery Company “Timisoreana” are presented (Figure 2.41):

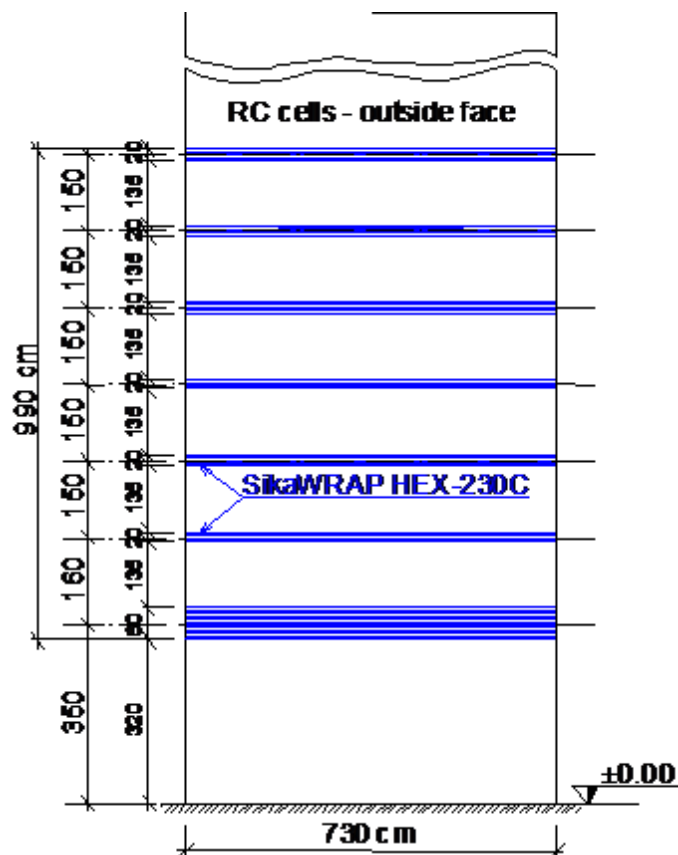
Figure 2.43. CFRP strengthening of cells walls

The strengthening solution for the **silos circular cells** was the use of CFRP strips as near surface mounted reinforcement. The SikaWRAP HEX-230C strips were placed on the most stressed zone (+3,20...+13,20 m), outside of cells (Figure 2.43). This solution seemed to be more advantageous than the near surface mounted reinforcement of CFRP rods:

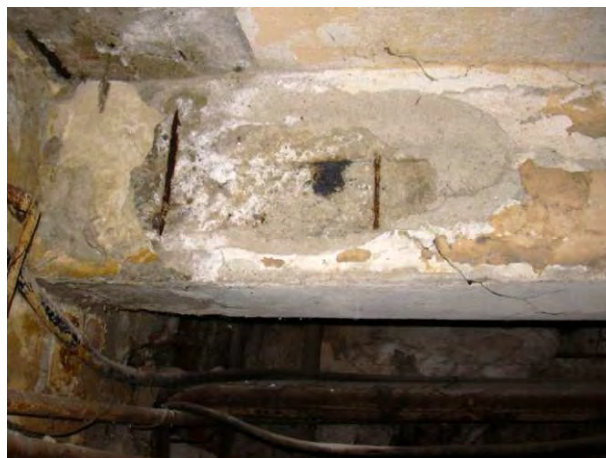
Figure 2.47. Damage of beams

The main problems comprised local damage of some structural elements and weakness of reinforcement of columns and beams at present-day magnitude of seismic action. Local damages were observed and assessed at slabs, main girders, secondary beams (Figure 2.47) and columns (Figure 2.48). The damage consisted of: concrete cover dislocated over a large surface; corrosion of many stirrups; deep corrosion of main reinforcement.

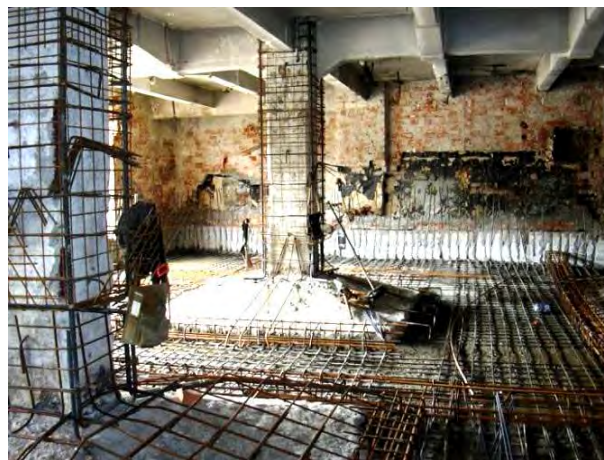
Figure 2.49. Reinforced concrete jacketing of columns and foundations

The rehabilitation of the reinforced concrete structure, performed in 2008, was adopted for both types of damages. The strengthening consisted in jacketing with reinforced concrete of columns and foundations:

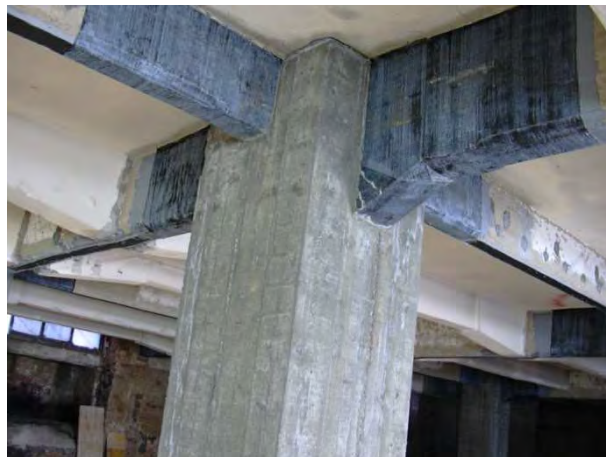
The strengthening solution adopted for beams and slabs was based on carbon fibre polymer composites (CFRP) as it is illustrated in Figure 2.51:

- longitudinal CFRP lamellas and transversal CFRP wrap for beams;
- CFRP wrap for slabs.

Figure 2.51. CFRP strengthening solution for beams

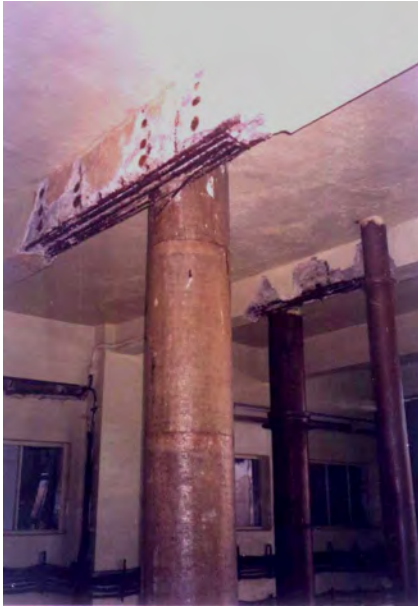
damage consisted of: concrete carbonation; concrete cover spalled over a large surface; complete corrosion of many stirrups and deep corrosion of main reinforcement; some broken reinforcement. The damaged areas were located at the second floor (level +10,80 m), in the middle of the span for secondary beams, on potentially plastic hinge regions of the main girder and columns (Figures 2.56-2.59).

Figure 2.56. Damage of secondary beams

Such damage was caused by the action of chloride ions ( $\text{Cl}^-$ ) from salt solution, which was stored on the second floor as well as of  $\text{CO}_2$ ,  $\text{RH} \approx 80\%$  and temperatures over  $40^\circ\text{C}$ .

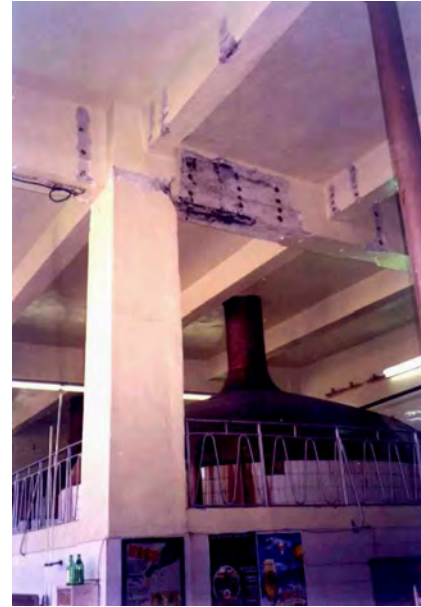
Figure 2.57. Damage of main beams

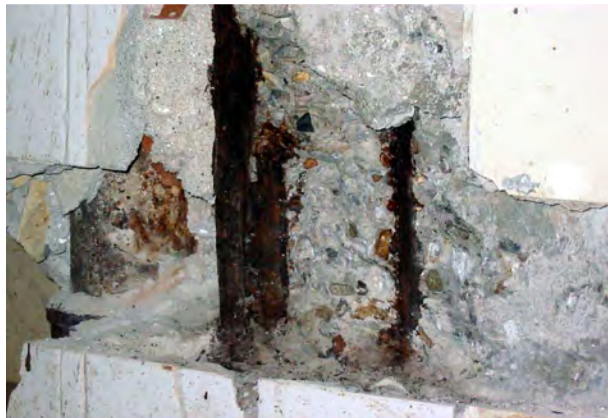
Figure 2.58. Damage of columns

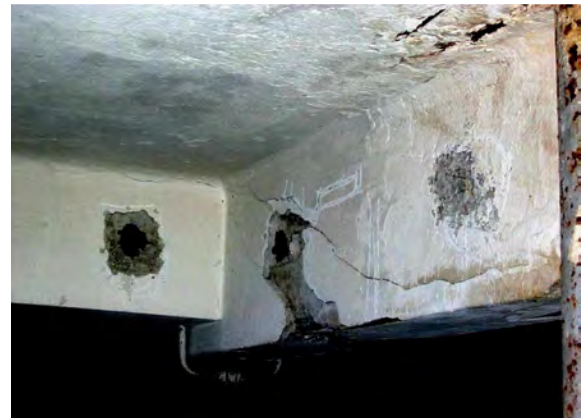
Figure 2.59. Inclined cracks at main beams

At some main beams dangerous inclined cracks were also detected at the secondary beam to main beam connection due inadequate transversal reinforcement at shear force.

A special analysis was performed on the floor beams GE14 and GE15 of the 4<sup>th</sup> storey, where some inclined and dangerous cracks were present, due to: inadequate shear reinforcement (stirrups or/and inclined bars) near the force load (around the secondary beam) where the shear force has an important sensitive value.

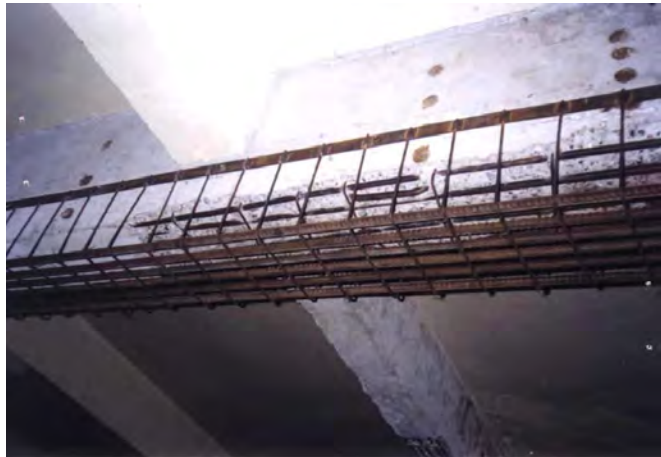
The main girders and secondary beams were strengthened by coating with reinforced concrete. New  $4\phi 25$  mm reinforcement bars for each secondary beam and  $6\phi 25$  mm reinforcement bars for main girder were placed at 15 cm from the bottom side of the beams with new stirrups  $\phi 8/15$  cm (see Figures 2.61-2.62). One column was strengthened for both local damage and inadequate existing reinforcement. The coating with reinforced concrete was used over two storeys and consists of  $16\phi 28$  mm longitudinal reinforcement bars, stirrups  $\phi 10/15$  cm and 22,5 cm concrete depth on all four sides (see Figure 2.63). The existing foundation was jacketed over and around by 50 cm depth reinforced concrete for secure fixing of the column new main reinforcement. Reinforcement steel characteristics used for strengthening are: Romanian ribbed bars PC52 ( $f_{yk} = 350 \text{ N/mm}^2$ ;  $f_{yd} = 300 \text{ N/mm}^2$ ) for longitudinal reinforcement and Romanian plain bars OB37 ( $f_{yk} = 245 \text{ N/mm}^2$ ;  $f_{yd} = 210 \text{ N/mm}^2$ ) for stirrups. New concrete was class C20/25.

Figure 2.62. Reinforced concrete strengthening of main girder

The new longitudinal reinforcement bars from beams were anchored at the ends by welding on steel plates fixed in the nodes by steel collars around the end nodes of the existing concrete structure. The new stirrups from beams were welded on longitudinal continuous steel plates fixed in the web of existing beams by using mechanic bolts. All these detailing aspects will be further illustrated as construction procedures.

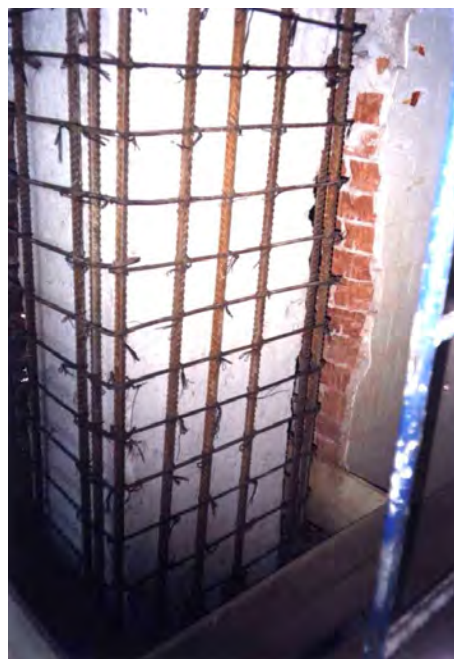
The rehabilitation of the reinforced concrete structure adopted and performed in 1999 for both types of damages consisted of jacketing with reinforced concrete of deteriorated beams, one column and its foundation (Figures 2.61-2.63).

Figure 2.63. Reinforced concrete strengthening of column
