# HABILITATION THESIS

**Rehabilitation of Existing Concrete and/or  
Masonry Structures in Seismic Regions.  
A Permanent Challenge for Civil Engineers**

**Assoc. Prof. DAN Sorin-Ioan, PhD**

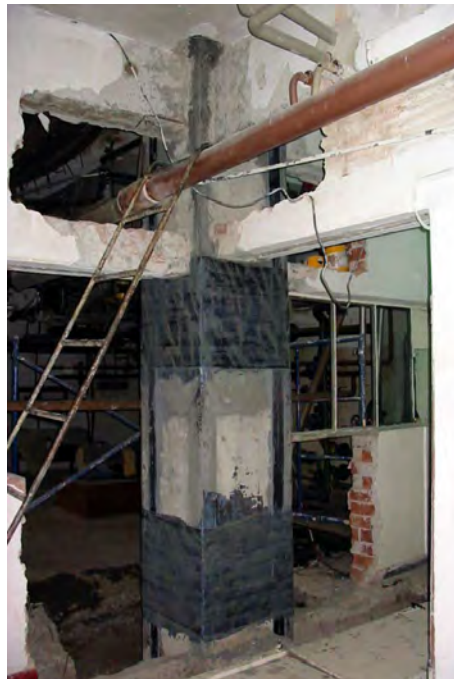
The bond of CFRP materials to the existing concrete layer was ensured by specific adhesives (Sikadur). The longitudinal CFRP strips for columns strengthening were anchored in holes of 20 cm depth performed into existing reinforced concrete foundation.

Figure 2.64. CFRP strengthening of column

The column was strengthened with longitudinal CFRP strips on all four sides. The strips were placed in a different position in the cross section in order to pass by the structures node. As shear strengthening, a single layer of CFRP closed jacket sheet was used at the ends of the column. The beams were strengthened by a longitudinal CFRP strip placed at the bottom side of the cross section. As shear strengthening, a single layer of CFRP open jacket sheet was used at the ends of the beams. The construction steps for CFRP strengthening were:

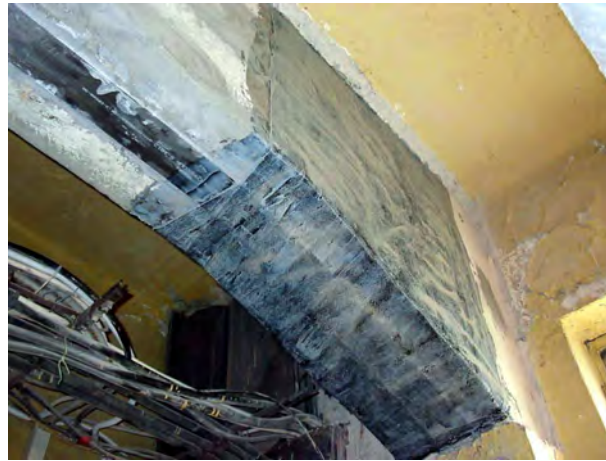
The longitudinal CFRP strips for beams strengthening started at the face of column-beam node as it were used as lower reinforcement in the beams span.

Figure 2.65. CFRP strengthening of main girder

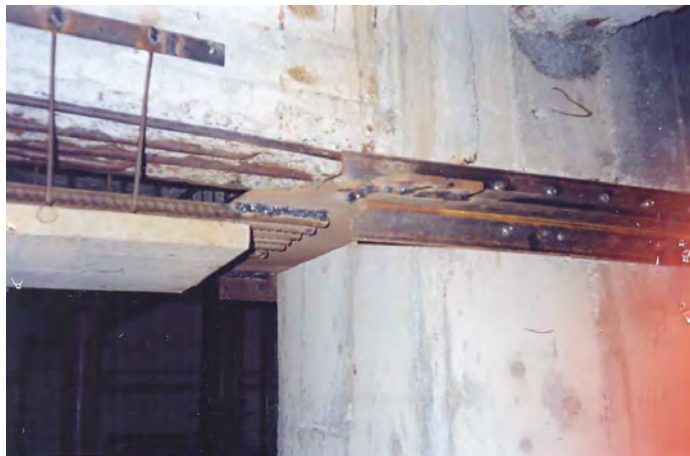
Figure 2.67. Anchorage detailing at beams end

- Spalling of damaged concrete cover and mechanical cleaning (sand blasting) of existing concrete substrate;
- Fixing of steel collars around the beam-column nodes by mechanical bolts and the steel plates for welded anchorages of longitudinal new reinforcement bars from beams (see Figure 2.67);
- Placing of longitudinal new reinforcement for beams (see Figure 2.68) and for columns with the secure fixing into foundation (see Figure 2.69);
- Placing of the new transversal stirrups for beams and columns. The stirrups from beams were welded on longitudinal continuous steel plates fixed in the in the web of existing beams by using mechanic bolts.
- Manufacture and placing of timber framework and shoring;
- Casting of concrete.

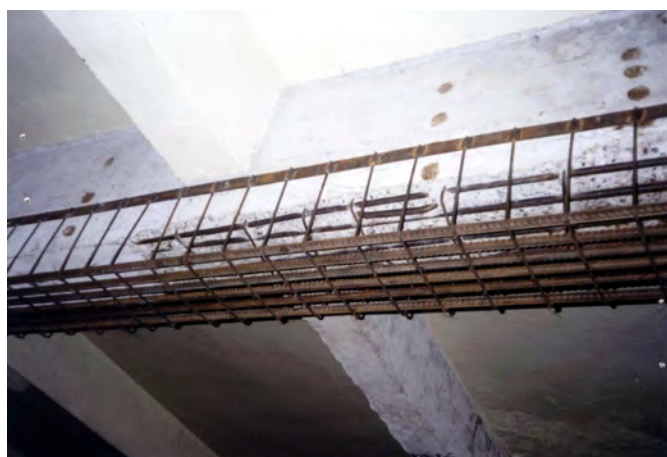
The first rehabilitation of the reinforced concrete structure was performed as follows. The beams were strengthened by coating with reinforced concrete at the bottom side for embedding the new longitudinal reinforcement bars and on the two lateral sides for embedding the new stirrups (Figures 2.67-2.68). The column was strengthened by coating with reinforced concrete on all four sides (Figure 2.69). The construction steps for reinforced concrete jacketing were:

Figure 2.68. Reinforcement detailing at beams

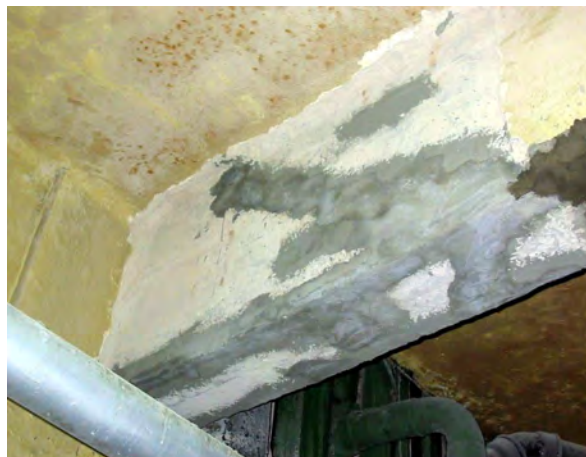
- Mechanical cleaning (sand blasting) of existing concrete substrate and dust removal;
- Sealing of existing cracks and surface repair with Sika epoxy based mortars for obtaining a smooth plane application surface (see Figure 2.70);
- Mechanical rounding of concrete cross section corners at 20 mm radius for CFRP sheets application;
- Application of specific two components mixed adhesives on the concrete substrate. The used adhesives were Sikadur-30 for CFRP longitudinal strips and Sikadur-330 for CFRP sheets.

Figure 2.70. Surface repair and preparation before CFRP application

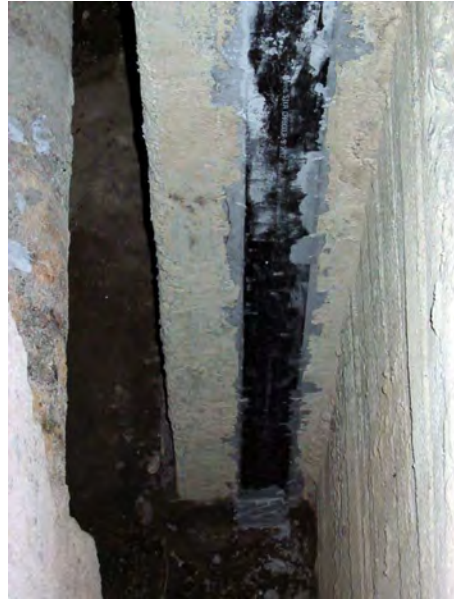
Figure 2.71. End anchorage of longitudinal CFRP strips for column

- Placing CFRP strips (see Figures 2.71-2.75) bonded by previous presented adhesives. The end anchorage of longitudinal CFRP strips for columns was ensured into holes of 20 cm depth performed into existing reinforced concrete foundation (see Figure 2.71). The longitudinal CFRP strips for beams started at the face of column-beam node as it was used as lower reinforcement in the beams span.
- Placing of CFRP sheets (see Figures 2.72-2.75) bonded by previous presented adhesives. The CFRP wrapping was applied: on four sides for column as closed jacket with a horizontal overlapping of 10 cm and on three sides for beams as open jacket.
- Protection of CFRP strengthening materials by a cement mortar layer.

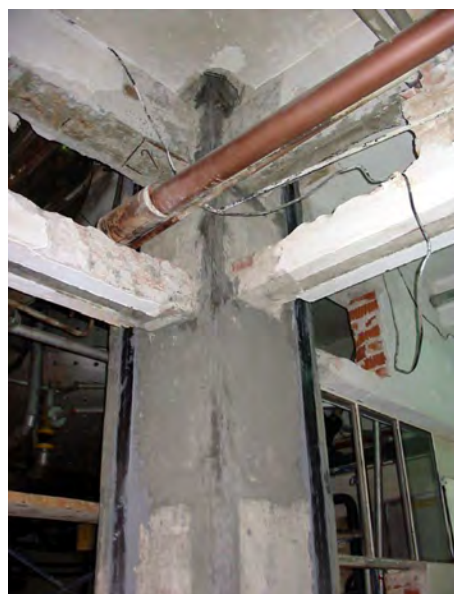
Figure 2.72. CFRP application for column longitudinal strips

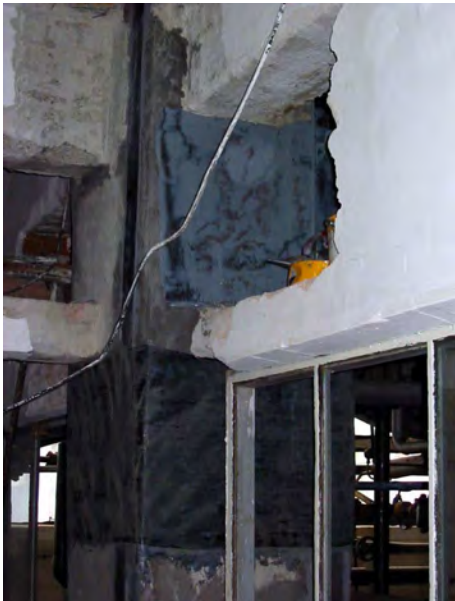
Figure 2.73. CFRP application for column transversal sheets

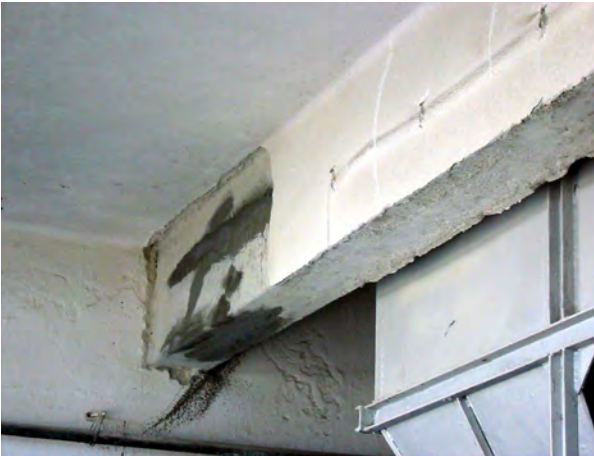
Figure 2.74. CFRP application for beams longitudinal strips

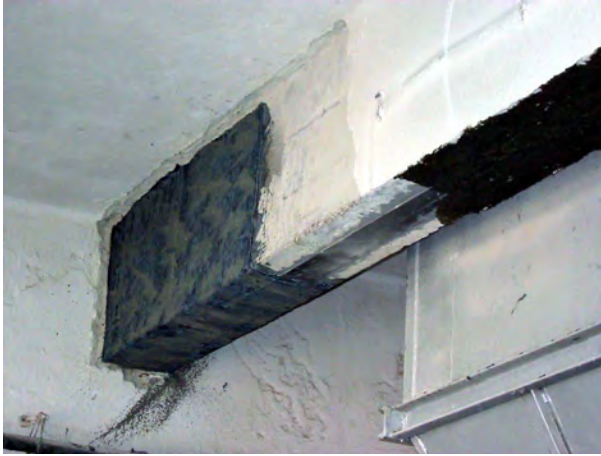
Figure 2.75. CFRP application for beams transversal sheets

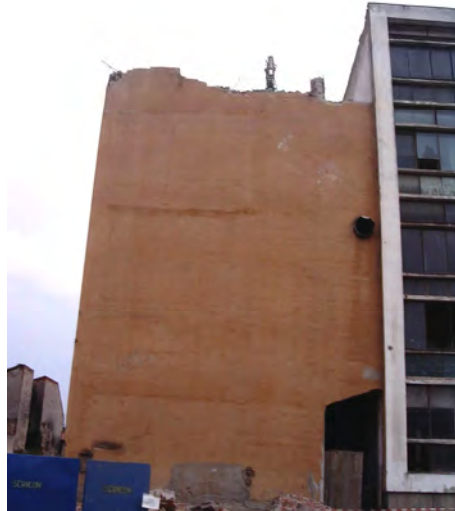
Due to of general conditions of the RC framed structures with local damage caused by industrial exploitation and weakness of reinforcement of columns and beams due to design made before 1970, the company decided to build a new and modern location for industrial process. A demolition design and drawings were produced for a part of building and the other part remained in conservation stage (Figures 2.78-2.79).

Figure 2.78. Partial demolition phase of RC structure

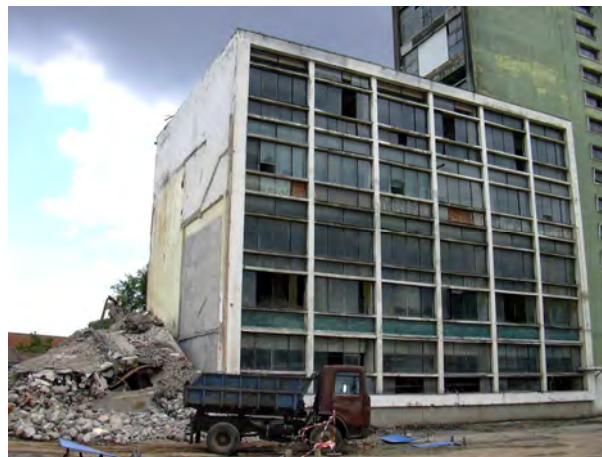
Figure 2.79. RC structure after demolition

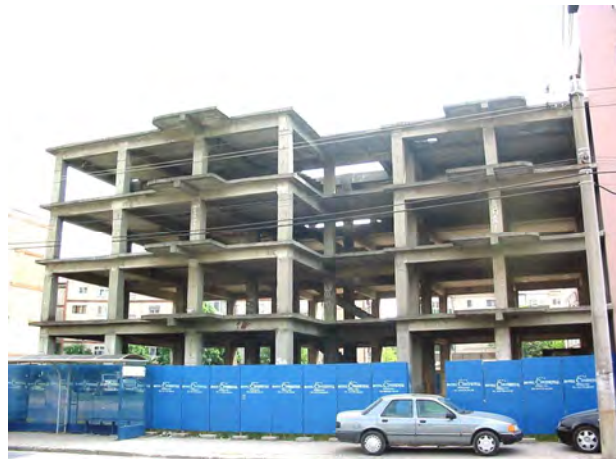
The reinforced concrete structure (Figure 2.82) consists of: rigid underground storey made of shear walls; monolithic spatial frame; horizontal precast floors supported by frame beams; isolated foundations under columns and continuous foundations under shear walls.

Figure 2.82. Block of flats

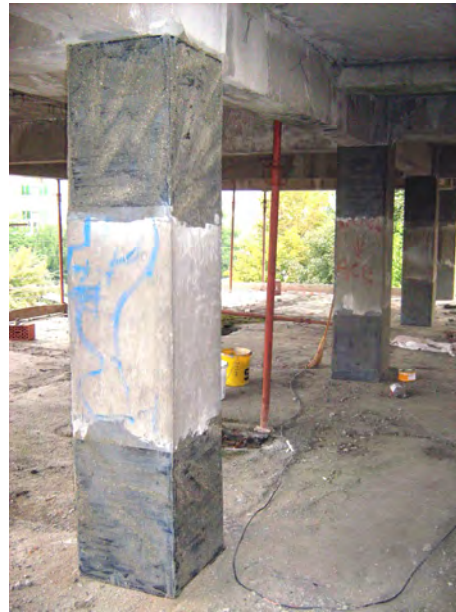
The strengthening consisted in transversal confinement with a single layer of wrap closed jacket at both ends of the columns (Figure 2.83) were the maximum design efforts showed up. The columns have a square cross-section of 450x450 mm. Mechanical rounding of concrete cross section corners at 20 mm radius for CFRP wrap application was performed. The jackets had a width  $b_f = 600$  mm and a thickness  $t_f = 0,12$  mm. CFRP materials characteristics used for strengthening are:  $E_f = 231$  kN/mm<sup>2</sup> and  $\epsilon_{fu} = 0.017$ . The bond of CFRP materials to the existing concrete layer was ensured by specific epoxy adhesives.

Figure 2.83. CFRP confinement of columns

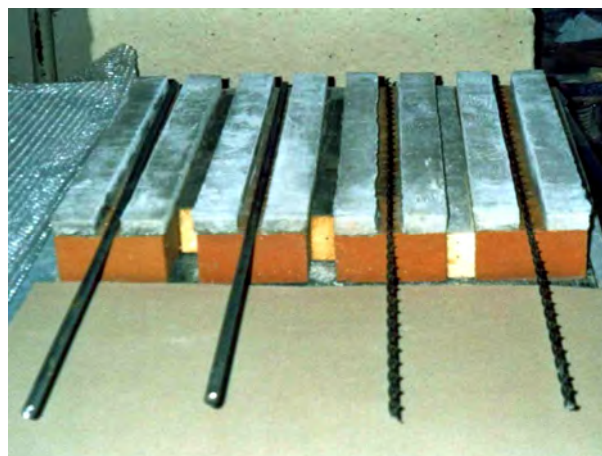
The effect of the near-surface technology can be explained by results of the experimental tests of adherence between brick masonry and steel bars. The test samples before the two bricks specimen are glued together are presented in Figure 3.1:

Figure 3.1. The samples before embedment

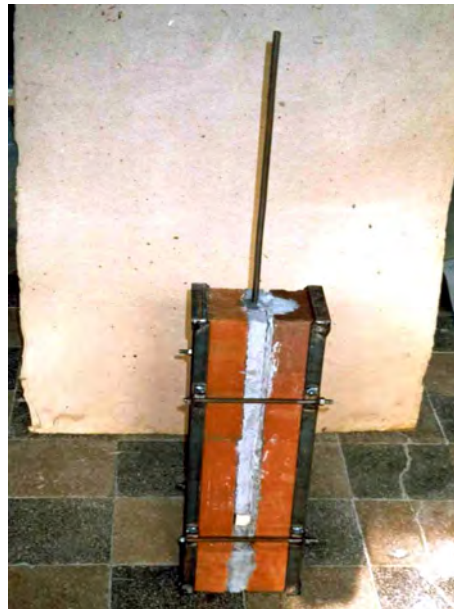
Brutt Helical bars and Profiled Steel bar of  $\phi 6$  mm, failed outside the embedment zone (Figure 3.3) and for the specimens of Profiled Steel with  $\phi 8$  mm and  $\phi 10$  mm the failure have been produced by sleeping of bars (Figure 3.4).

Figure 3.4. Profiled steel bar slipping

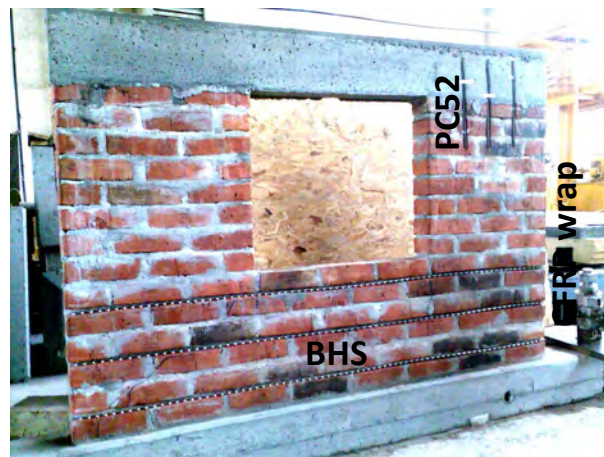
The first tests were done on the un-strengthened masonry wall until cracking and then strengthened (Figure 3.7) and rested.

Figure 3.7. Masonry wall strengthening

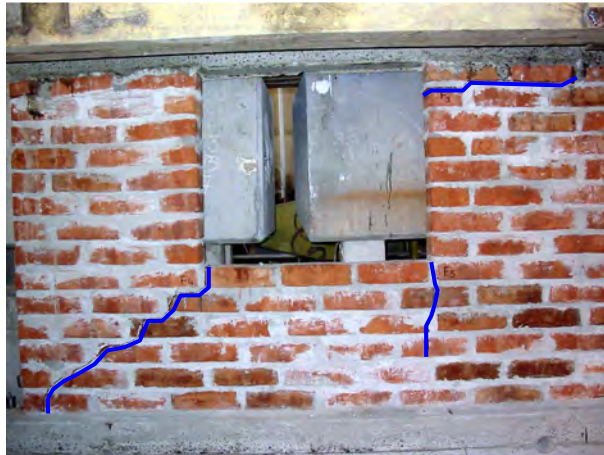
During the tests the vertical load had a constant magnitude, while the horizontal load was increased up to the failure. The failure and the crack pattern for the un-strengthened masonry wall are presented in Figure 3.8:

Figure 3.8. Un-strengthened masonry wall failure and crack pattern

The un-strengthened masonry wall failure was characterized by cracking in different ways:

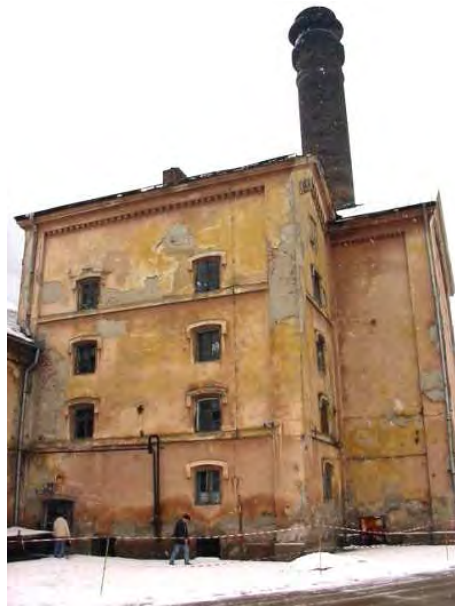
The old malting building, erected between 1857-1876 at the “Timisoreana” Brewery, is a five storeys masonry structure and a tower (Figure 3.18) composed of:

- walls of (140-50) cm thickness;
- inter-storey floors - brick masonry vaults supported by steel profiles;
- a tower, of about 14.00 m height and 2.80 m diameter, supported by an interior dome.

Figure 3.18. Old malting building

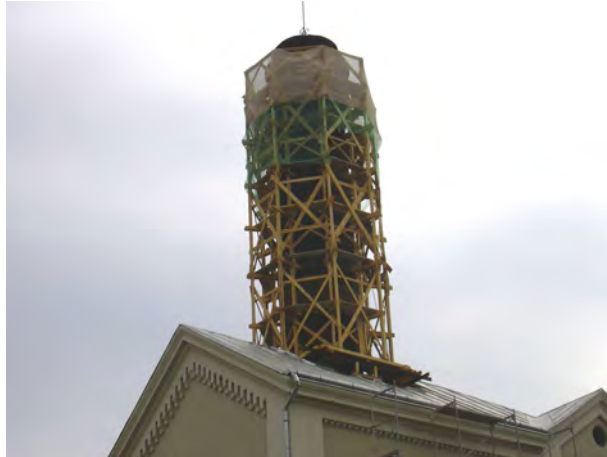
Figure 3.25. Strengthening of tower structure

The old malting building at the “Timisoreana” Brewery was firstly repaired and rehabilitated. Then, in 2008, the masonry tower structure was strengthened.

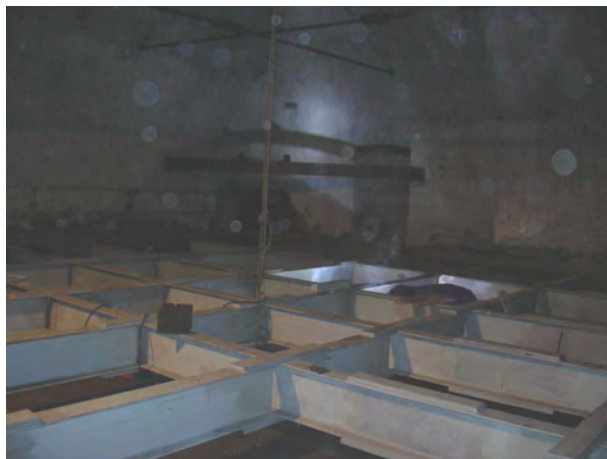
In the dome, at the tower base was placed the steel beams network and embedded in the masonry walls by means of reinforced concrete straps (Figures 3.26-3.27).

Figure 3.26. Steel beams network

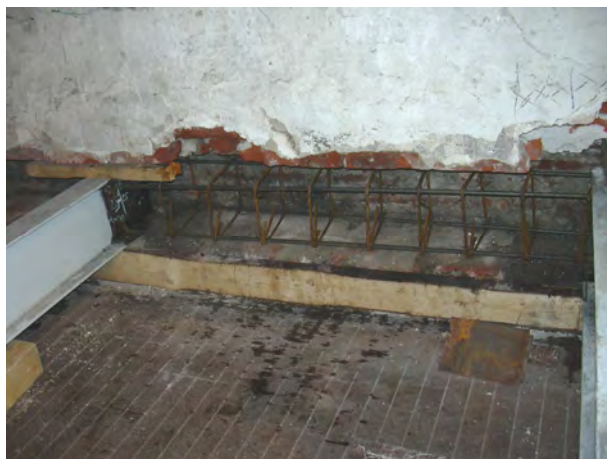
Figure 3.27. RC straps for steel beams embedding

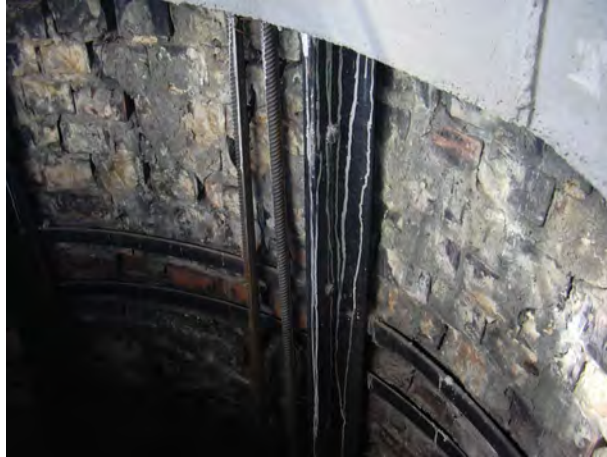
The general stability of masonry tower was ensured by vertical reinforcement bars and vertical CFRP wrap on the entire tower height (Figure 3.28).

Figure 3.28. Vertical rebar and CFRP strips

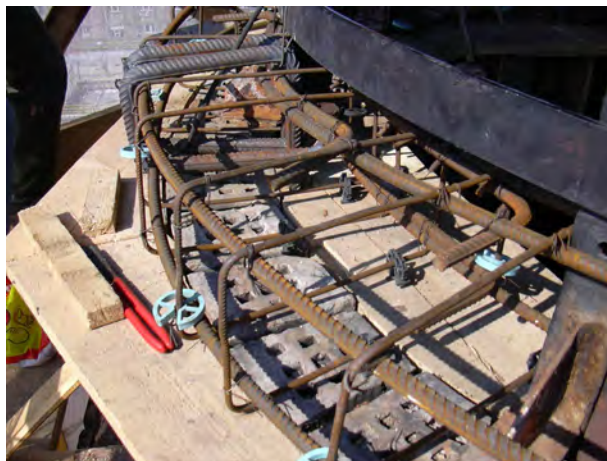
Vertical reinforcement bars were embedded at the upper side of the tower in a reinforced concrete beam (Figures 3.29-3.30) and welded at the bottom side on steel profiles from the tower base.

Figure 3.29. Reinforcing of the tower top beam

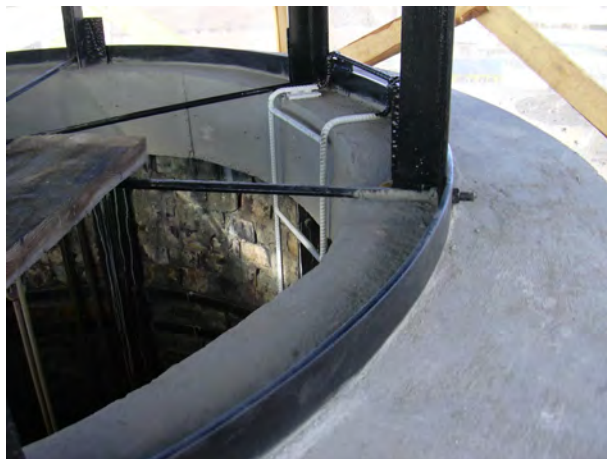
Figure 3.30. Reinforced concrete top beam
