List of 10 relevant publications

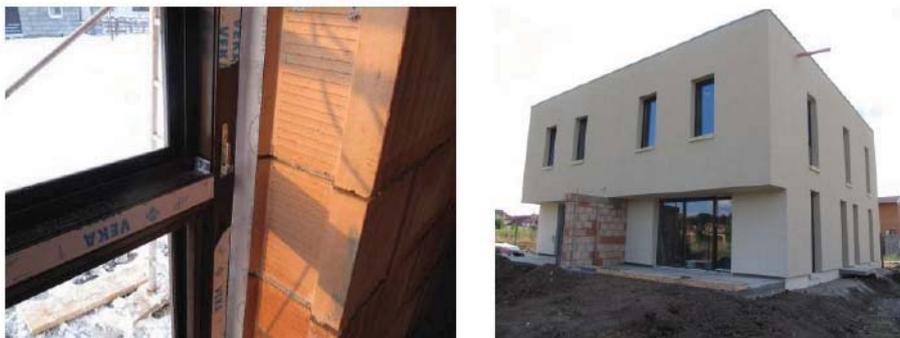
Fig.1. Facade detail and exterior finishing of the passive house

As it is known, a passive house is defined as a building with very low energy consumption (max 15kWh/m²/year for heating and cooling and a total energy footprint of less than 120kWh/m²/year) [1]. The house has approximately 144 m² living space, corresponding to the needs of an average family. The project complies with Passive House Standards, being built in a newly developing urban area nearby the city of Timisoara. [2] The exterior envelope of the passive house is composed of masonry structural walls from ceramic hollow blocks of 25 cm thickness, complemented with 300 mm thickness thermal insulation, for the vertical surfaces (fig. 1) [3].
